## Inspection Report

### ERD Home Inspections

**Property Address:**  
home inspection way  
Monroe NC

<b>Date:</b> 5/10/2016	<b>Time:</b>	<b>Report ID:</b> 5/10/2016
<b>Property:</b> home inspection way Monroe NC	<b>Customer:</b> ERD Home Inspections	<b>Real Estate Professional:</b>

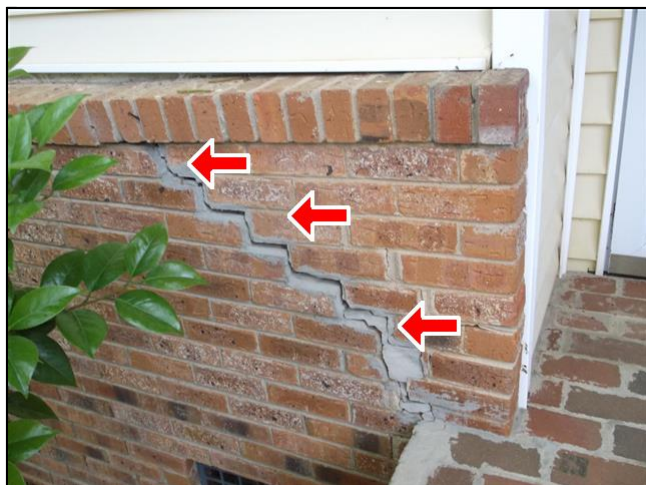
2.0 Item 1(Picture)

**2.0** Substantial foundation cracking was observed at front of home. This implies that structural movement of the building has occurred. The rate of movement cannot be predicted during a one time inspection.. A qualified Structural Engineer should be consulted to further evaluate this condition and the remedies available for correction.

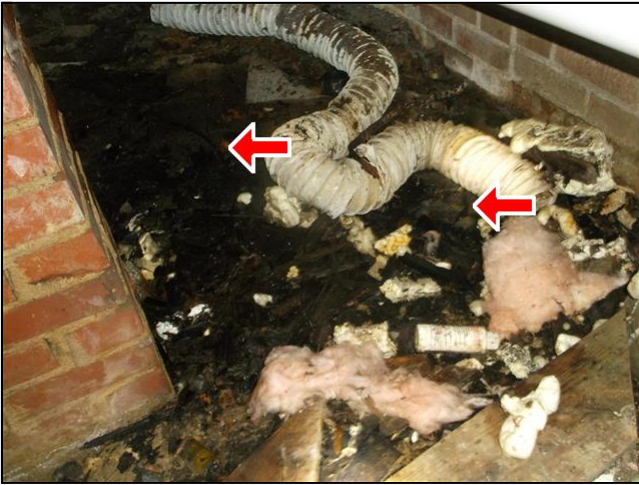
2.1 Item 1(Picture)

**2.1** There is evidence of past water in the crawl space at various locations. This condition may vary seasonally and/or with precipitation intensity. Lot drainage and / or roof drainage improvements should be addressed as a first step to controlling water in the crawl space. This condition should then be monitored to determine if drainage systems are necessary. All wood debris and/or trash should be removed from the crawl space. Crawl space wood/soil contact should be eliminated. This condition is conducive to rot and wood boring insect activity. A licensed technician should be consulted to evaluate and make corrections.

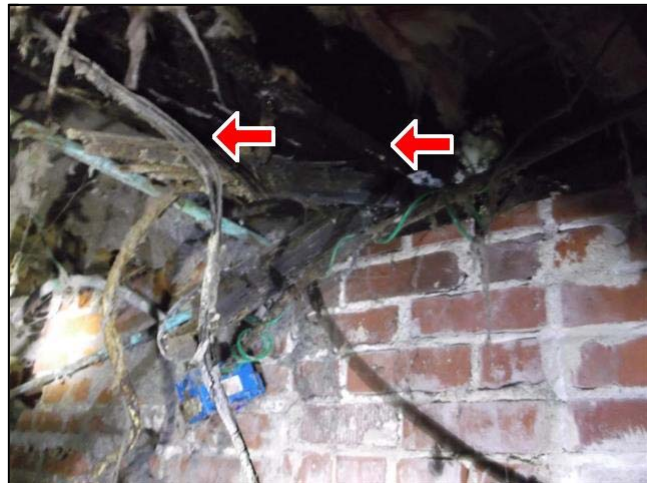
2.2 Item 10(Picture)

**2.2** The sub-flooring, beams and band sills at various locations of the building are damaged where visible. The sub-floor is a part of the structure and we recommend that a licensed contractor or engineer be consulted for the type and extent of the repairs. As with all areas that are concealed more extensive damage may be revealed when the repairs are undertaken

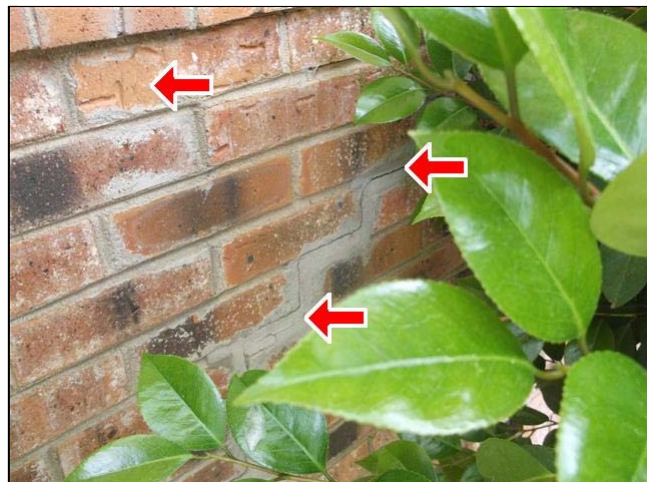
2.3 Item 2(Picture)

**2.3** Pronounced exterior wall cracks were observed. This implies that structural movement of the building has occurred. The rate of movement cannot be predicted during a one-time inspection. A structural engineer should be consulted to further evaluate this condition and the remedies available for correction.

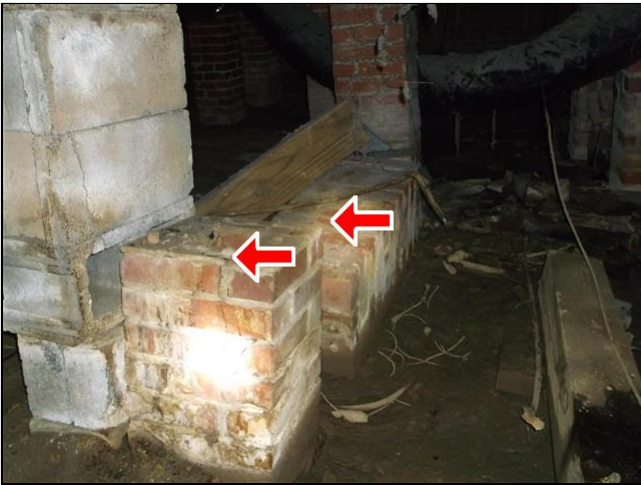
2.4 Item 1(Picture)

**2.4** Concrete pier(damaged) and wood piers are not supported by a proper concrete footing in the crawlspace at the (rear of home). Recommend a qualified licensed contractor be consulted for further evaluation and recommendations..

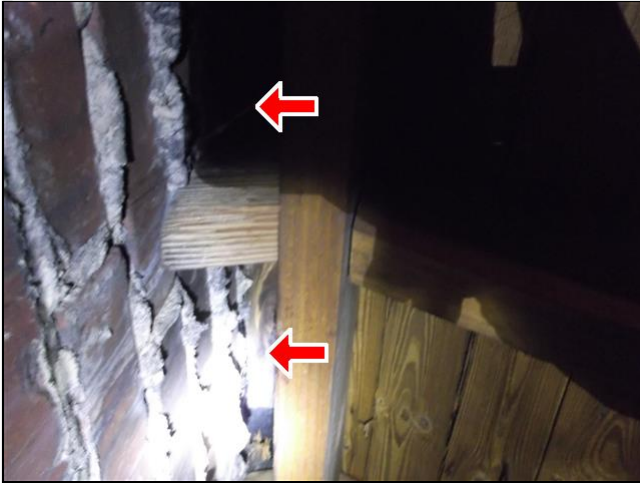
2.5 Item 1(Picture)

**2.5** Evidence of prior leaking was noted to the roof decking / sheathing observed in the attic at chimney. The weather conditions leading up to and including the day of the inspection can greatly effect this test. We recommend that these areas and all roof penetrations should be monitored and sealed as necessary. Rafters damaged are under-size or over spanned, and proper support should be provided to reinforce roof around chimney. Recommend a qualified licensed repair contractor be consulted for further evaluation and recommendations.

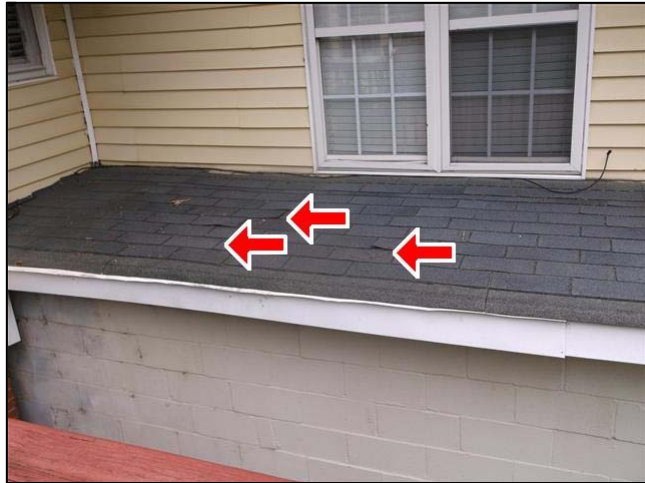
3.0 Item 14(Picture)

**3.0** Repairs to the roofing are recommended. Damaged or missing roofing material should be repaired. All roof penetrations should be examined and sealed as necessary. Nail "Pops" (Nails pushing up shingles) should be repaired to prevent permanent damage to roof coverings. A qualified roofing contractor should be consulted for further evaluation and recommendations.

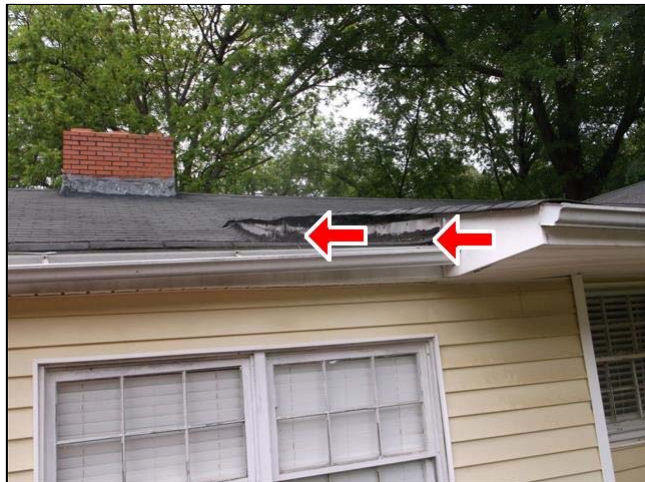
3.1 Item 2(Picture)

**3.1** The flashing is loose and should be secured at rear. If leakage occurs, patching could be attempted. If this is unsuccessful, replacement may be necessary. A licensed roofing contractor should be consulted to evaluate and make necessary repairs.

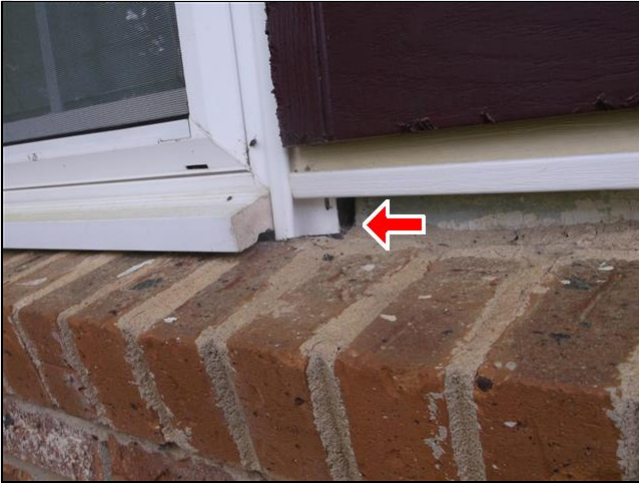
4.0 Item 1(Picture)

**4.0** Localized pointing of deteriorated mortar between the bricks of the exterior walls is advisable. Replace or repair as needed. Holes in siding or damaged siding need repairing or closing off with sealant or liquid foam at various locations. Water may enter if not corrected. Vinyl siding not installed correctly at various locations. Damaged siding at various locations. Hole in siding needs closing off with sealant or liquid foam at various locations. Water may enter. A licensed technician should make repairs.

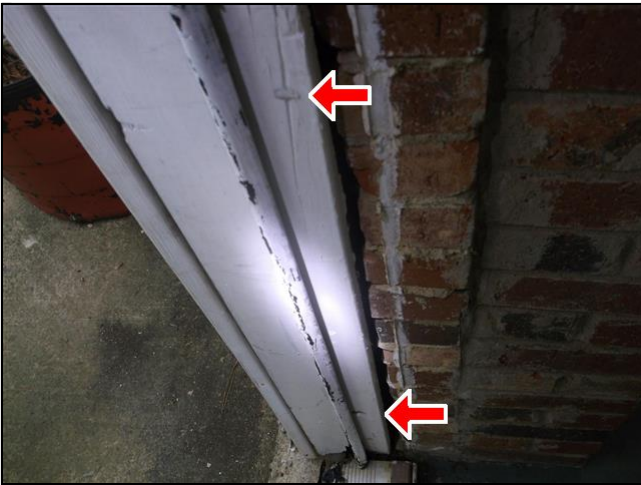
4.2 Item 1(Picture)

**4.2** Exposed wood door frame and entry door at front are damaged and has wood rot. As with all repairs hidden damage may be discovered while repairs are being completed. Repair or replace. Damaged or non functional hardware needs replacing or repairing as needed. This condition should be improved. A licensed technician should be consulted to evaluate and make corrections.

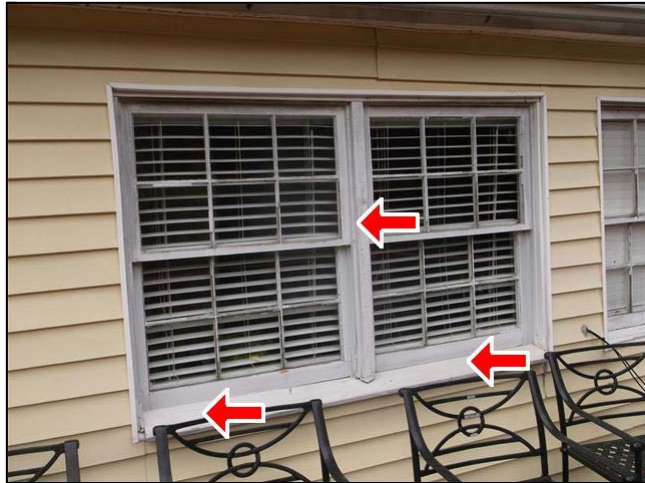
4.4 Item 8(Picture)

**4.4** The windows are in need of repair. This is a common condition that does not necessitate major repair. Trimming and adjustment, hardware improvements and glazing repairs would be logical improvements. The most important factor is that the window exteriors are well maintained to avoid rot or water infiltration. A licensed technician should make corrections.

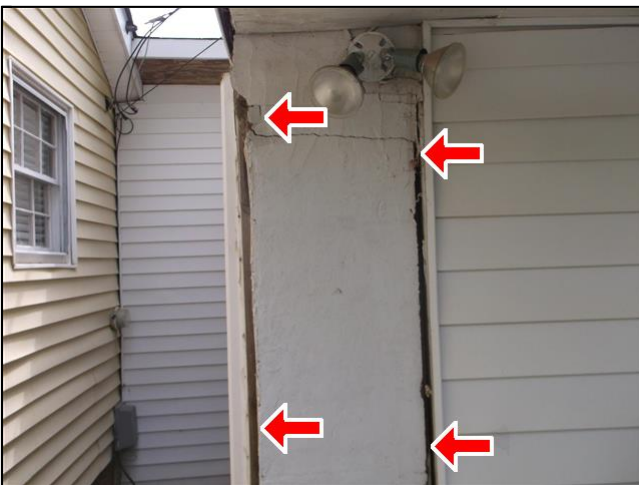
4.6 Item 1(Picture)

**4.6** The wood trim at various locations surfaces should be scraped, caulked and painted. Damaged or poorly painted and caulked wood may lead to water infiltration into the wall and / or floor cavities promoting serious structural damage. As with all repairs hidden damage may be discovered while repairs are being completed. A licensed technician should be consulted to evaluate and make corrections.

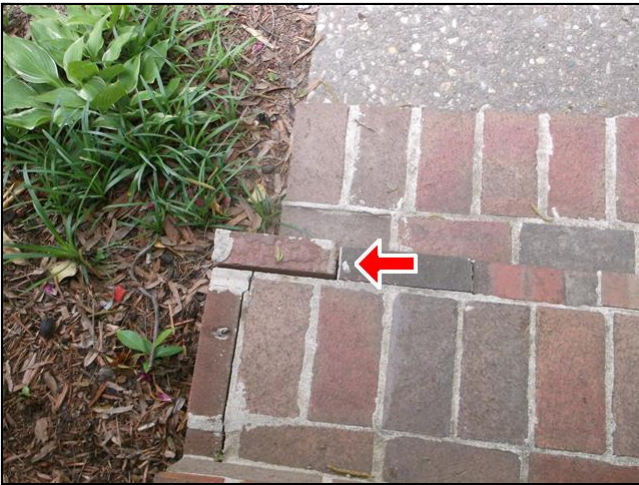
4.7 Item 1(Picture)

**4.7** The masonry steps should be "pointed up" or tuck pointed and any loose material should be repaired or replaced. Water may enter if not corrected. The deck is in need of minor repairs. Loose hand rails need securing at rear deck and rear door. This is a safety hazard if not corrected. Staining the deck will prolong the life of the decking. A licensed technician should be consulted to make necessary repairs.

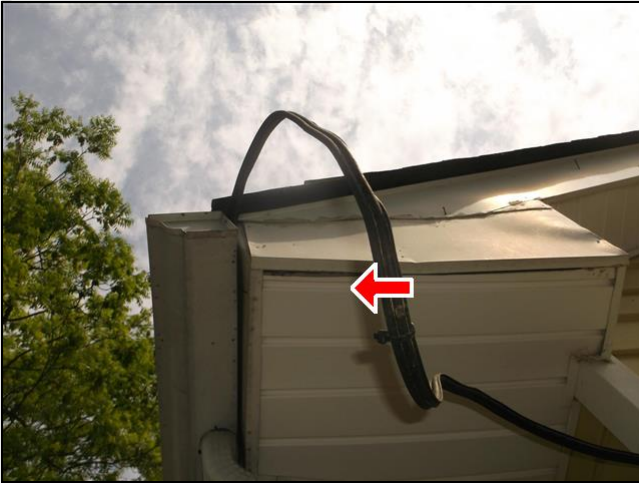
4.9 Item 1(Picture)

**4.9** Fascia board and soffits at various locations of home are loose. Recommend repair or replace as necessary board at rear of home needs scraping, painting and caulking. Damaged or poorly painted and caulked wood may lead to water infiltration into the wall and / or floor cavities promoting serious structural damage. As with all repairs hidden damage may be discovered while repairs are being completed. A licensed technician should be consulted to make corrections.

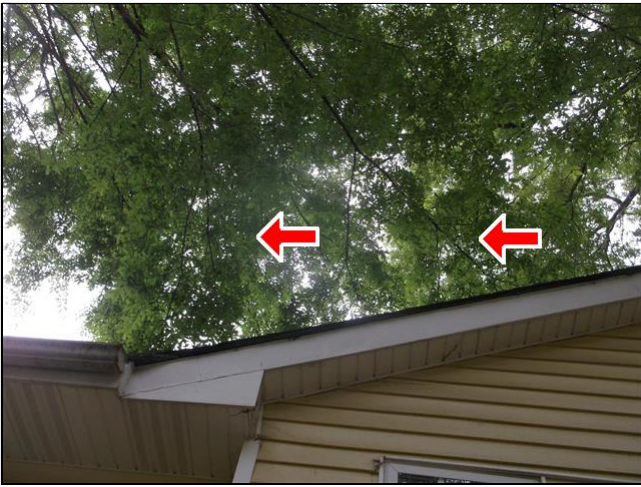
4.10 Item 1(Picture)

**4.10** Photo depicts a sample of the observation. Not all areas were photographed. Tree branches and bushes should be trimmed away from the building.

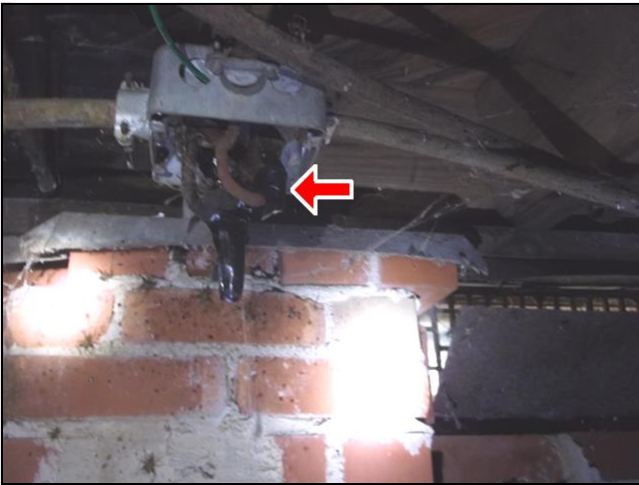
5.4 Item 1(Picture)

**5.4** Several junction boxes need cover plates in attic space and in crawlspace. Extension cord used as permanent wiring at light fixture in unfinished room and at sump pump . Ceiling fan "wobbles" and needs repair in Living room. Exterior light fixture is not installed correctly. Replace or repair. A licensed technician should be consulted to evaluate and make corrections.

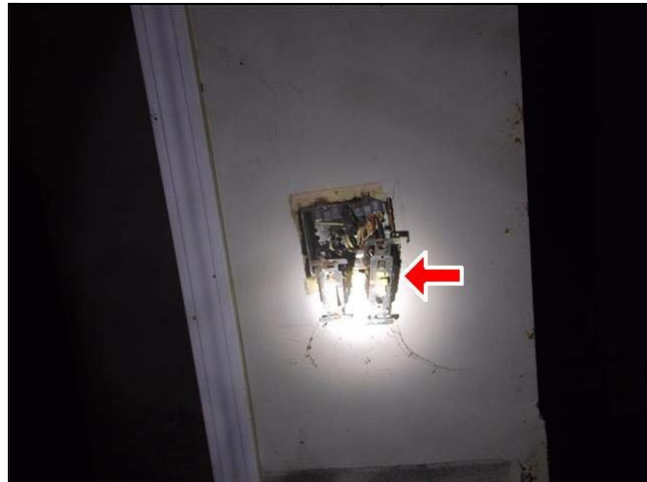
5.6 Item 2(Picture)

**5.6** Outlet covers missing at various locations throughout home. This is a safety issue if not corrected. A licensed technician should make corrections.

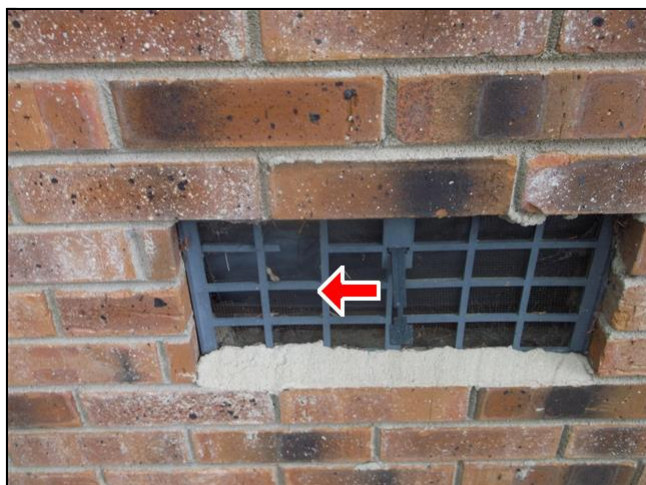
8.0 Item 1(Picture)

**8.0** Foundation vent(s) need screens at various locations. May allow critters to enter if not corrected. A licensed technician should be consulted to evaluate and make corrections.

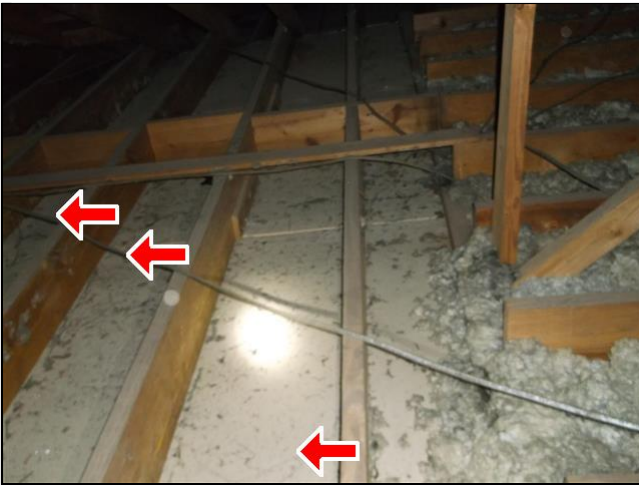
8.1 Item 1(Picture)

**8.1** Un-insulated areas in the attic over conditioned space should be better insulated. This condition may cause energy loss if not replaced. A licensed technician should be consulted to evaluate and make corrections.

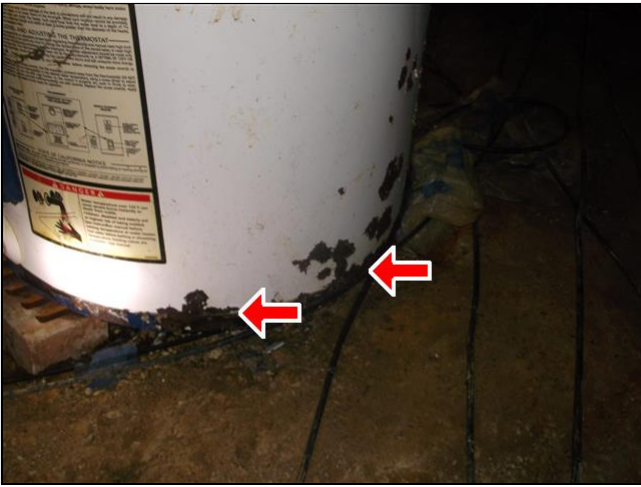
9.0 Item 1(Picture)

**9.0** Water heater appears to be leaking at the bottom. A qualified service technician should be consulted and repair as necessary.

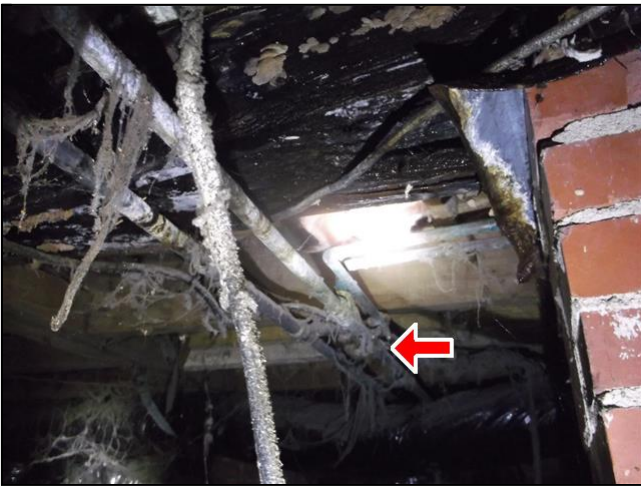
9.1 Item 1(Picture)

**9.1** Copper and galvanized water lines connected in crawlspace. Replace or repair. A licensed technician should be consulted to evaluate and make corrections.

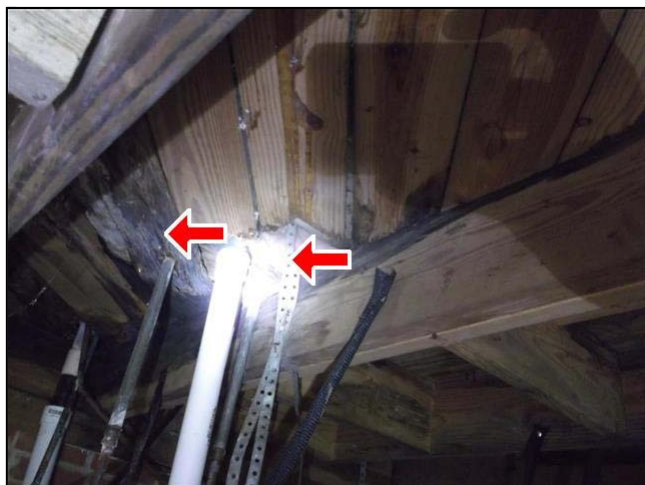
9.2 Item 6(Picture)

**9.2** Plumbing waste line leaks is damaged and shows signs of previous leaking at Hall Bath.Recommend repairing. A licensed technician should be consulted to evaluate and make corrections.

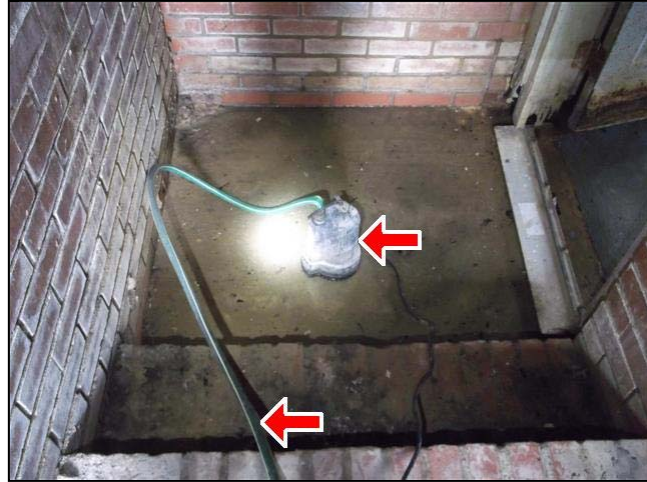
9.5 Item 2(Picture)

**9.5** Visible signs of water intrusion in basement are present and a "Sump Pump" is installed. Existing sump pump fails to remove all areas of water intrusion. Replace or repair. The sump pump uses an extension cord as permanent power source. This is a safety issue if not corrected. A licensed technician should be consulted to evaluate and make corrections.

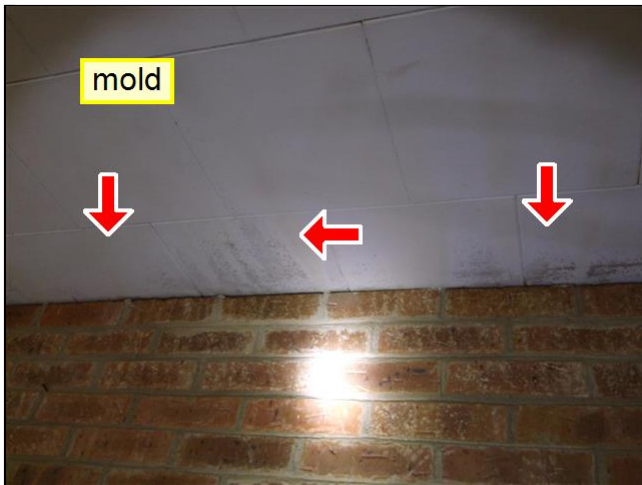
10.0 Item 1(Picture)

**10.0** Damage to the interior finish was observed in various locations(mold in living room at fireplace). Recommend repairing. A licensed technician should make corrections.

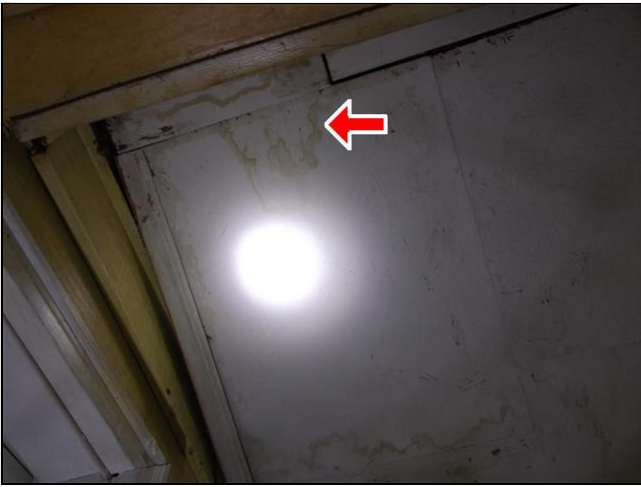
10.1 Item 1(Picture)

**10.1** Damage to the interior finish was observed in several ceilings throughout home. Repair as needed. A licensed technician should make corrections.

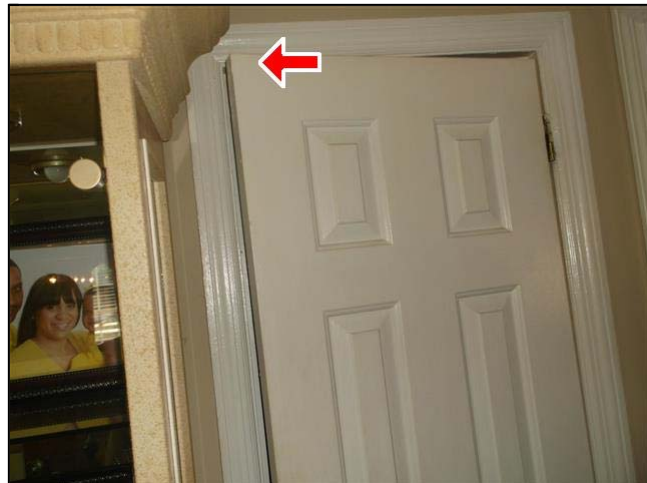
10.7 Item 10(Picture)

**10.7** Entry door shows daylight when closed at patio. Weather stripping needs improving to keep out unconditional air. Several doors does not fit opening properly (out of square) . Replace or repair. A licensed technician should evaluate and make corrections.

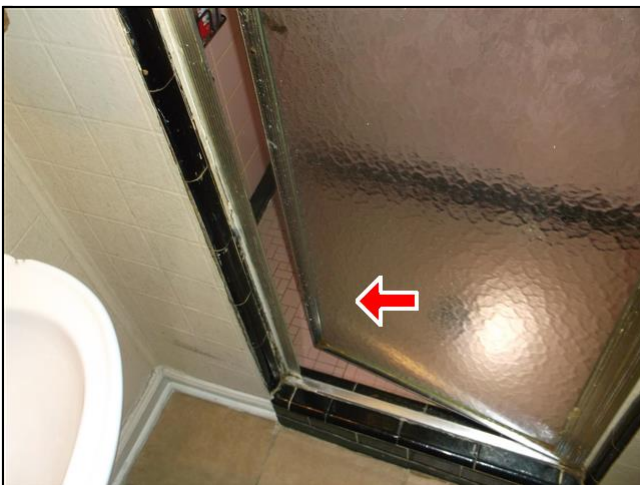
10.8 Item 1(Picture)

**10.8** Shower door is damaged at hall bath. Replace or repair. Damaged metal door to basement . Replace or repair. A licensed technician should be consulted to evaluate and make corrections.

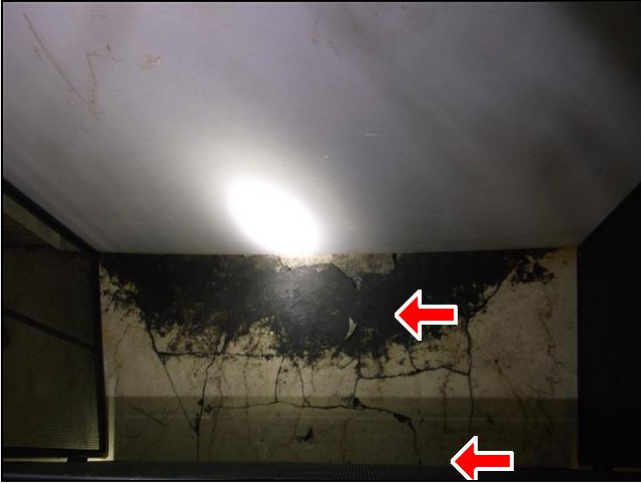
10.9 Item 1(Picture)

**10.9** The hearth outside the fireplace is damaged. Replace. Localized pointing of deteriorated mortar between the bricks of the fireplace is recommended to avoid fire chips from entering. A licensed technician should be consulted to evaluate and make corrections.

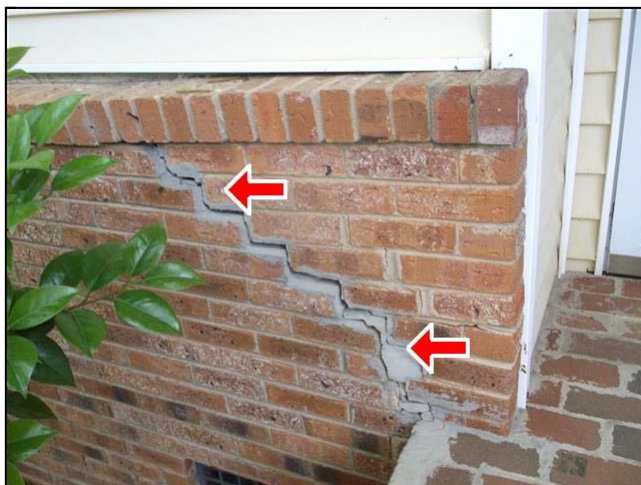
2.3 Item 1(Picture)

Pronounced exterior wall cracks were observed. This implies that structural movement of the building has occurred. The rate of movement cannot be predicted during a one-time inspection. A structural engineer should be consulted to further evaluate this condition and the remedies available for correction.

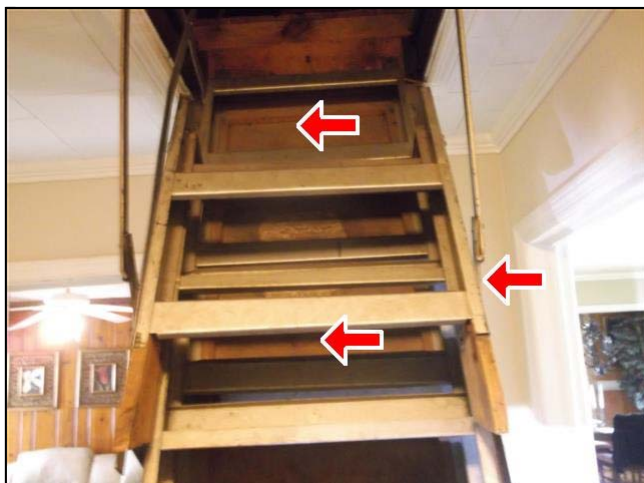
2.6 Item 1(Picture)

**2.6** Door to attic needs weather-stripping or insulate. Heat loss can occur more on this house than one that is properly insulated. Pull Down Stairs at hallway has loose hardware and is undersized. Recommend repairing to avoid possible fall or collapse from ladder. A licensed technician should make corrections.

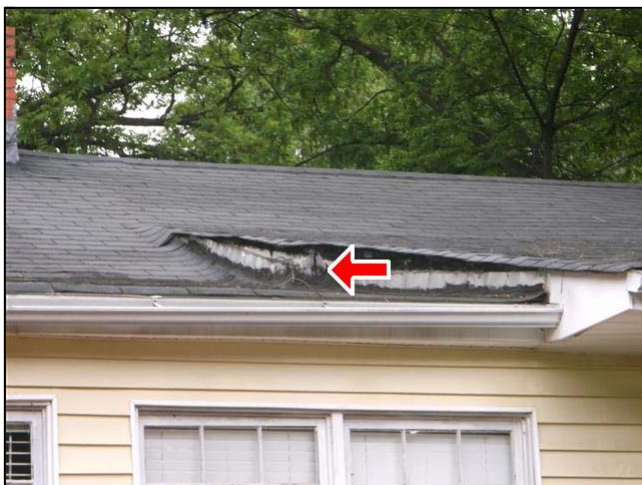
3.1 Item 1(Picture)

The flashing is loose and should be secured at rear. If leakage occurs, patching could be attempted. If this is unsuccessful, replacement may be necessary. A licensed roofing contractor should be consulted to evaluate and make necessary repairs.

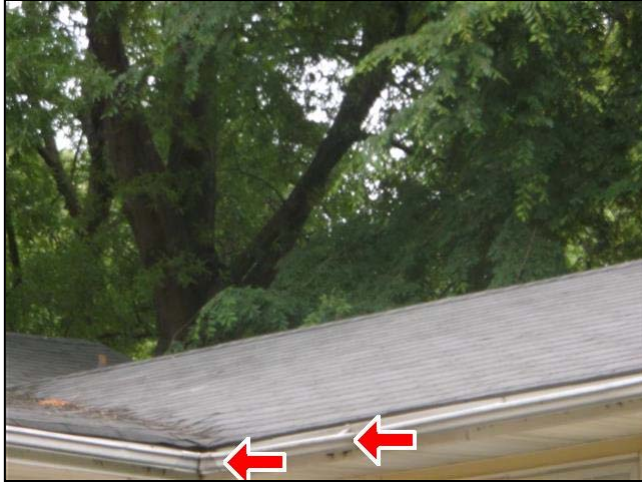
3.2 Item 1(Picture)

The gutters appear to leak at seams and are clogged with leaves at front and rear of home. Recommend cleaning and sealing. Stains on the fascia boards indicate roof runoff overflows the gutters. The gutters and downspouts should be aligned, caulked and cleaned to work properly. A licensed technician should be consulted to evaluate and make corrections.

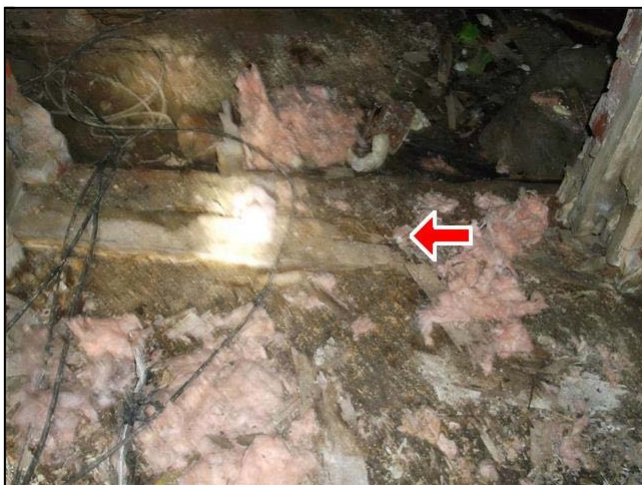
4.1 Item 1(Picture)

Crawlspace access is damaged. Recommend installing a proper size door and hardware. It may be desirable to install new exterior lock sets upon taking possession of the home. Front door needs adjusting and properly sized to avoid revealing daylight when closed.

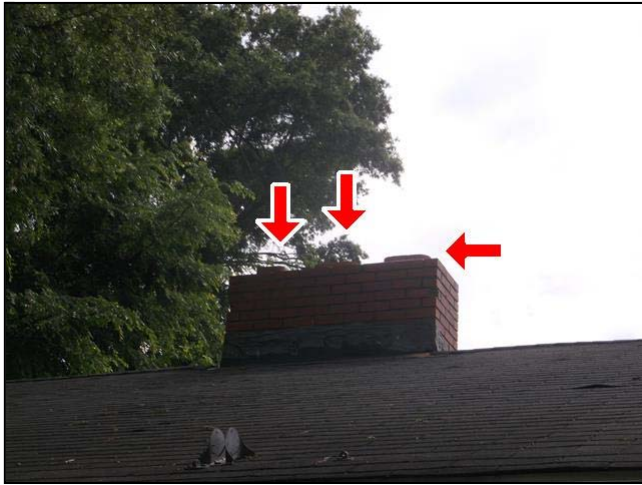
4.8 Item 1(Picture)

**4.8** Brick chimney is missing metal caps. Recommend replacing to avoid critters from entering if not corrected. Masonry chimney has missing and loose bricks at top of chimney and needs repair. Recommend replacing or repairing missing or loose materials. A licensed technician should make corrections.

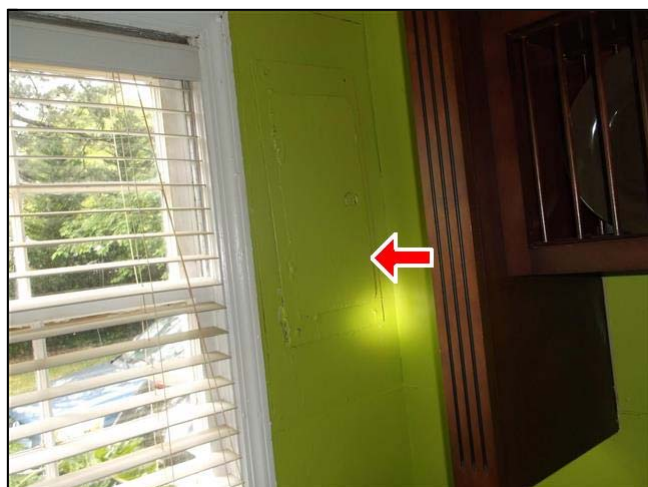
5.1 Item 1(Picture)

The main panel was not accessible and was in flooded basement at the time of inspection. This is a safety issue if not corrected. A licensed technician should be consulted to evaluate and make corrections.

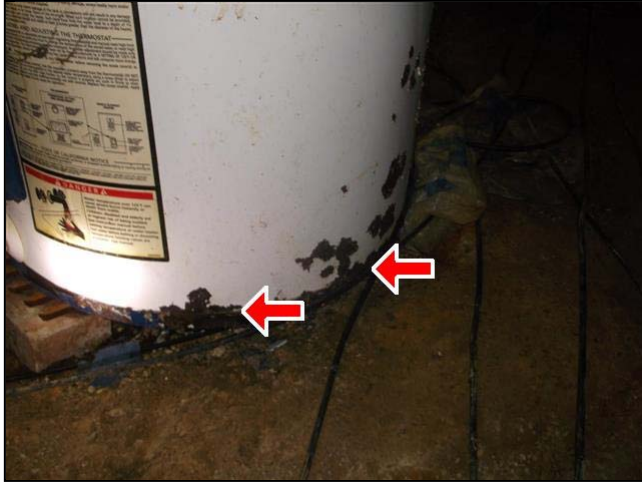
9.0 Item 1(Picture)

Water heater appears to be leaking at the bottom. A qualified service technician should be consulted and repair as necessary.

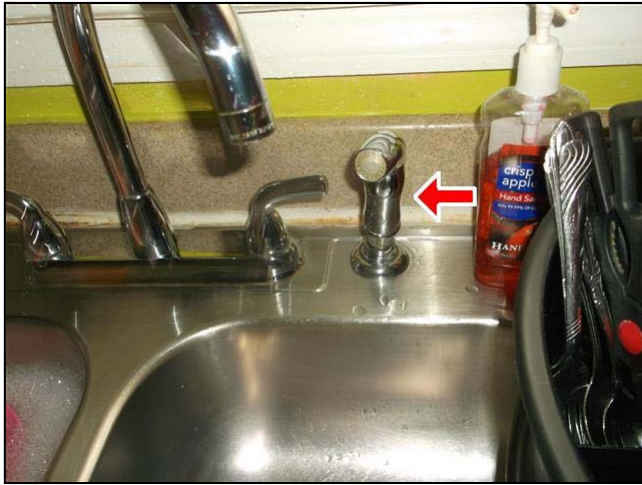
9.3 Item 1(Picture)

9.3 Spray nozzle is not working properly, and needs repair or replace at kitchen sink. Pedestal sink and toilet in hall bath are loose. Replace or repair. Tub faucet is leaky in hall bath. A licensed technician should make corrections.

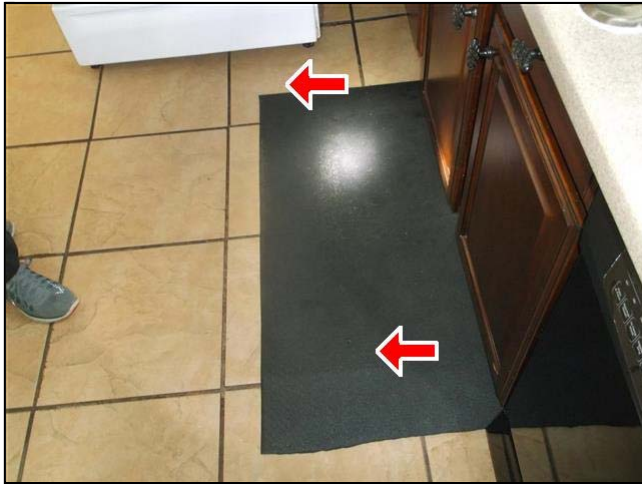
10.2 Item 1(Picture)

**10.2** Sagging floors are apparent at kitchen and baths. Recommend repairing. Flooring in basement is flooded. Recommend repairing. A licensed technician should be consulted to evaluate and make corrections.

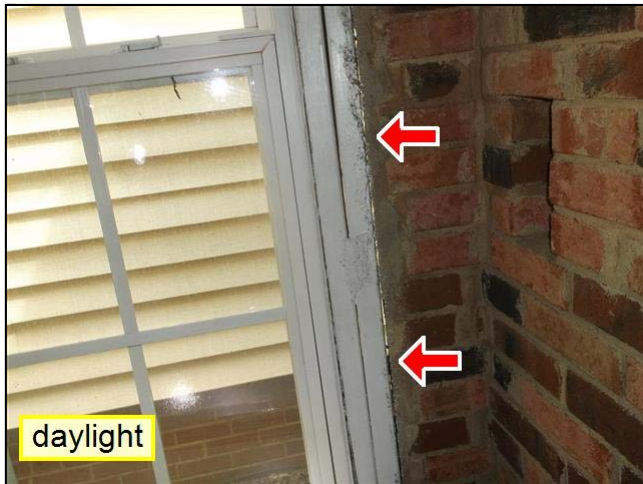
10.5 Item 1(Picture)

**10.5** The windows are in need of repair. This is a common condition that does not necessitate major repair. Trimming and adjustment, hardware improvements would be logical improvements. The most important factor is that the window exteriors are well maintained to avoid rot or water infiltration. Windows are difficult to operate and are not considered a functional window at various locations. Recommend repairing. A licensed technician should be consulted to evaluate and make corrections.

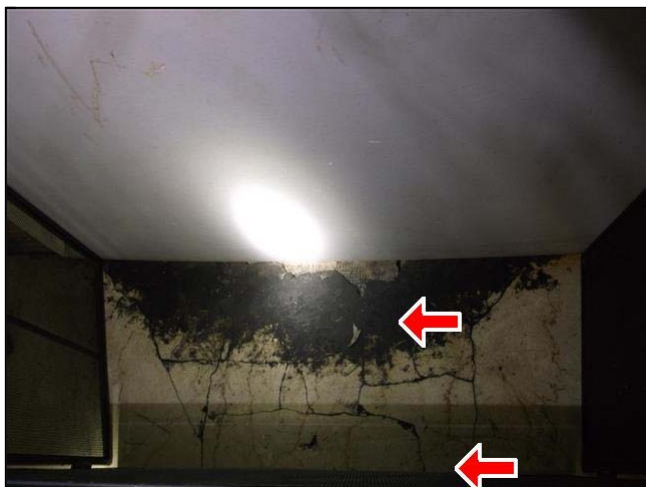
10.9 Item 1(Picture)

The hearth outside the fireplace is damaged. Replace. Localized pointing of deteriorated mortar between the bricks of the fireplace is recommended to avoid fire chips from entering. A licensed technician should be consulted to evaluate and make corrections.

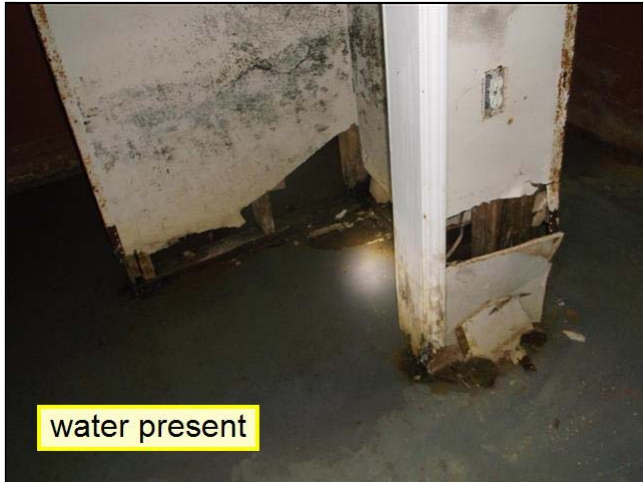
10.10 Item 1(Picture)

**10.10** The basement shows evidence of moisture penetration. It should be understood that it is impossible to predict the severity or frequency of moisture penetration on a one time visit to a home. Virtually all basements exhibit signs of moisture penetration and virtually all basements will indeed leak at some point in time. The visible evidence is not considered unusual for a home of this age, construction and location. Further monitoring of the foundations will be required to determine what improvements, if any, will be required. Basement leakage rarely affects the structural integrity of a home.

The vast majority of basement leakage problems are the result of insufficient control of storm water at the surface. The ground around the house should be sloped to encourage water to flow away from the foundations. Gutters and downspouts should act to collect roof water and drain the water at least five (5) feet from the foundation, or into a functional storm sewer. Downspouts that are clogged or broken below grade level, or that discharge too close to the foundation, are the most common source of basement leakage. In the event that basement leakage problems are experienced, lot and roof drainage improvements should be undertaken as a first step. Please beware of contractors who recommend expensive solutions. Excavation, damp-proofing and/or the installation of drainage tiles should be considered a last resort. In some cases, however, it is necessary. Your plans for using the basement may also influence the approach taken to curing any dampness that is experienced.

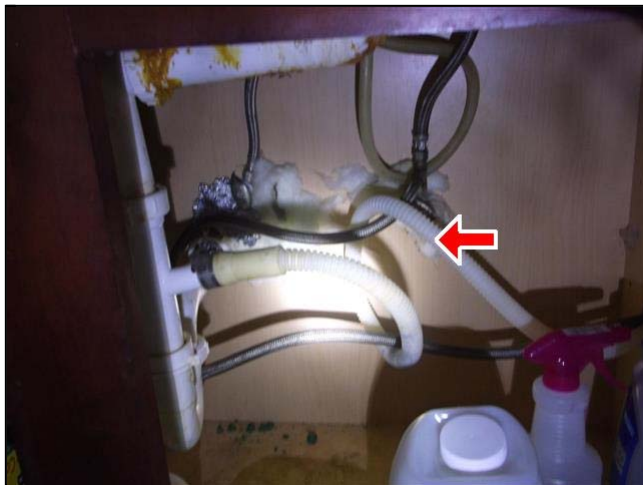
11.0 Item 1(Picture)

Dishwasher did not perform a loop to create a trap under sink. Recommend correcting to avoid a possible back up of sewer water into dishwasher.
