## Inspection Report

### ERD Home Inspections

**Property Address:**  
home inspection way  
Monroe NC

<b>Date:</b> 5/10/2016	<b>Time:</b>	<b>Report ID:</b> 5/10/2016
<b>Property:</b> home inspection way Monroe NC	<b>Customer:</b> ERD Home Inspections	<b>Real Estate Professional:</b>

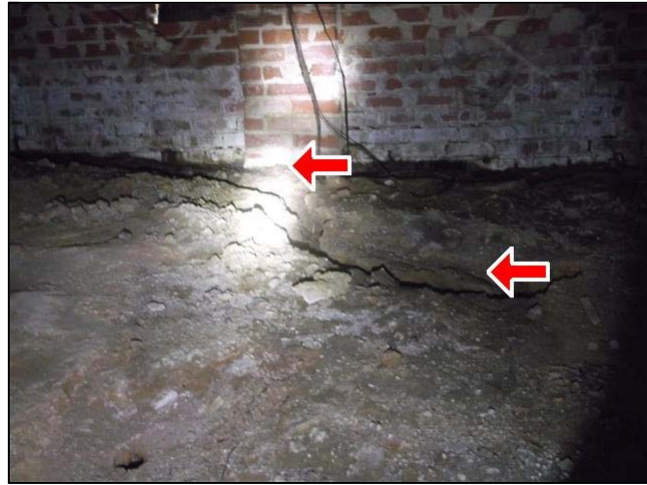
2.1 Item 2(Picture)

**2.1** There is evidence of past water in the crawl space at various locations. This condition may vary seasonally and/or with precipitation intensity. Lot drainage and / or roof drainage improvements should be addressed as a first step to controlling water in the crawl space. This condition should then be monitored to determine if drainage systems are necessary. All wood debris and/or trash should be removed from the crawl space. Crawl space wood/soil contact should be eliminated. This condition is conducive to rot and wood boring insect activity. A licensed technician should be consulted to evaluate and make corrections.

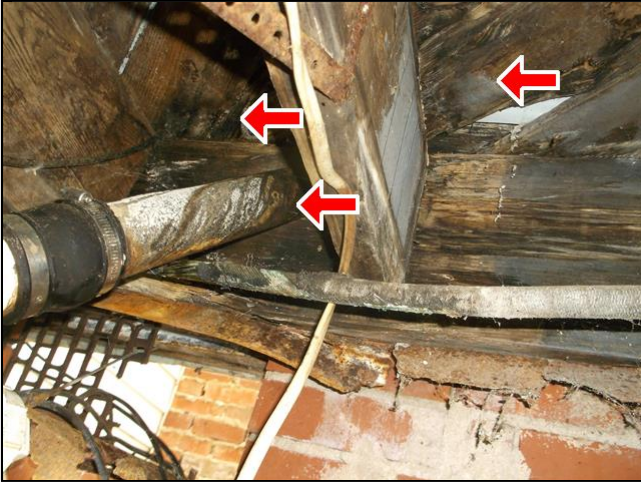
2.2 Item 1(Picture)

**2.2** The sub-flooring, beams and band sills at various locations of the building are damaged where visible. The sub-floor is a part of the structure and we recommend that a licensed contractor or engineer be consulted for the type and extent of the repairs. As with all areas that are concealed more extensive damage may be revealed when the repairs are undertaken

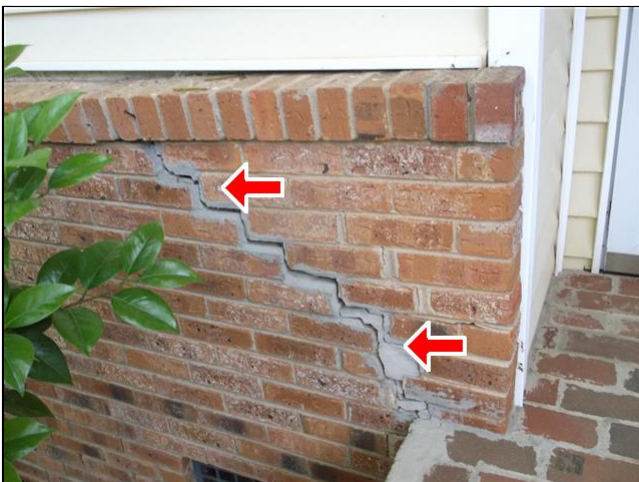
2.3 Item 1(Picture)

**2.3** Pronounced exterior wall cracks were observed. This implies that structural movement of the building has occurred. The rate of movement cannot be predicted during a one-time inspection. A structural engineer should be consulted to further evaluate this condition and the remedies available for correction.

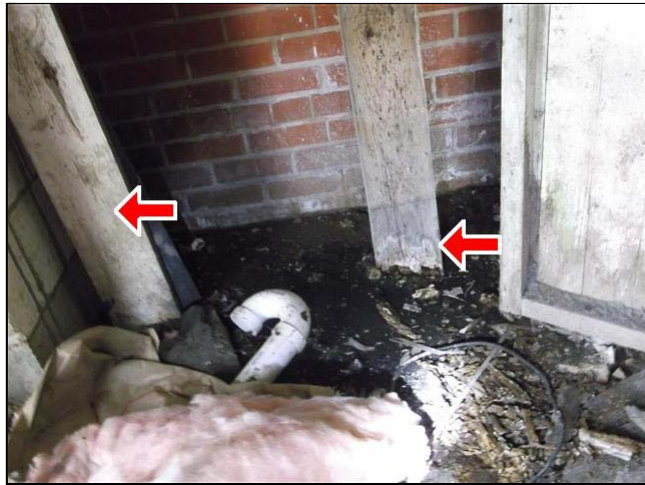
2.4 Item 2(Picture)

**2.4** Concrete pier(damaged) and wood piers are not supported by a proper concrete footing in the crawlspace at the (rear of home). Recommend a qualified licensed contractor be consulted for further evaluation and recommendations..

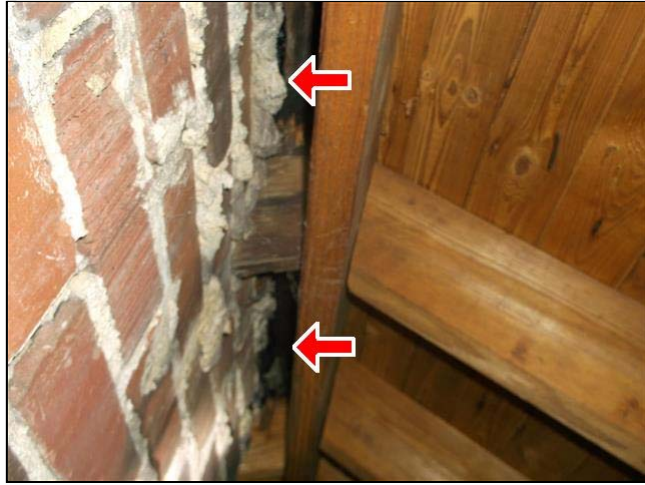
2.5 Item 2(Picture)

**2.5** Evidence of prior leaking was noted to the roof decking / sheathing observed in the attic at chimney. The weather conditions leading up to and including the day of the inspection can greatly effect this test. We recommend that these areas and all roof penetrations should be monitored and sealed as necessary. Rafters damaged are under-size or over spanned, and proper support should be provided to reinforce roof around chimney. Recommend a qualified licensed repair contractor be consulted for further evaluation and recommendations.

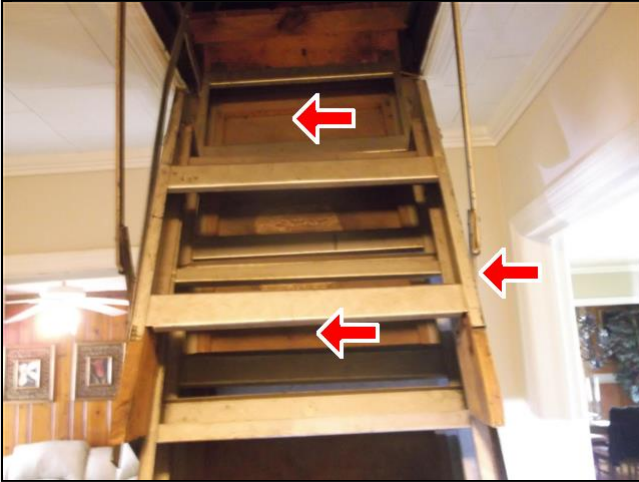
2.6 Item 1(Picture)

**2.6** Door to attic needs weather-stripping or insulate. Heat loss can occur more on this house than one that is properly insulated. Pull Down Stairs at hallway has loose hardware and is undersized. Recommend repairing to avoid possible fall or collapse from ladder. A licensed technician should make corrections.

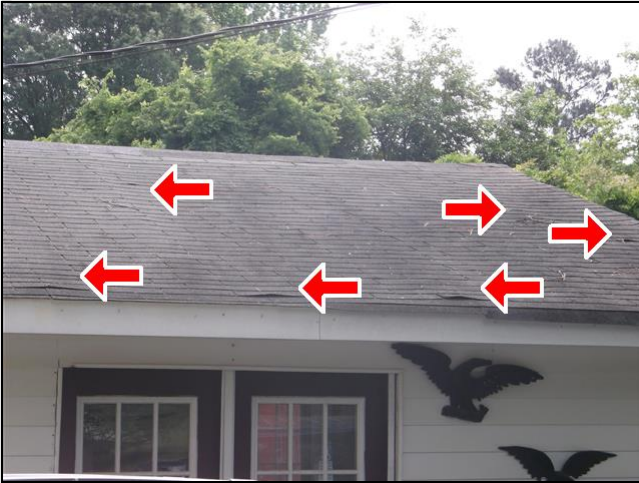
3.0 Item 1(Picture)

**3.0** Repairs to the roofing are recommended. Damaged or missing roofing material should be repaired. All roof penetrations should be examined and sealed as necessary. Nail "Pops" (Nails pushing up shingles) should be repaired to prevent permanent damage to roof coverings. A qualified roofing contractor should be consulted for further evaluation and recommendations.

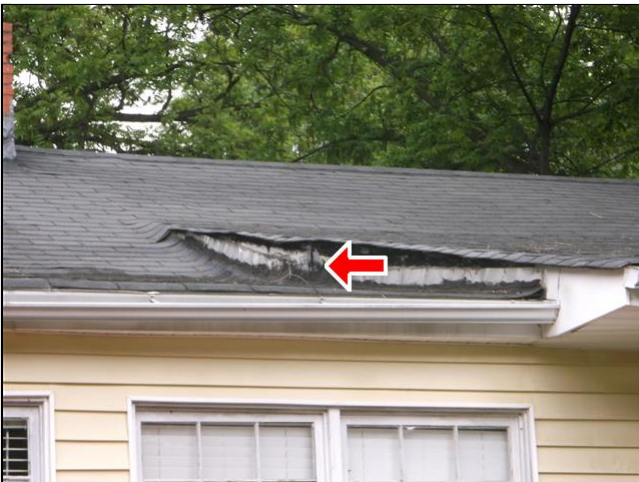
3.1 Item 1(Picture)

**3.1** The flashing is loose and should be secured at rear. If leakage occurs, patching could be attempted. If this is unsuccessful, replacement may be necessary. A licensed roofing contractor should be consulted to evaluate and make necessary repairs.

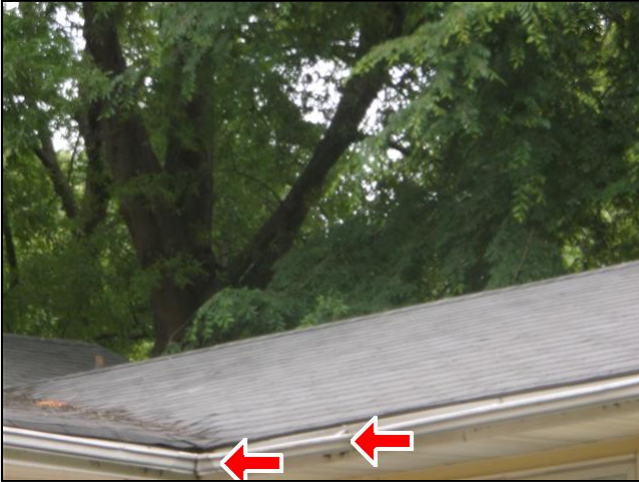
3.2 Item 1(Picture)

**3.2** The gutters appear to leak at seams and are clogged with leaves at front and rear of home. Recommend cleaning and sealing. Stains on the fascia boards indicate roof runoff overflows the gutters. The gutters and downspouts should be aligned, caulked and cleaned to work properly. A licensed technician should be consulted to evaluate and make corrections.

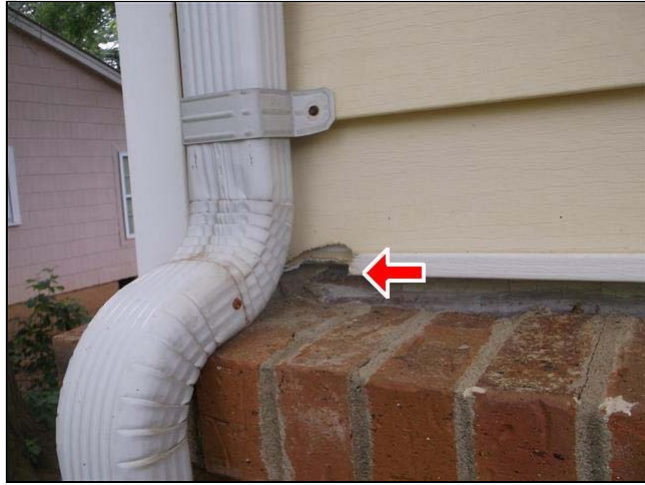
4.0 Item 2(Picture)

**4.0** Localized pointing of deteriorated mortar between the bricks of the exterior walls is advisable. Replace or repair as needed. Holes in siding or damaged siding need repairing or closing off with sealant or liquid foam at various locations. Water may enter if not corrected. Vinyl siding not installed correctly at various locations. Damaged siding at various locations. Hole in siding needs closing off with sealant or liquid foam at various locations. Water may enter. A licensed technician should make repairs.

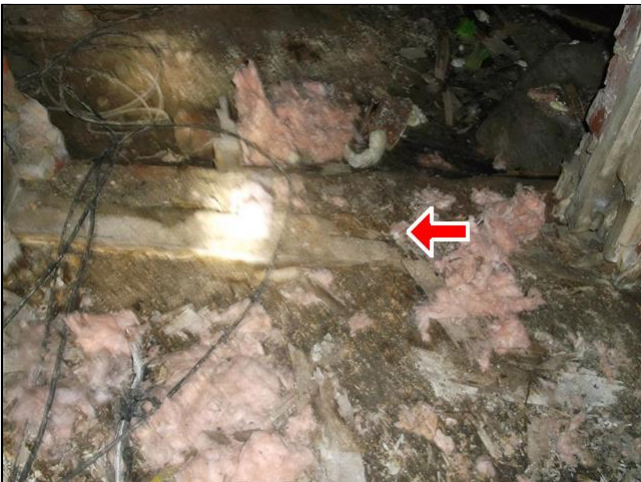
4.1 Item 1(Picture)

**4.1** Crawlspace access is damaged. Recommend installing a proper size door and hardware. It may be desirable to install new exterior lock sets upon taking possession of the home. Front door needs adjusting and properly sized to avoid revealing daylight when closed.

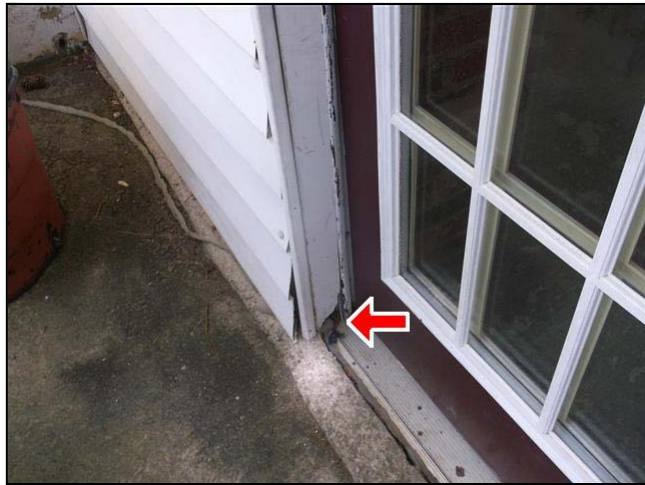
4.2 Item 2(Picture)

**4.2** Exposed wood door frame and entry door at front are damaged and has wood rot. As with all repairs hidden damage may be discovered while repairs are being completed. Repair or replace. Damaged or non functional hardware needs replacing or repairing as needed. This condition should be improved. A licensed technician should be consulted to evaluate and make corrections.

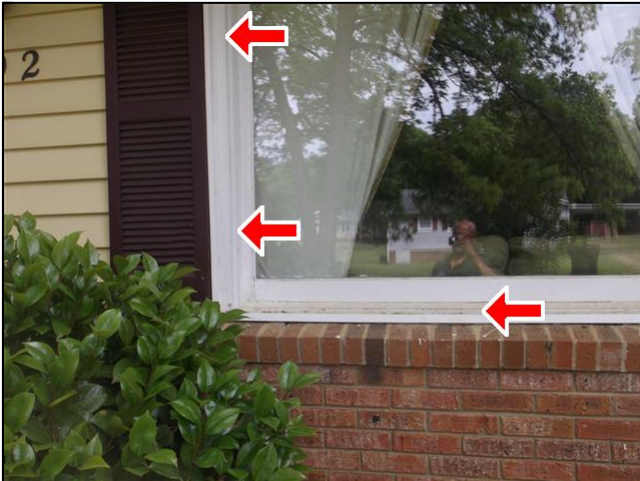
4.4 Item 1(Picture)

**4.4** The windows are in need of repair. This is a common condition that does not necessitate major repair. Trimming and adjustment, hardware improvements and glazing repairs would be logical improvements. The most important factor is that the window exteriors are well maintained to avoid rot or water infiltration. A licensed technician should make corrections.

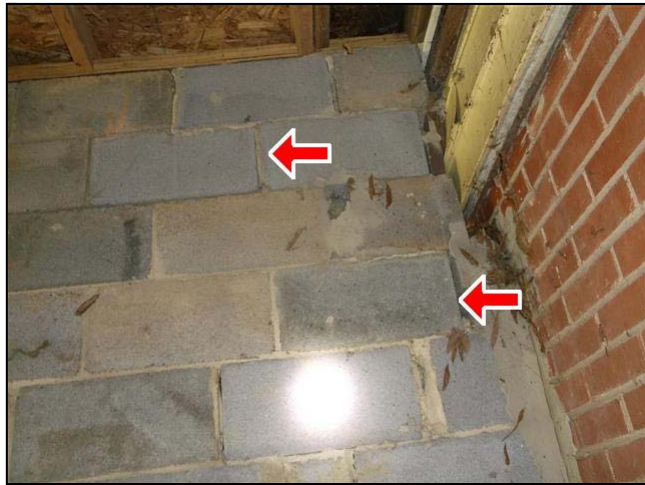
4.7 Item 2(Picture)

**4.7** The masonry steps should be "pointed up" or tuck pointed and any loose material should be repaired or replaced. Water may enter if not corrected. The deck is in need of minor repairs. Loose hand rails need securing at rear deck and rear door. This is a safety hazard if not corrected. Staining the deck will prolong the life of the decking. A licensed technician should be consulted to make necessary repairs.

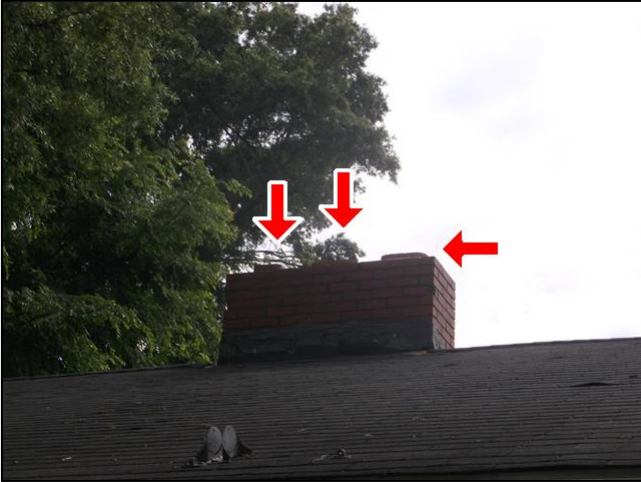
4.8 Item 1(Picture)

**4.8** Brick chimney is missing metal caps. Recommend replacing to avoid critters from entering if not corrected. Masonry chimney has missing and loose bricks at top of chimney and needs repair. Recommend replacing or repairing missing or loose materials. A licensed technician should make corrections.

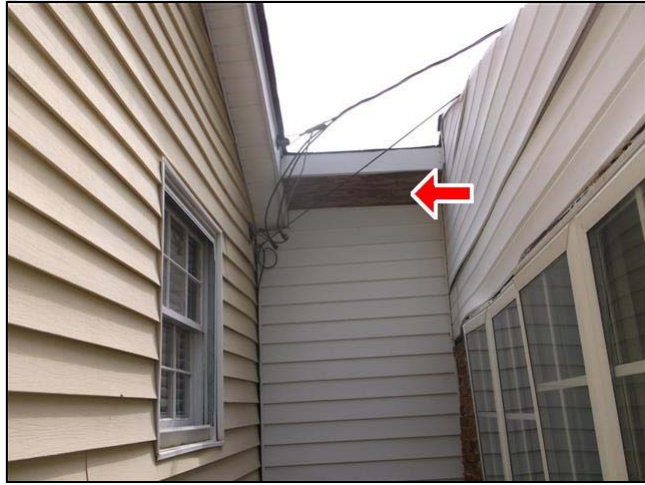
4.9 Item 2(Picture)

**4.9** Fascia board and soffits at various locations of home are loose. Recommend repair or replace as necessary board at rear of home needs scraping, painting and caulking. Damaged or poorly painted and caulked wood may lead to water infiltration into the wall and / or floor cavities promoting serious structural damage. As with all repairs hidden damage may be discovered while repairs are being completed. A licensed technician should be consulted to make corrections.

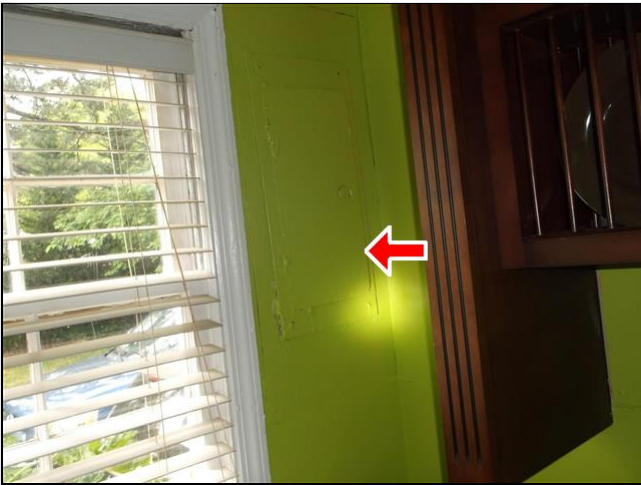
5.1 Item 1(Picture)

**5.1** The main panel was not accessible and was in flooded basement at the time of inspection. This is a safety issue if not corrected. A licensed technician should be consulted to evaluate and make corrections.

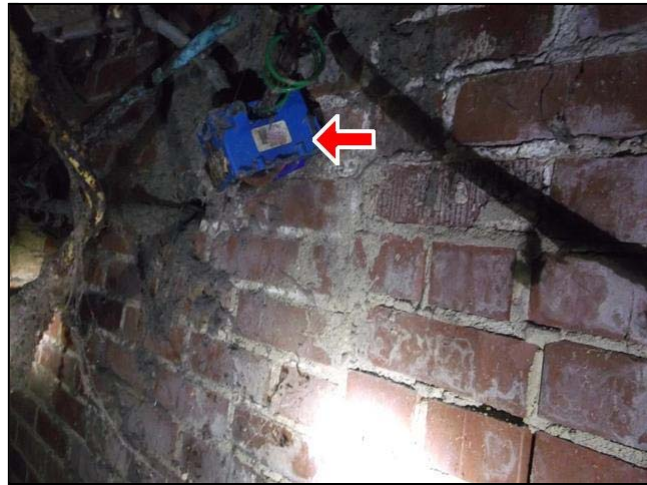
5.4 Item 2(Picture)

**5.4** Several junction boxes need cover plates in attic space and in crawlspace. Extension cord used as permanent wiring at light fixture in unfinished room and at sump pump . Ceiling fan "wobbles" and needs repair in Living room. Exterior light fixture is not installed correctly. Replace or repair. A licensed technician should be consulted to evaluate and make corrections.

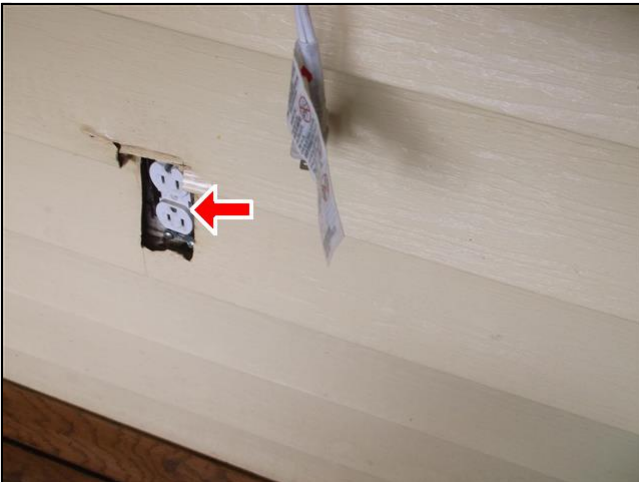
5.6 Item 1(Picture)

**5.6** Outlet covers missing at various locations throughout home. This is a safety issue if not corrected. A licensed technician should make corrections.

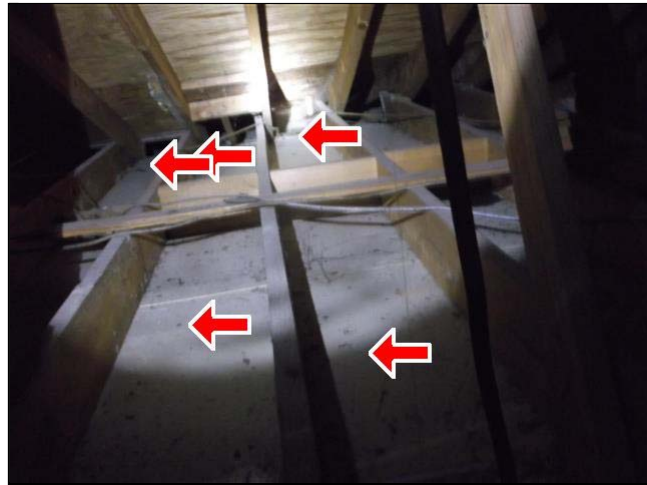
8.1 Item 2(Picture)

**8.1** Un-insulated areas in the attic over conditioned space should be better insulated. This condition may cause energy loss if not replaced. A licensed technician should be consulted to evaluate and make corrections.

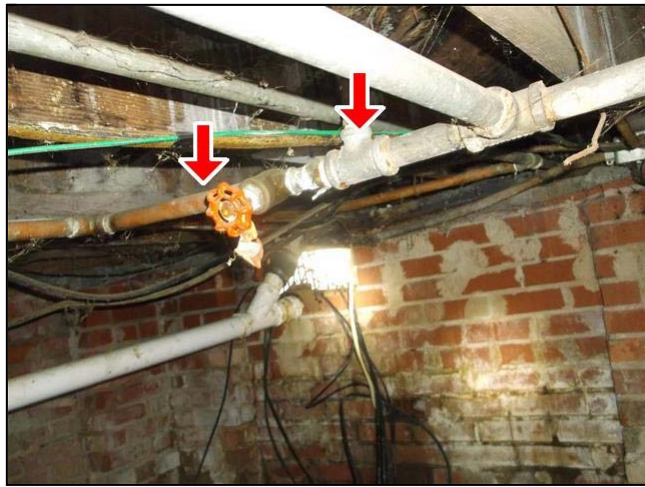
9.1 Item 2(Picture)

**9.1** Copper and galvanized water lines connected in crawlspace. Replace or repair. A licensed technician should be consulted to evaluate and make corrections.

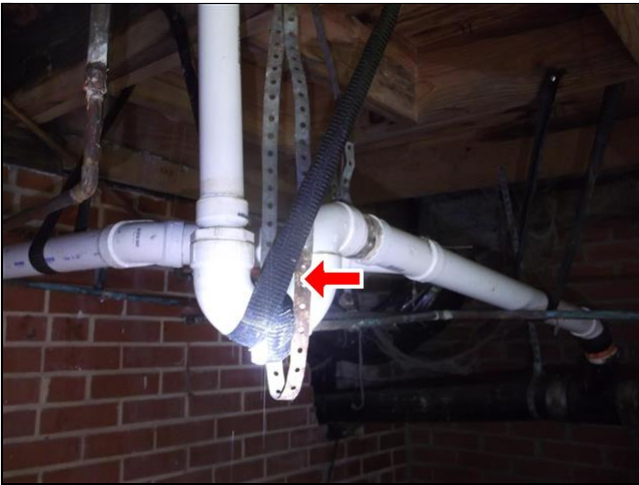
9.2 Item 1(Picture)

**9.2** Plumbing waste line leaks is damaged and shows signs of previous leaking at Hall Bath.Recommend repairing. A licensed technician should be consulted to evaluate and make corrections.

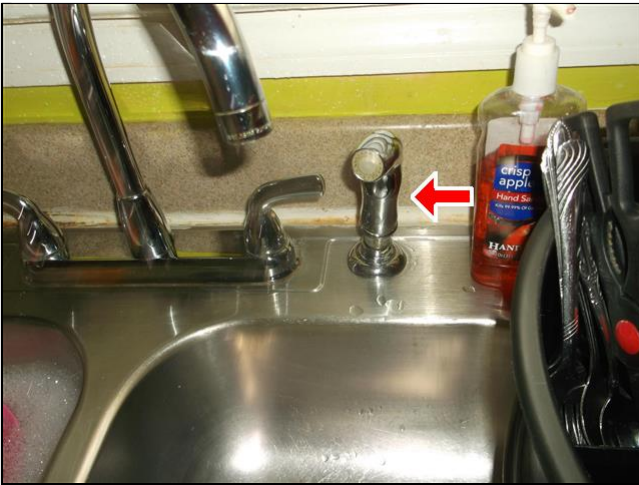
9.3 Item 1(Picture)

9.3 Spray nozzle is not working properly, and needs repair or replace at kitchen sink. Pedestal sink and toilet in hall bath are loose. Replace or repair. Tub faucet is leaky in hall bath. A licensed technician should make corrections.

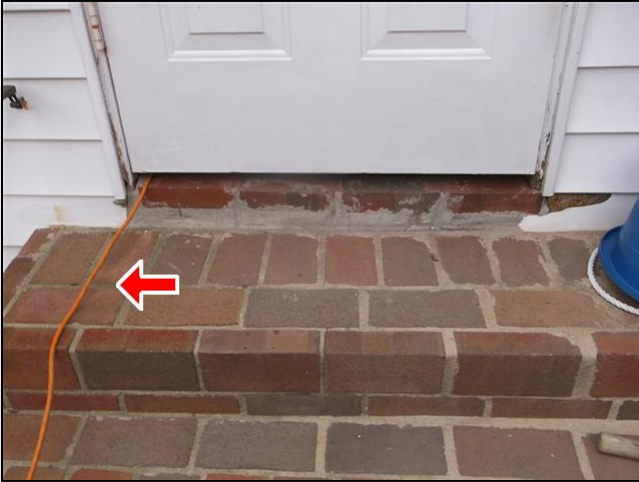
9.5 Item 1(Picture)

**9.5** Visible signs of water intrusion in basement are present and a "Sump Pump" is installed. Existing sump pump fails to remove all areas of water intrusion. Replace or repair. The sump pump uses an extension cord as permanent power source. This is a safety issue if not corrected. A licensed technician should be consulted to evaluate and make corrections.

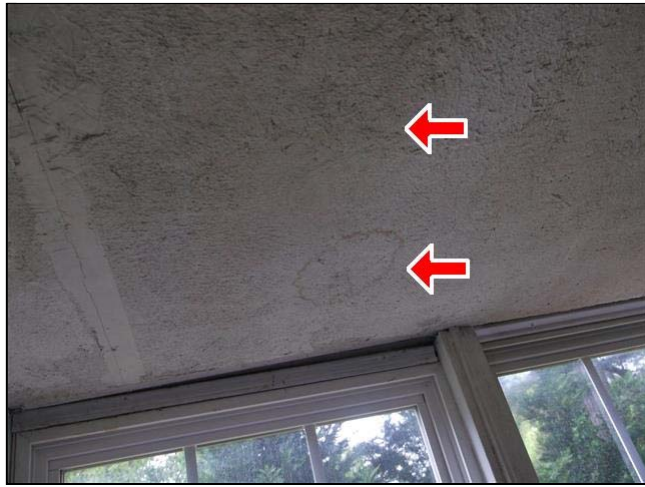
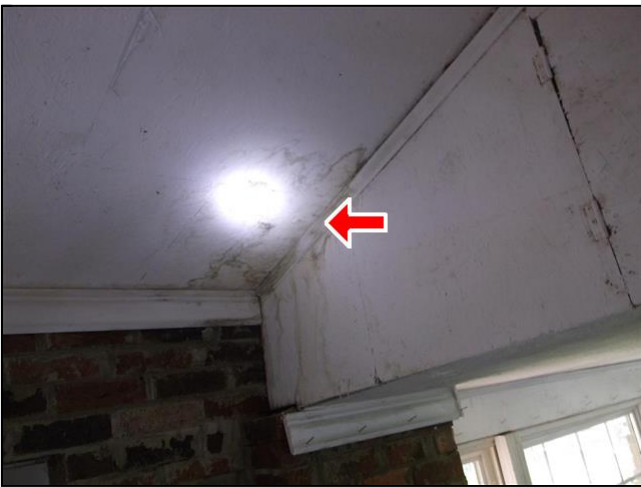
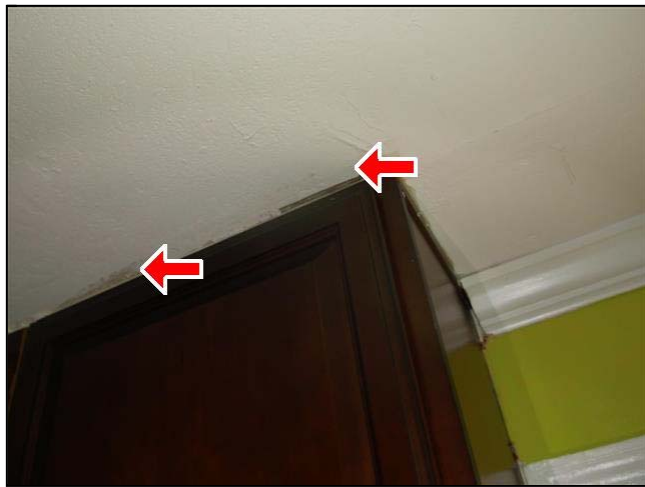
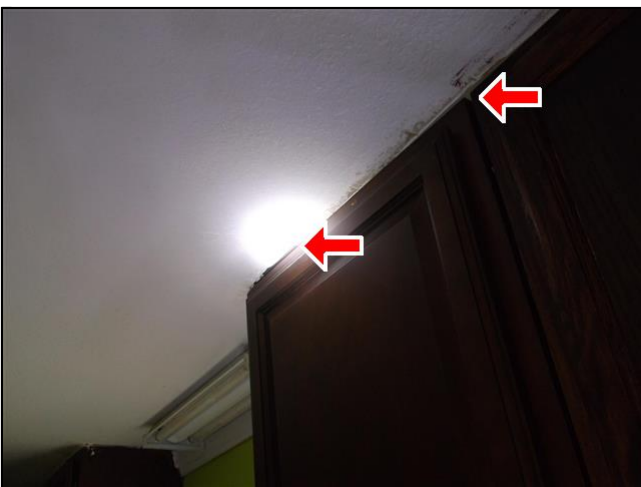
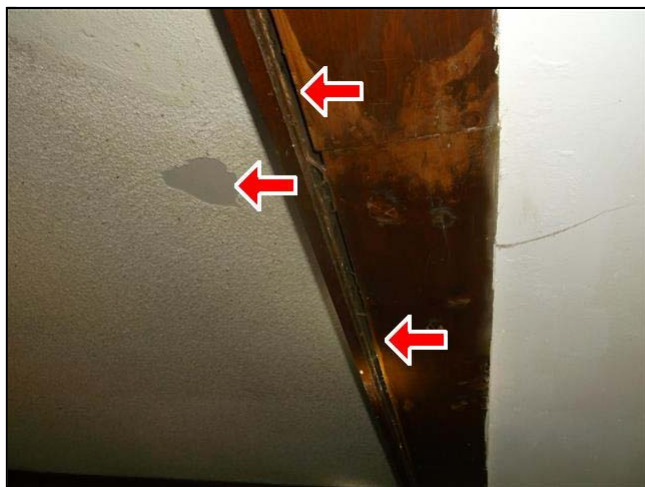
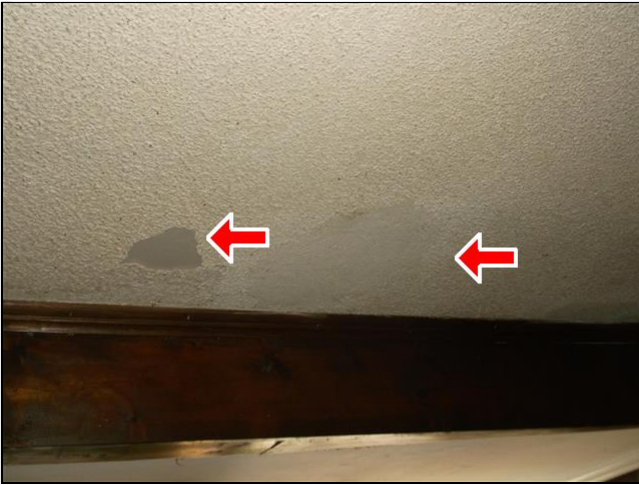
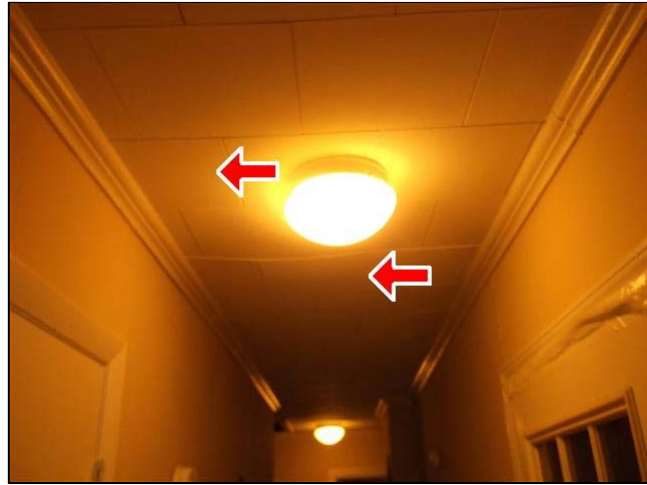
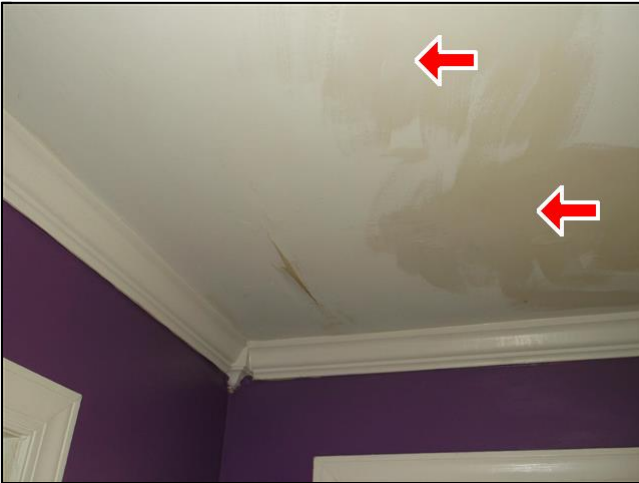
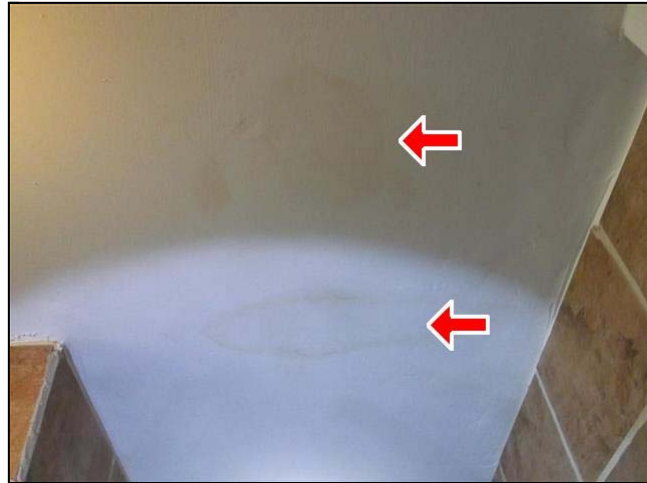
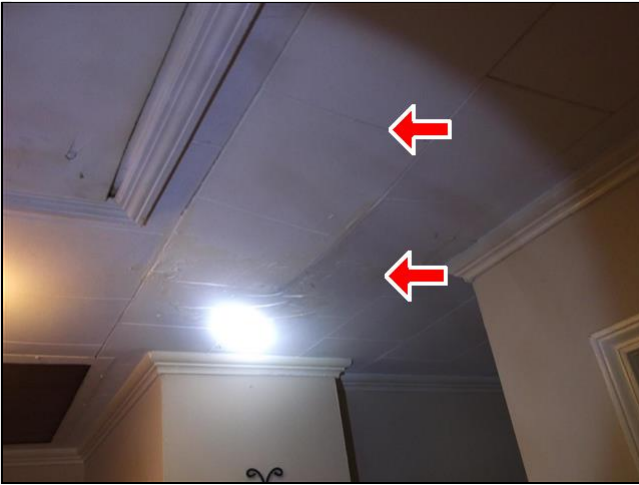
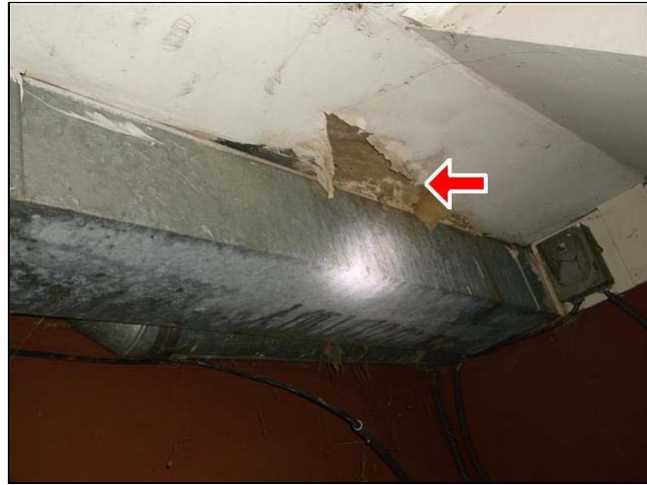
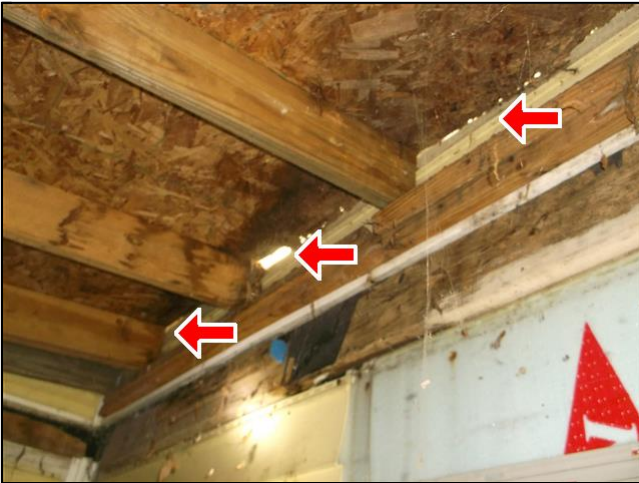
**10.1** Damage to the interior finish was observed in several ceilings throughout home. Repair as needed. A licensed technician should make corrections.

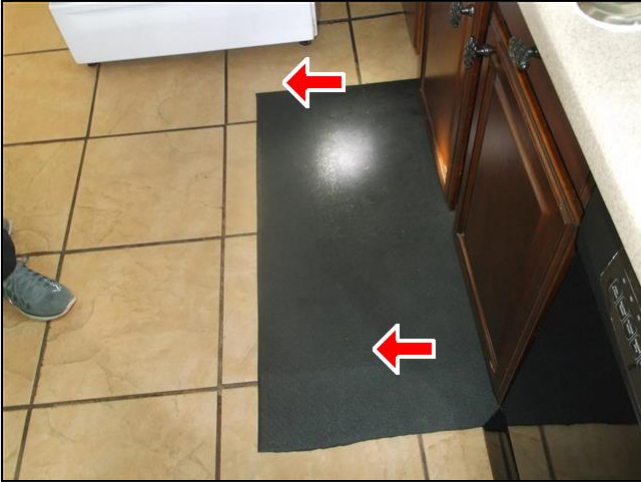
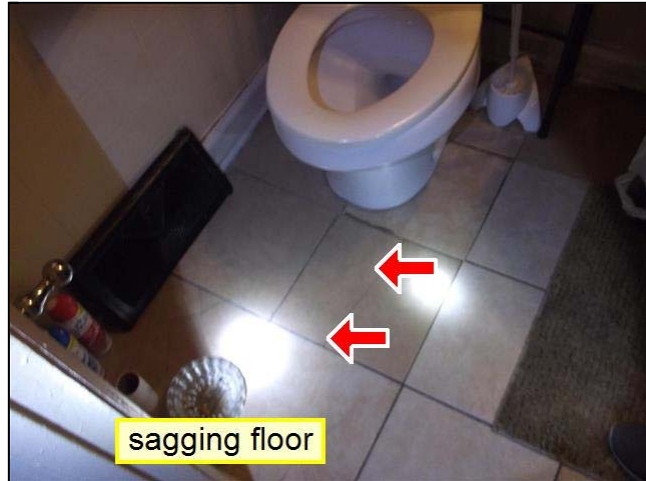
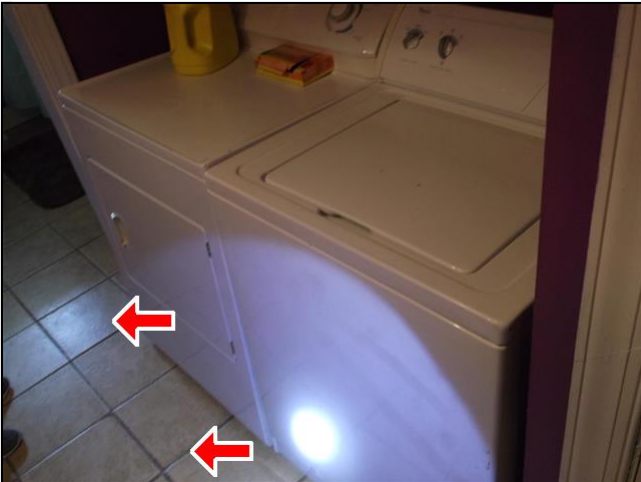
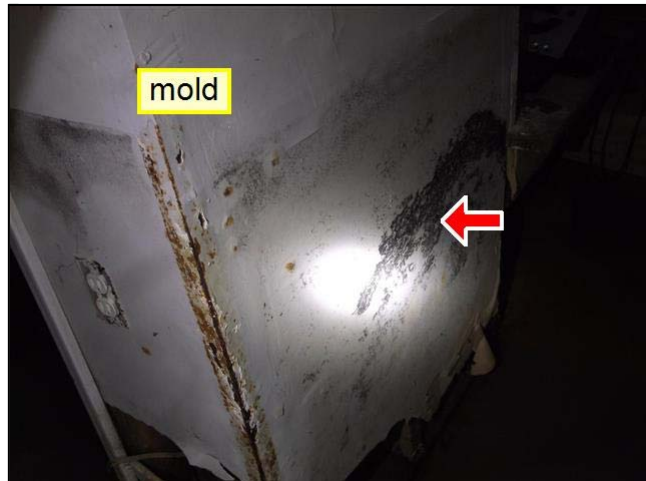
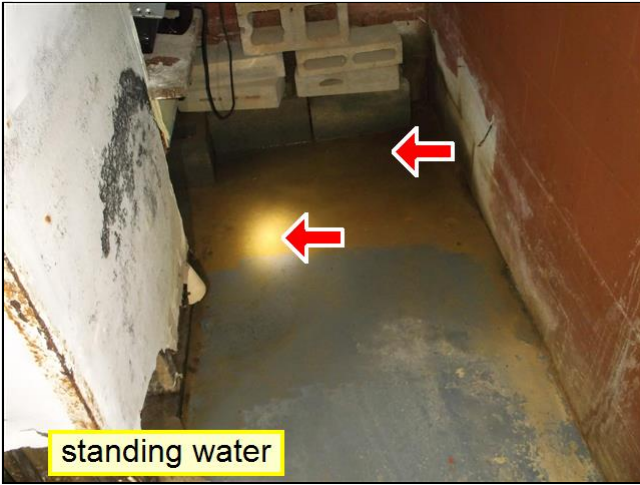
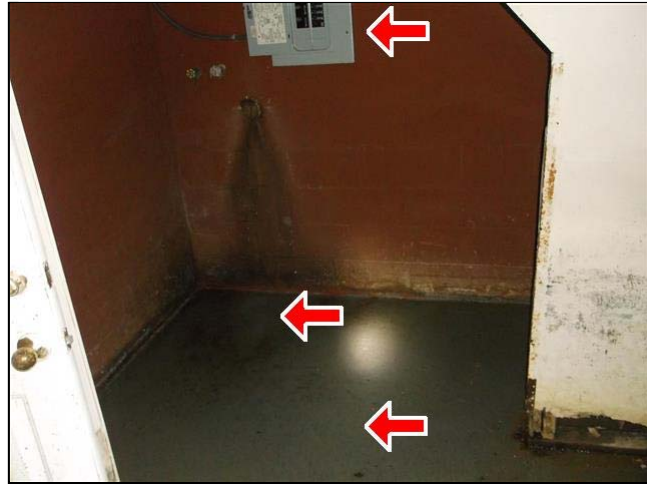
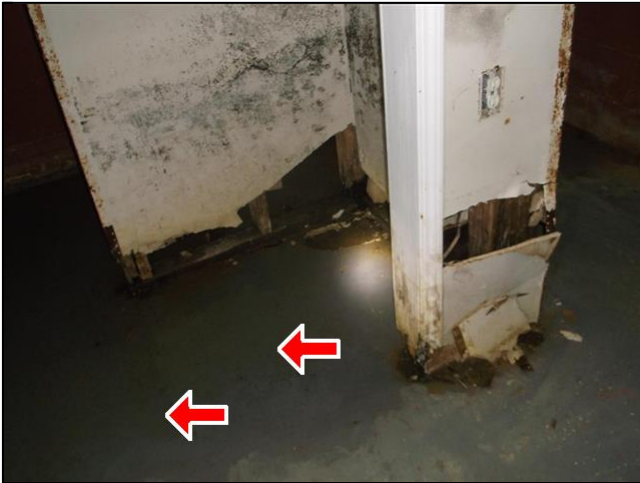
**10.2** Sagging floors are apparent at kitchen and baths. Recommend repairing. Flooring in basement is flooded. Recommend repairing. A licensed technician should be consulted to evaluate and make corrections.

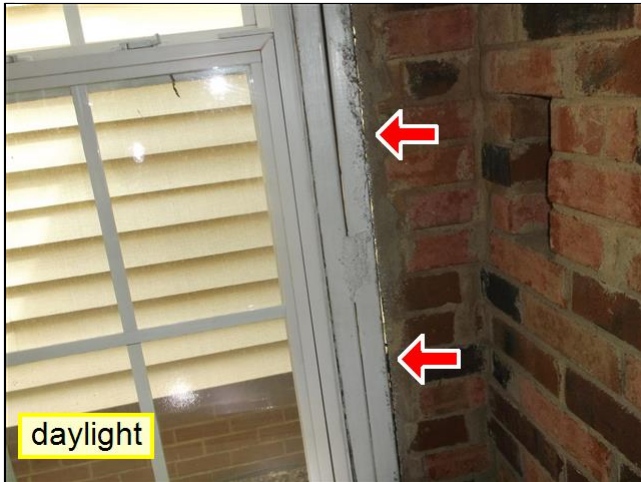
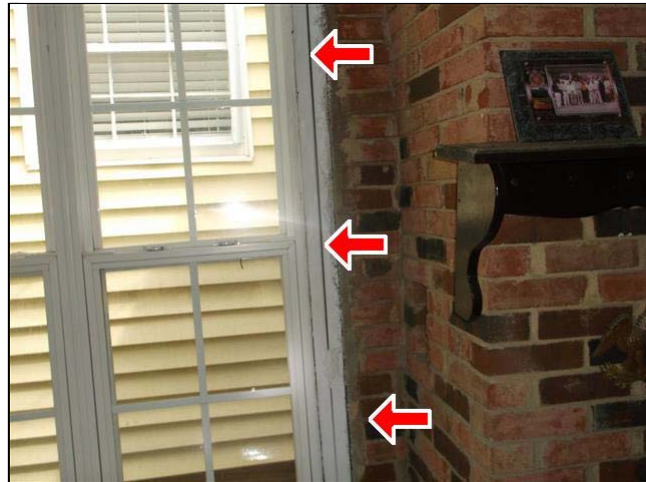
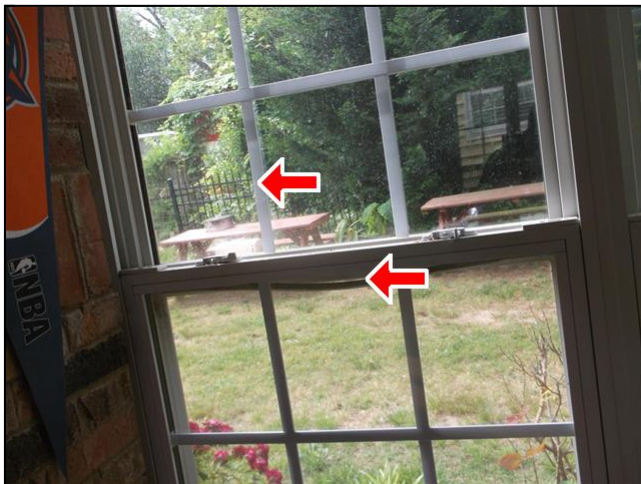
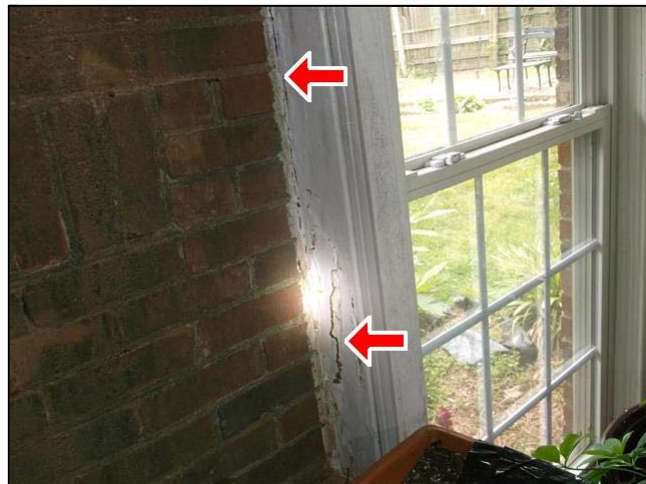
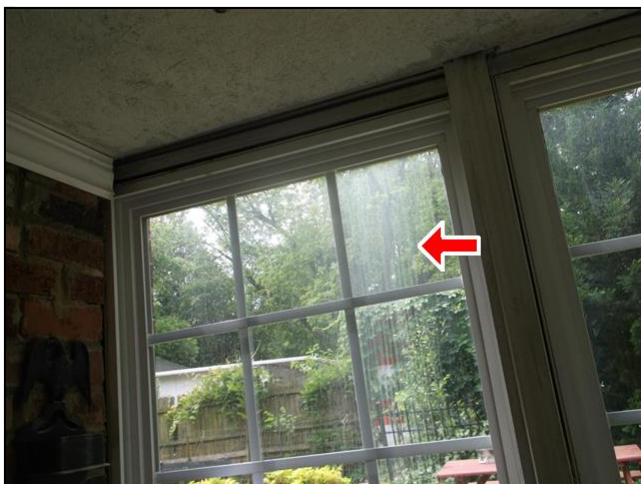
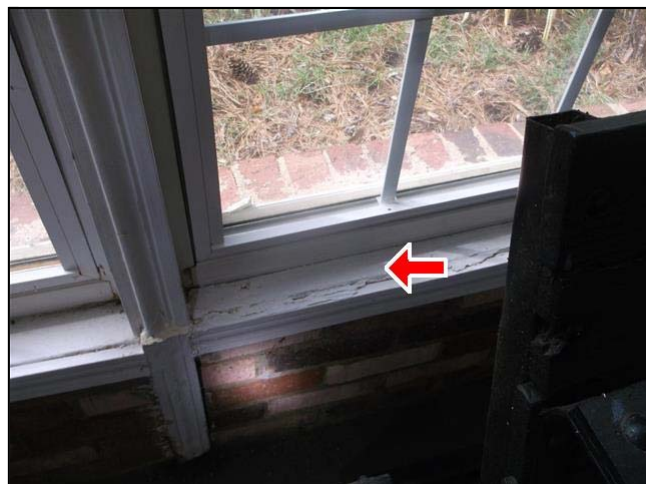
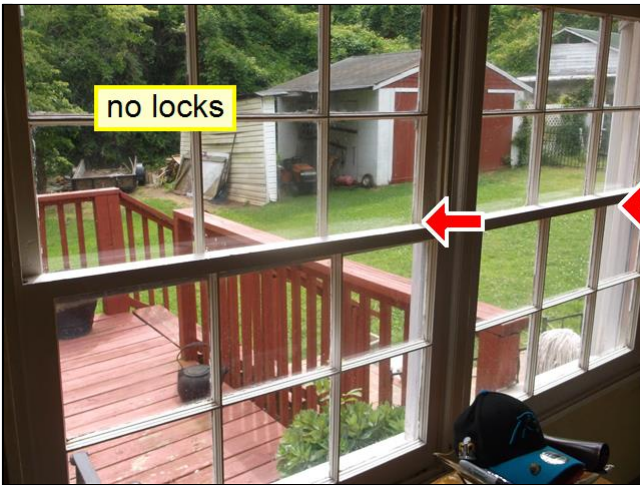
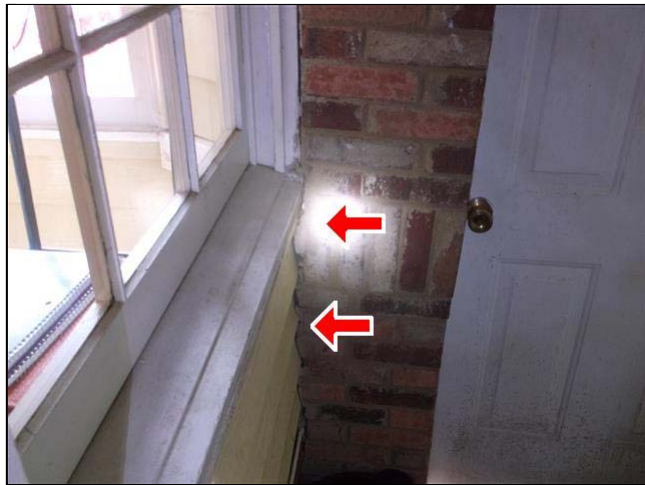
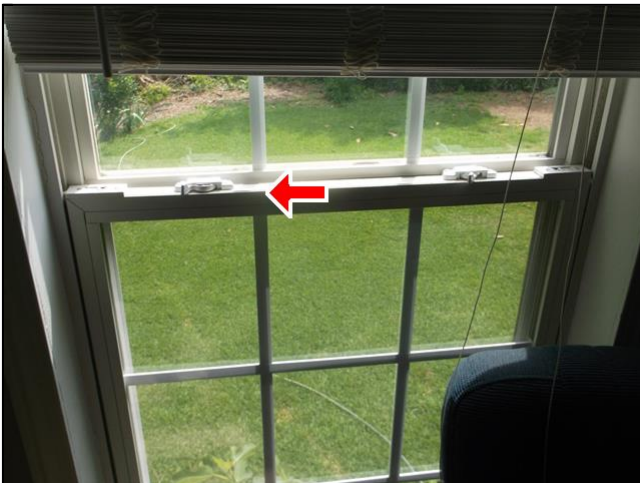
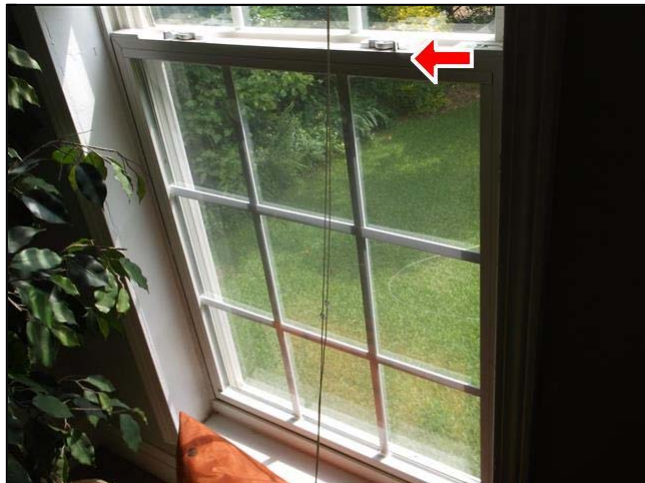
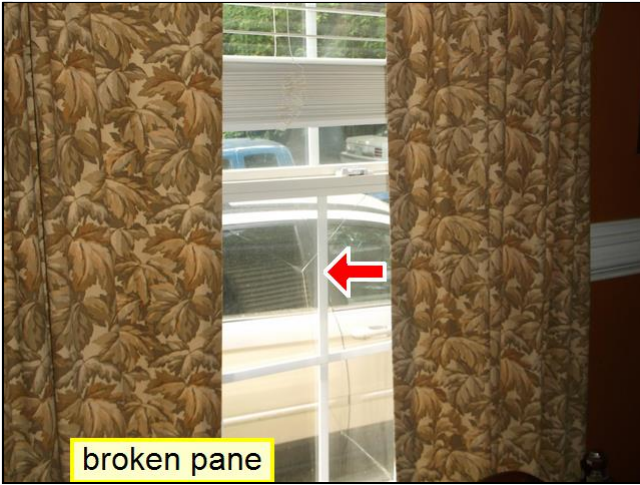
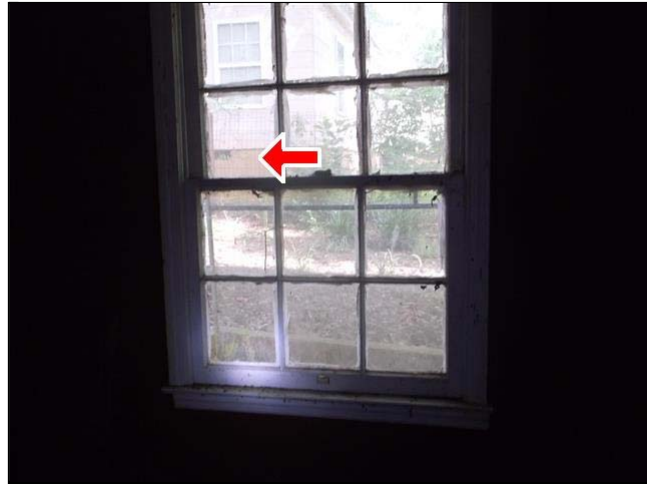
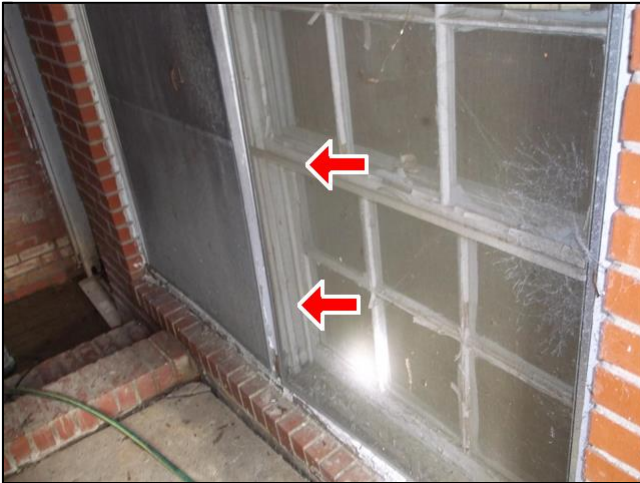
**10.5** The windows are in need of repair. This is a common condition that does not necessitate major repair. Trimming and adjustment, hardware improvements would be logical improvements. The most important factor is that the window exteriors are well maintained to avoid rot or water infiltration. Windows are difficult to operate and are not considered a functional window at various locations. Recommend repairing. A licensed technician should be consulted to evaluate and make corrections.

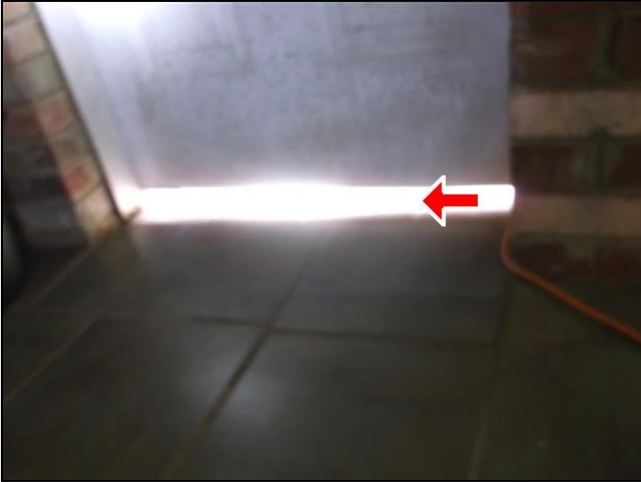
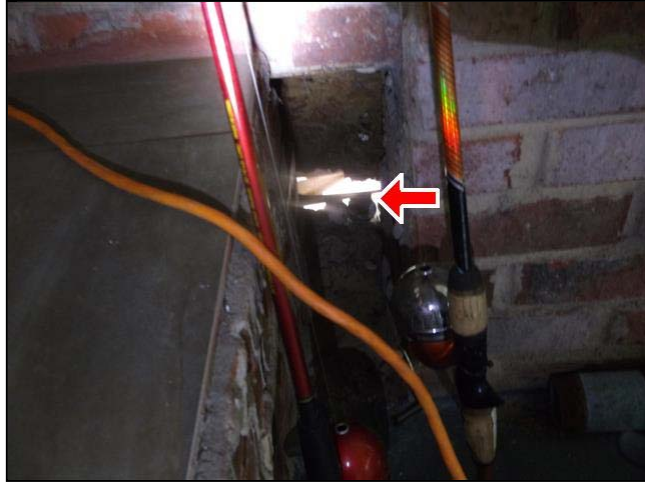
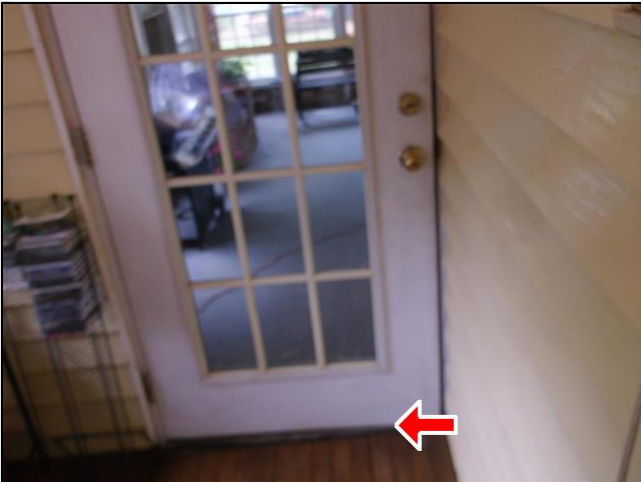
**10.7** Entry door shows daylight when closed at patio. Weather stripping needs improving to keep out unconditional air. Several doors does not fit opening properly (out of square) . Replace or repair. A licensed technician should evaluate and make corrections.

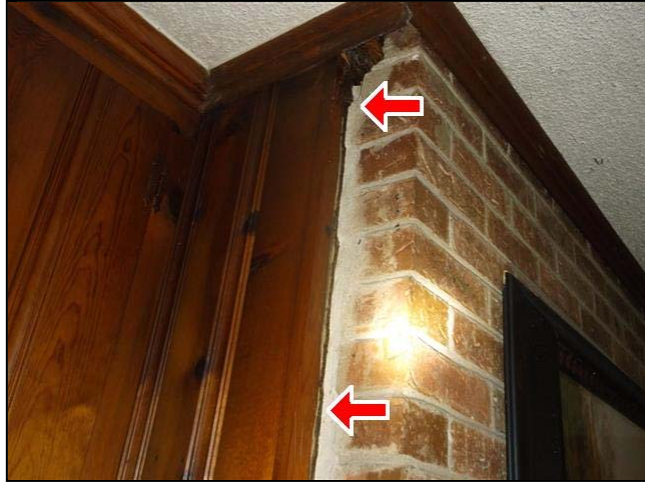
10.9 Item 1(Picture)

**10.9** The hearth outside the fireplace is damaged. Replace. Localized pointing of deteriorated mortar between the bricks of the fireplace is recommended to avoid fire chips from entering. A licensed technician should be consulted to evaluate and make corrections.

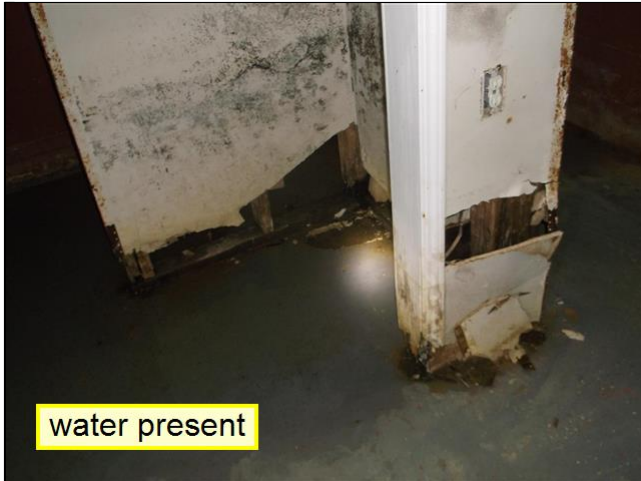
10.10 Item 1(Picture)

**10.10** The basement shows evidence of moisture penetration. It should be understood that it is impossible to predict the severity or frequency of moisture penetration on a one time visit to a home. Virtually all basements exhibit signs of moisture penetration and virtually all basements will indeed leak at some point in time. The visible evidence is not considered unusual for a home of this age, construction and location. Further monitoring of the foundations will be required to determine what improvements, if any, will be required. Basement leakage rarely affects the structural integrity of a home.

The vast majority of basement leakage problems are the result of insufficient control of storm water at the surface. The ground around the house should be sloped to encourage water to flow away from the foundations. Gutters and downspouts should act to collect roof water and drain the water at least five (5) feet from the foundation, or into a functional storm sewer. Downspouts that are clogged or broken below grade level, or that discharge too close to the foundation, are the most common source of basement leakage. In the event that basement leakage problems are experienced, lot and roof drainage improvements should be undertaken as a first step. Please beware of contractors who recommend expensive solutions. Excavation, damp-proofing and/or the installation of drainage tiles should be considered a last resort. In some cases, however, it is necessary. Your plans for using the basement may also influence the approach taken to curing any dampness that is experienced.

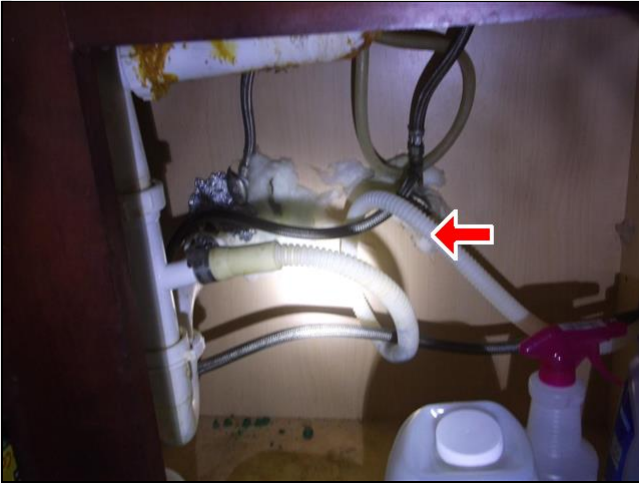
11.0 Item 1(Picture)

**11.0** Dishwasher did not perform a loop to create a trap under sink. Recommend correcting to avoid a possible back up of sewer water into dishwasher.
