## Inspection Report

### ERD Home Inspections

**Property Address:**  
home inspection way  
Monroe NC

<b>Date:</b> 5/10/2016	<b>Time:</b>	<b>Report ID:</b> 5/10/2016
<b>Property:</b> home inspection way Monroe NC	<b>Customer:</b> ERD Home Inspections	<b>Real Estate Professional:</b>

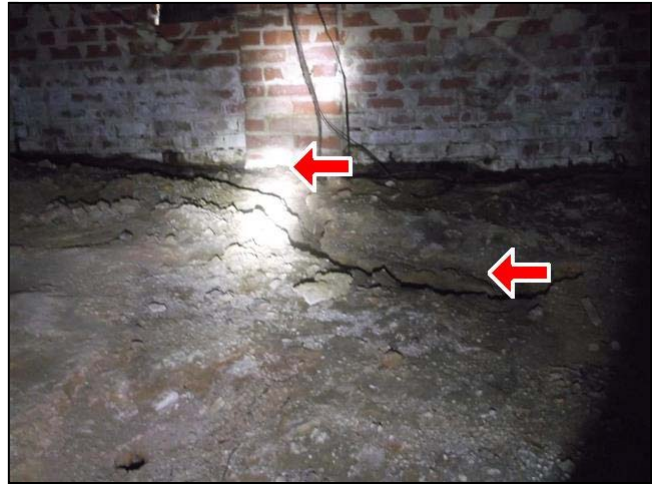
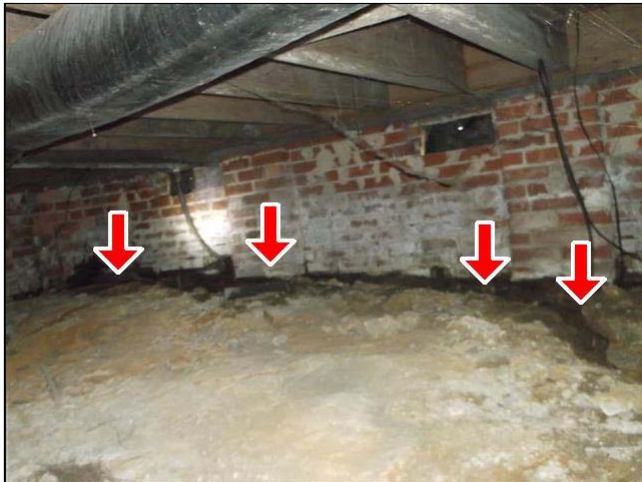
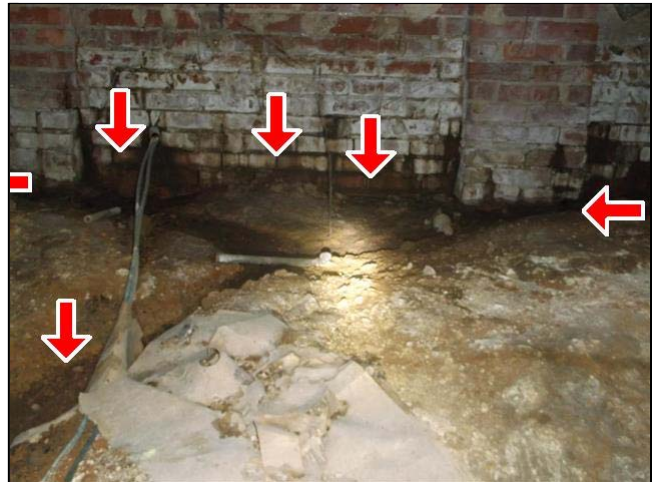
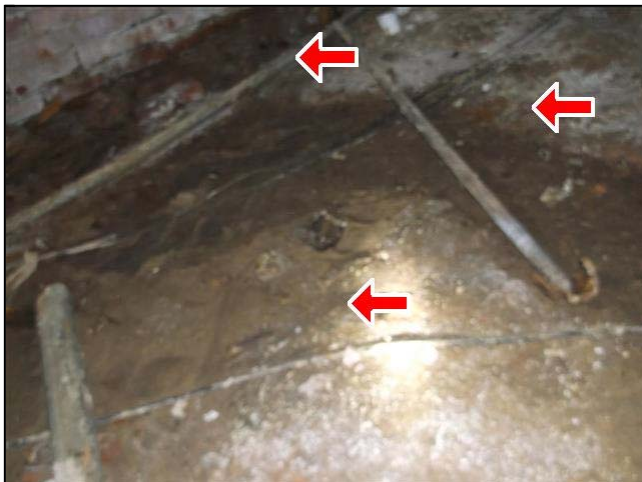
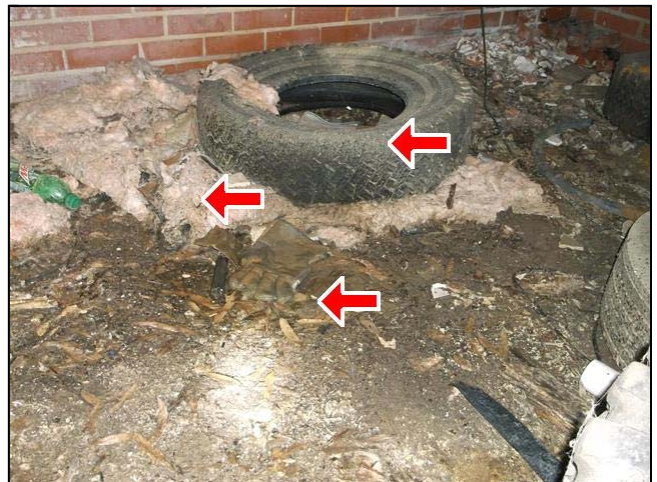
There is evidence of past water in the crawl space at various locations. This condition may vary seasonally and/or with precipitation intensity. Lot drainage and / or roof drainage improvements should be addressed as a first step to controlling water in the crawl space. This condition should then be monitored to determine if drainage systems are necessary.

All wood debris and/or trash should be removed from the crawl space. Crawl space wood/soil contact should be eliminated. This condition is conducive to rot and wood boring insect activity. A licensed technician should be consulted to evaluate and make corrections.

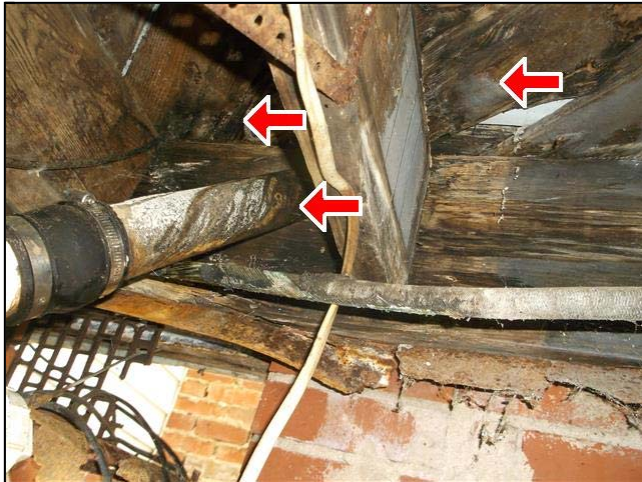
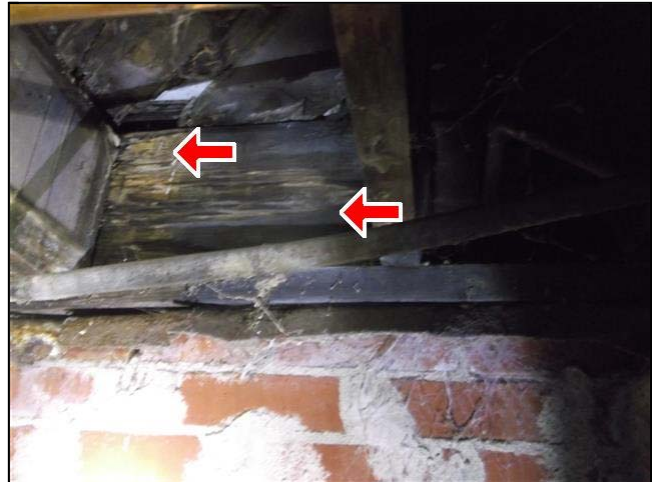
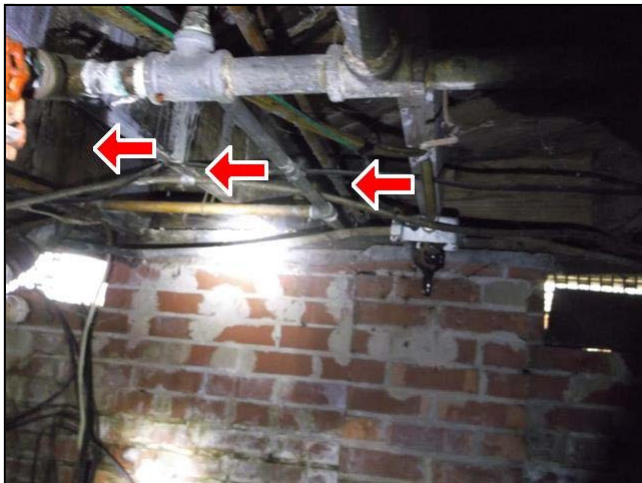
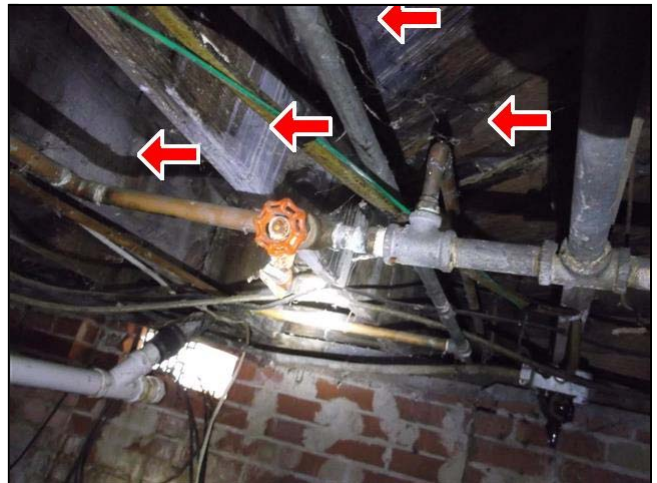
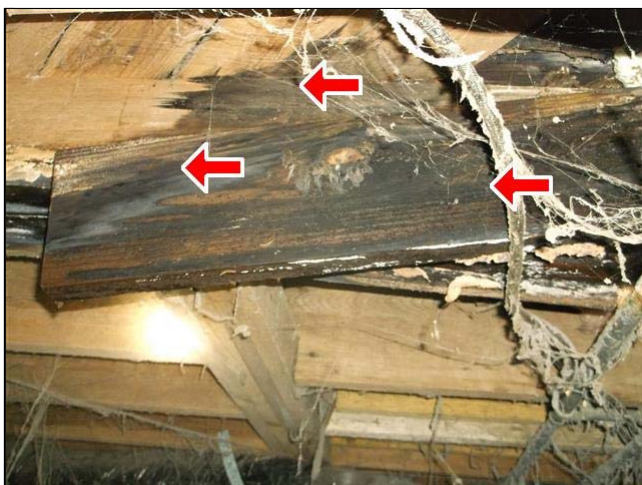
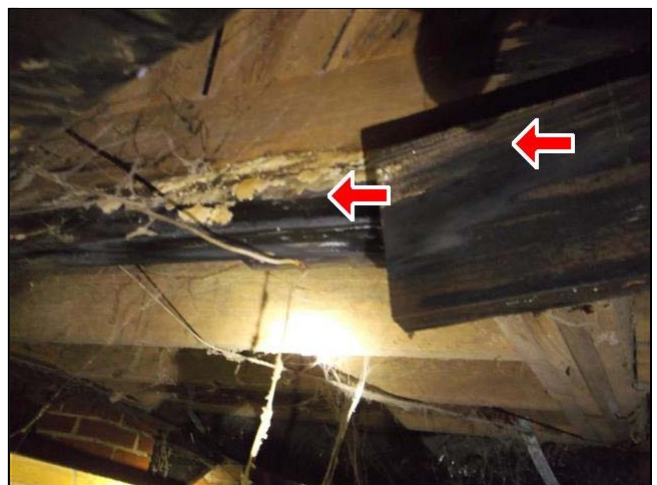
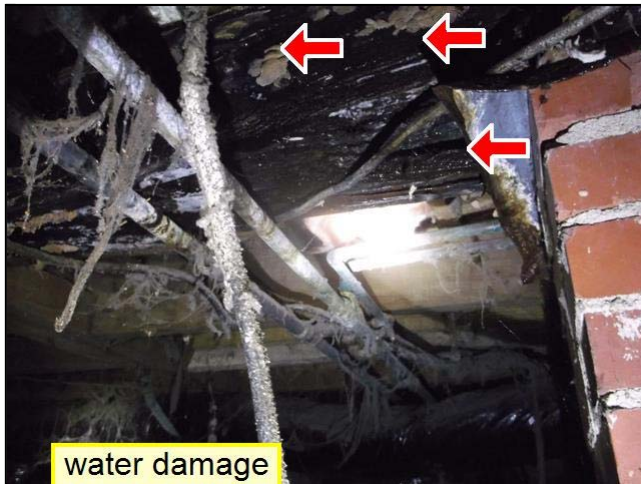
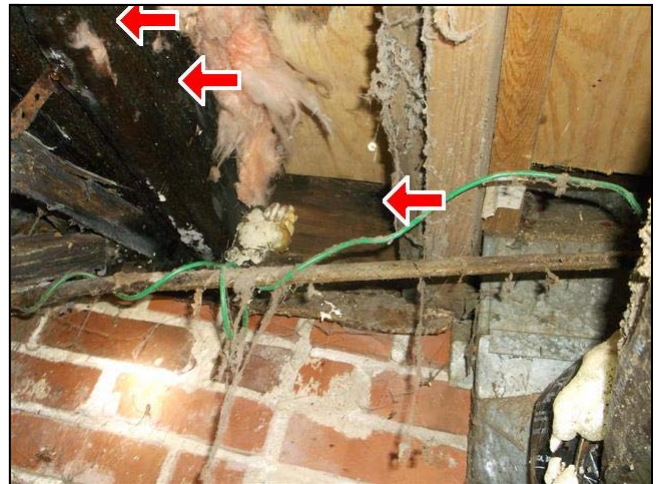
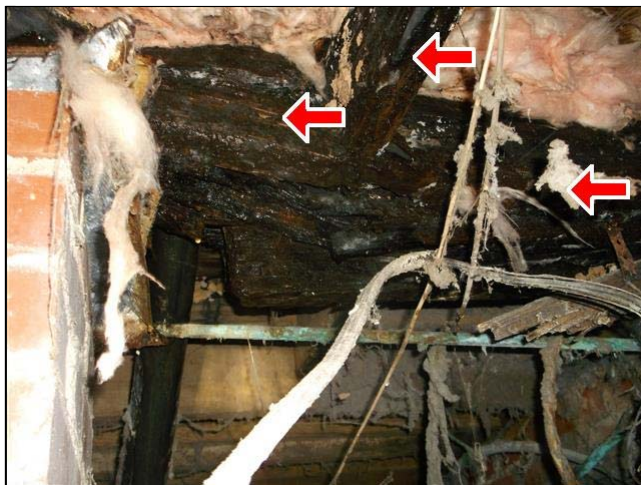
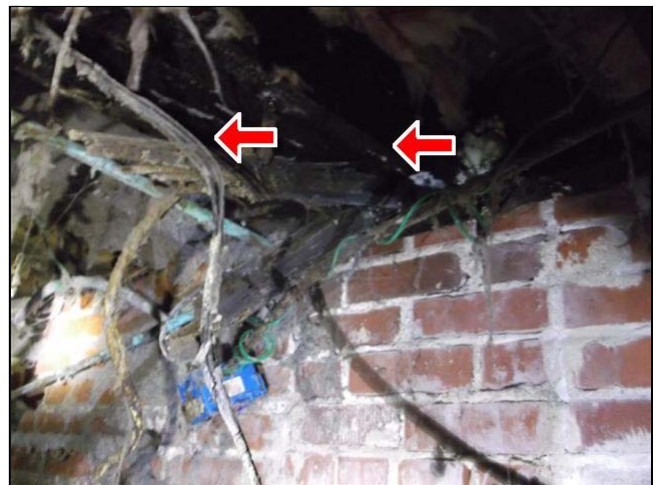
The sub-flooring, beams and band sills at various locations of the building are damaged where visible. The sub-floor is a part of the structure and we recommend that a licensed contractor or engineer be consulted for the type

and extent of the repairs. As with all areas that are concealed more extensive damage may be revealed when the repairs are undertaken

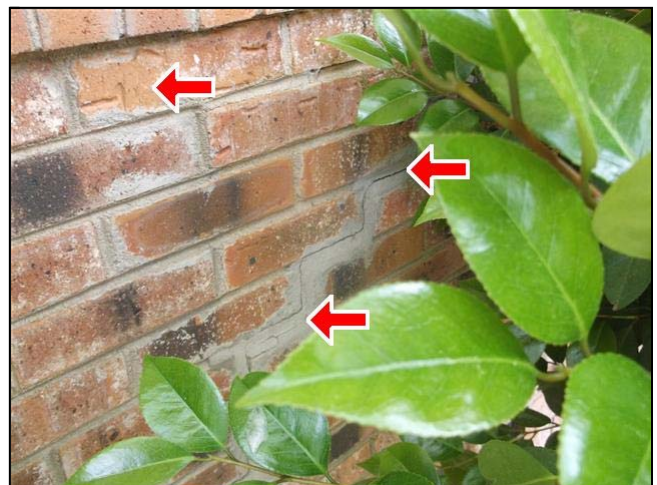
2.3 Item 2(Picture)

Pronounced exterior wall cracks were observed. This implies that structural movement of the building has occurred. The rate of movement cannot be predicted during a one-time inspection. A structural engineer should be consulted to further evaluate this condition and the remedies available for correction.

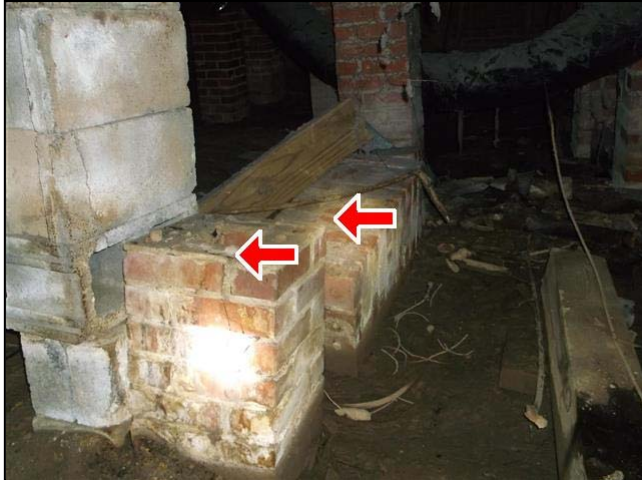
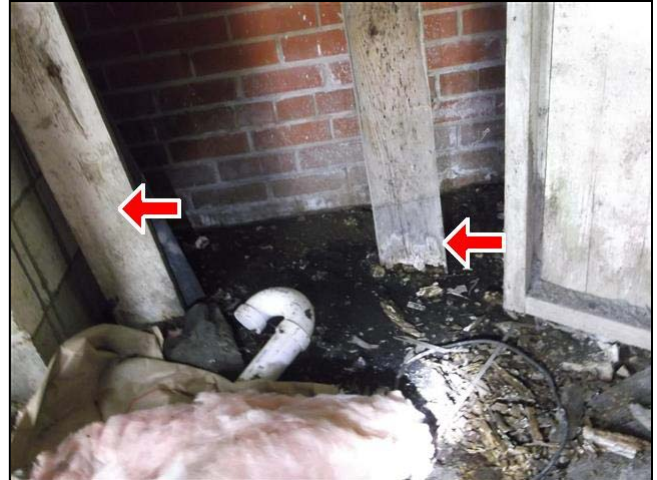
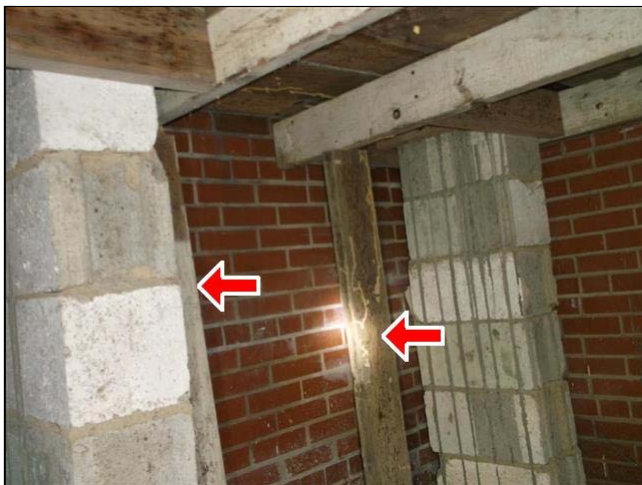
Concrete pier(damaged) and wood piers are not supported by a proper concrete footing in the crawlspace at the (rear of home). Recommend a qualified licensed contractor be consulted for further evaluation and recommendations..

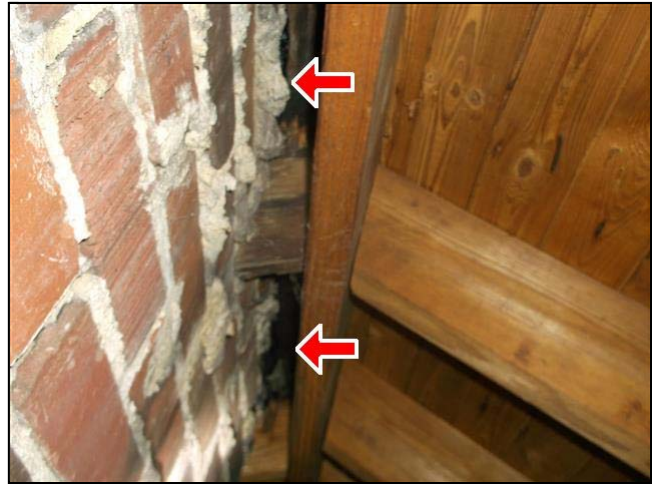
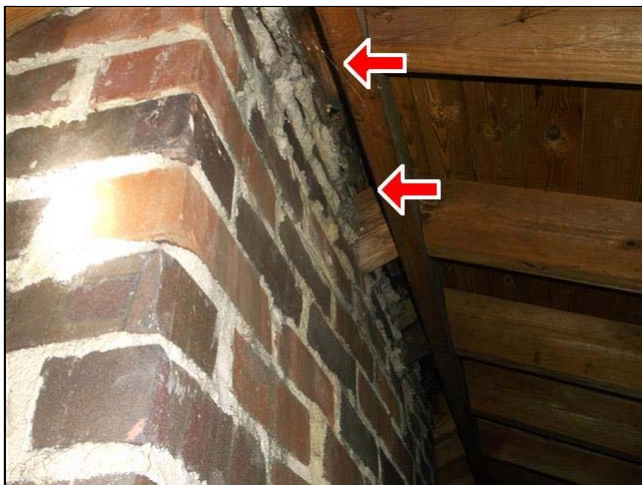
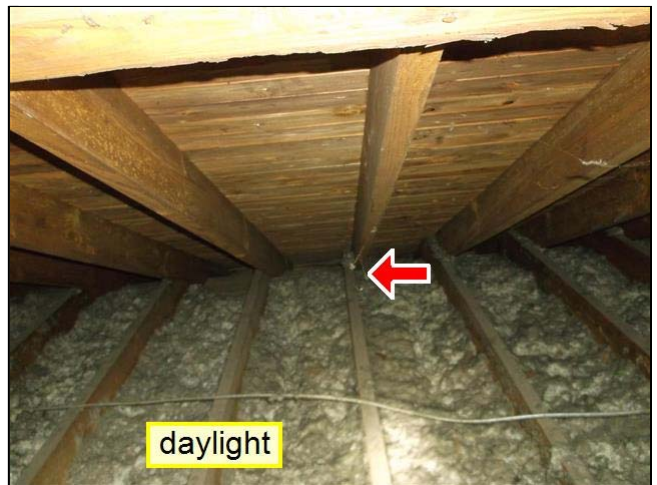
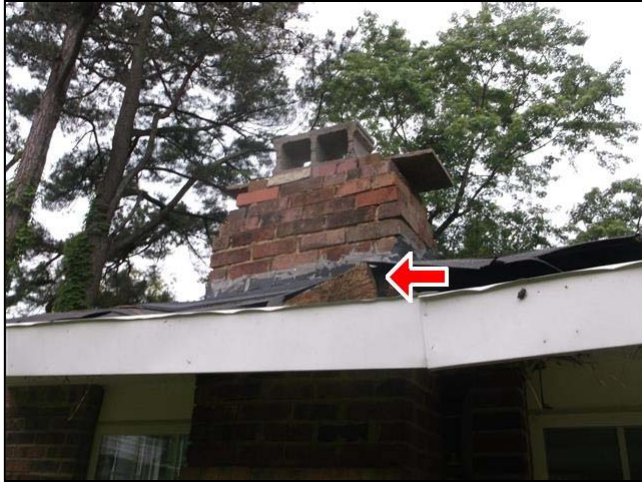
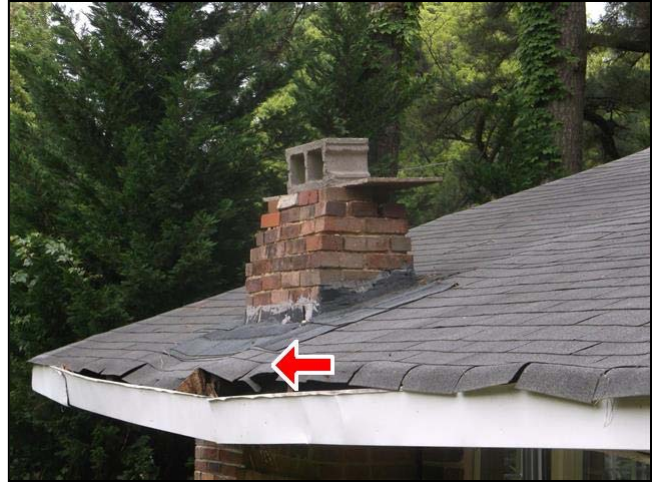
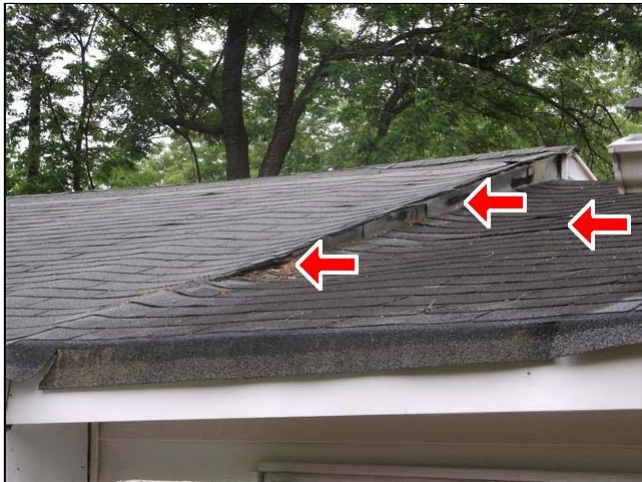
Evidence of prior leaking was noted to the roof decking / sheathing observed in the attic at chimney. The weather conditions leading up to and including the day of the inspection can greatly effect this test. We recommend that these areas and all roof penetrations should be monitored and sealed as necessary. Rafters damaged are under-size or over spanned, and proper support should be provided to reinforce roof around chimney. Recommend a qualified licensed repair contractor be consulted for further evaluation and recommendations.

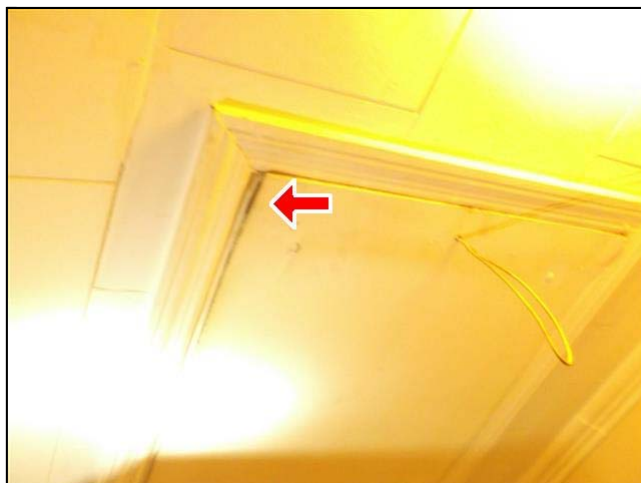
2.6 Item 2(Picture)

Door to attic needs weather-stripping or insulate. Heat loss can occur more on this house than one that is properly insulated. Pull Down Stairs at hallway has loose hardware and is undersized. Recommend repairing to avoid possible fall or collapse from ladder. A licensed technician should make corrections.

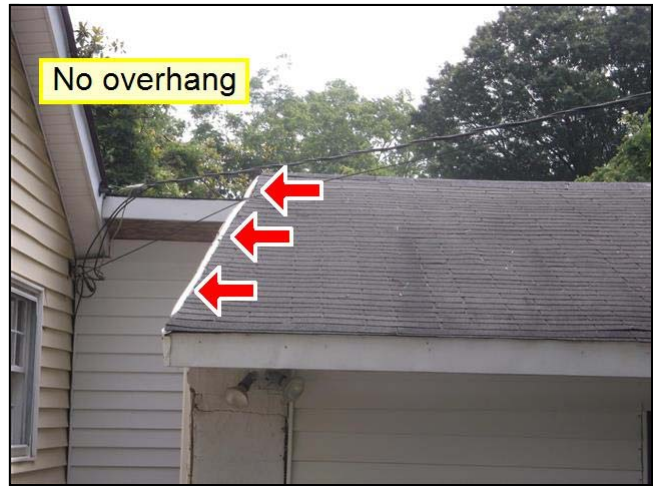
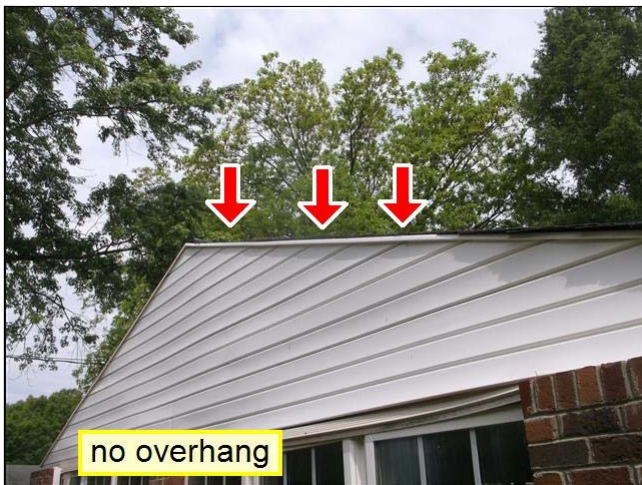
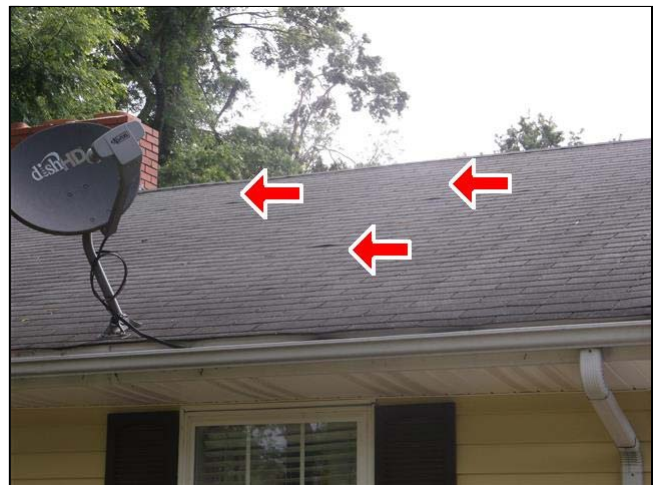
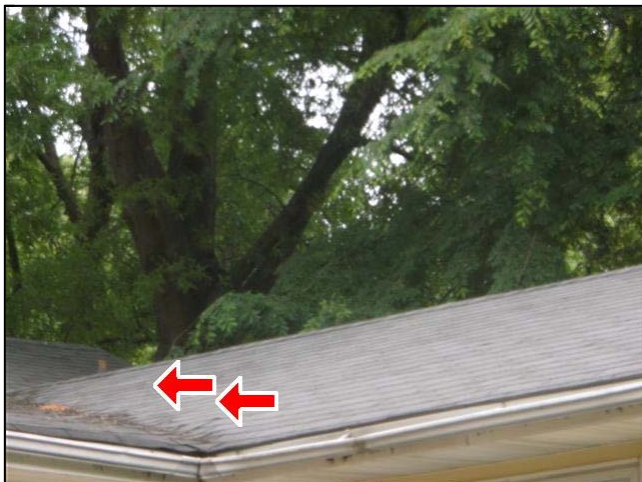
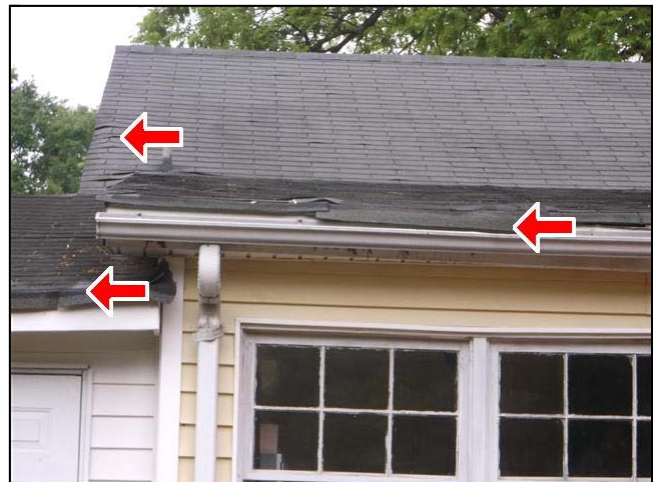
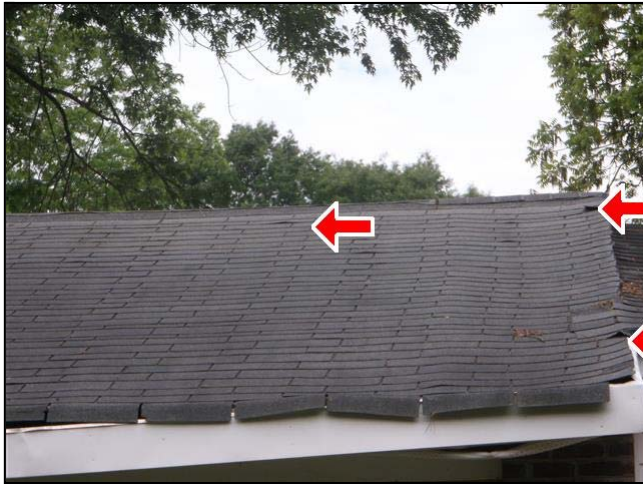
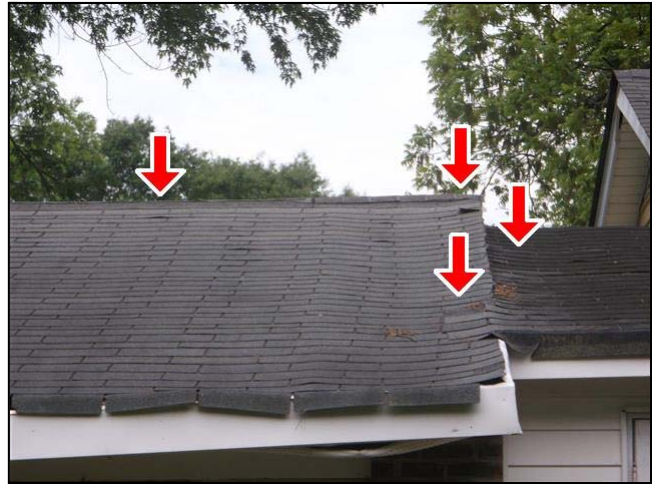
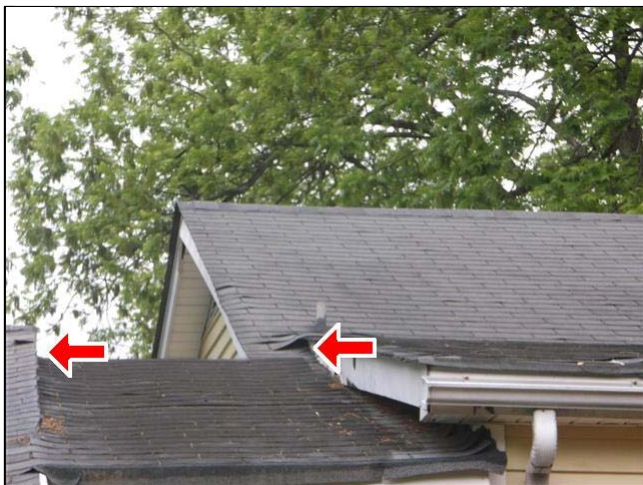
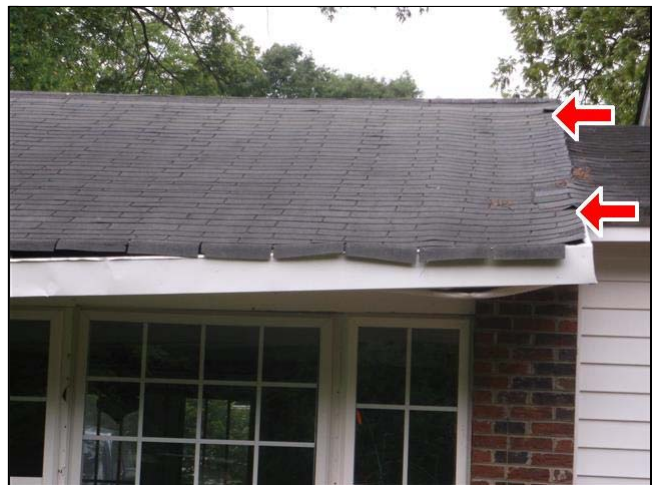
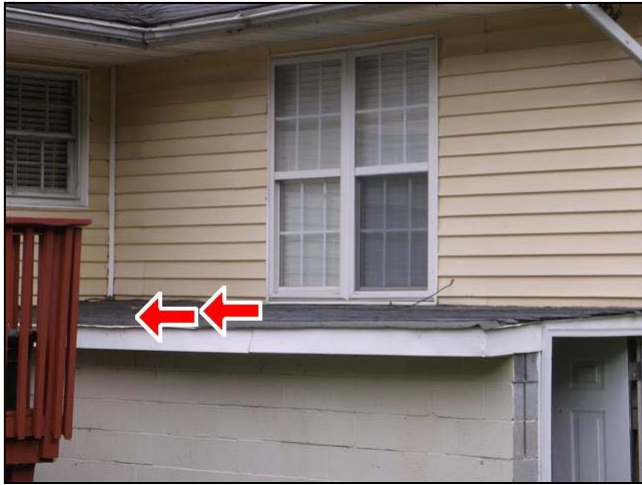
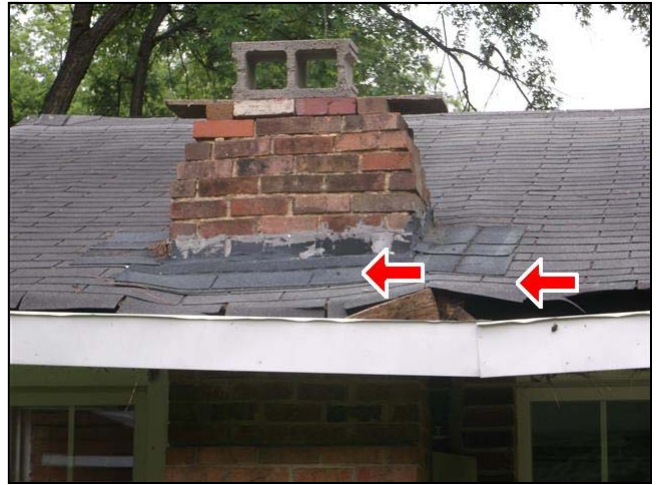
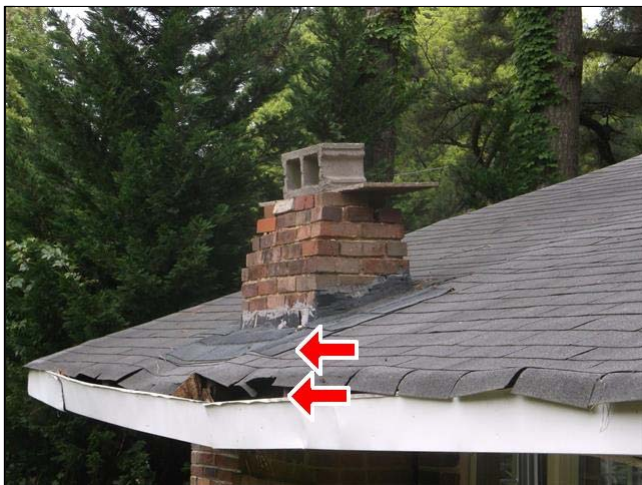
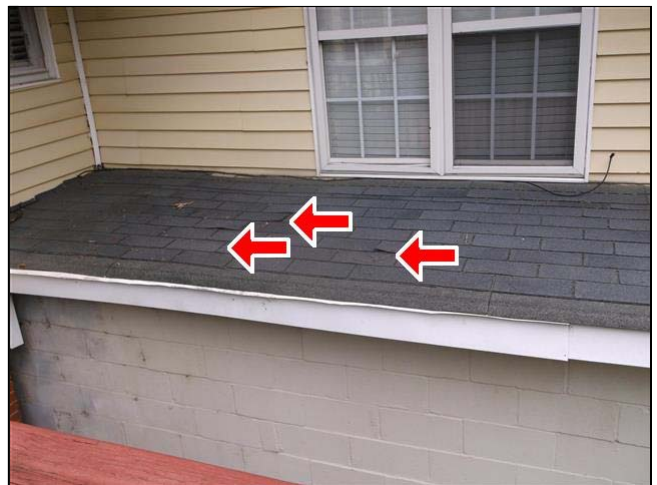
Repairs to the roofing are recommended. Damaged or missing roofing material should be repaired. All roof penetrations should be examined and sealed as necessary. Nail "Pops" (Nails pushing up shingles) should be repaired to prevent permanent damage to roof coverings. A qualified roofing contractor should be consulted for further evaluation and recommendations.

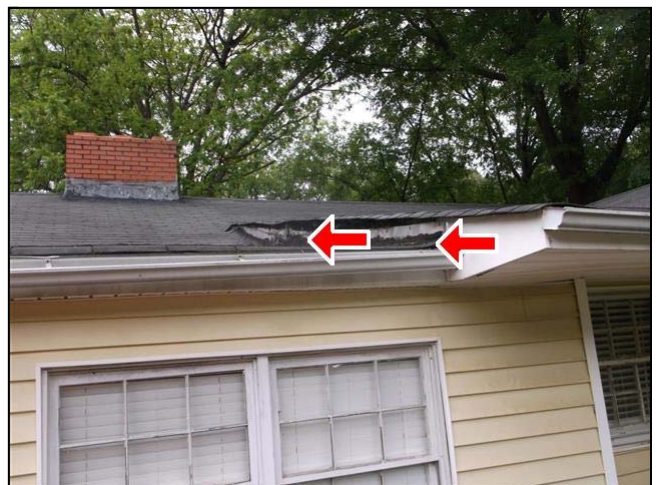
3.1 Item 2(Picture)

The flashing is loose and should be secured at rear. If leakage occurs, patching could be attempted. If this is unsuccessful, replacement may be necessary. A licensed roofing contractor should be consulted to evaluate and make necessary repairs.

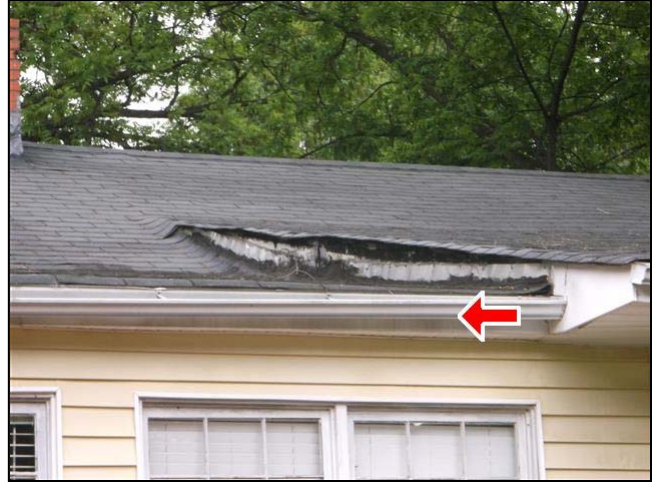
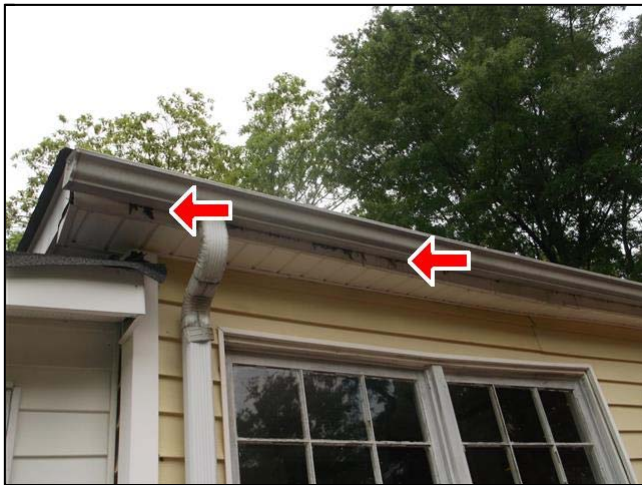
The gutters appear to leak at seams and are clogged with leaves at front and rear of home. Recommend cleaning and sealing. Stains on the fascia boards indicate roof runoff overflows the gutters. The gutters and downspouts should be aligned, caulked and cleaned to work properly. A licensed technician should be consulted to evaluate and make corrections.

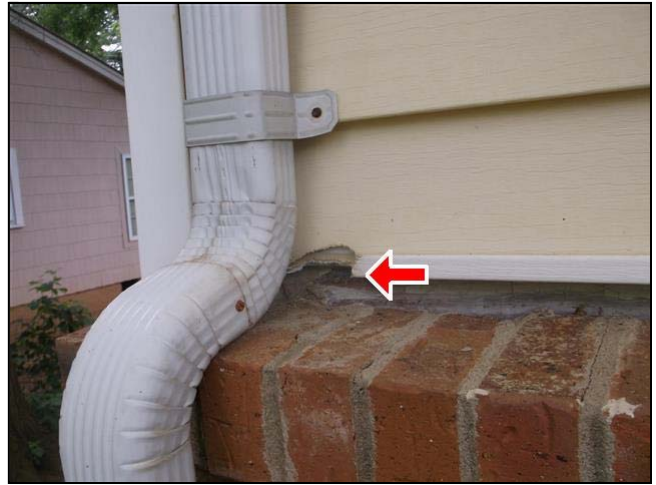
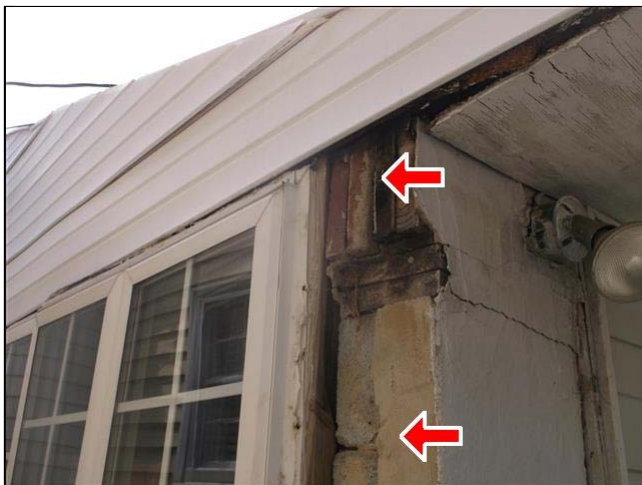
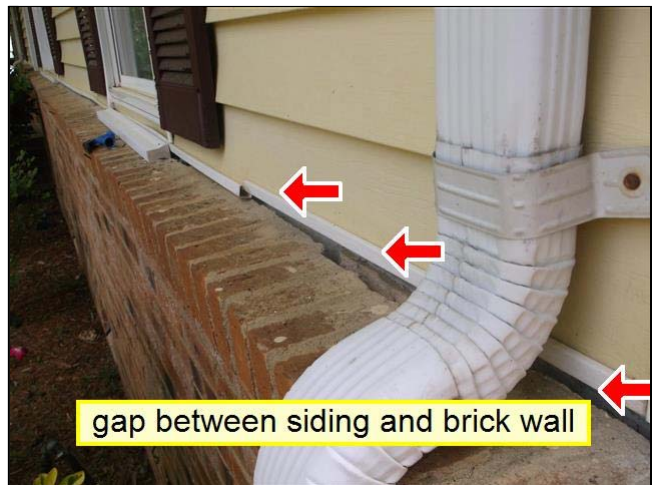
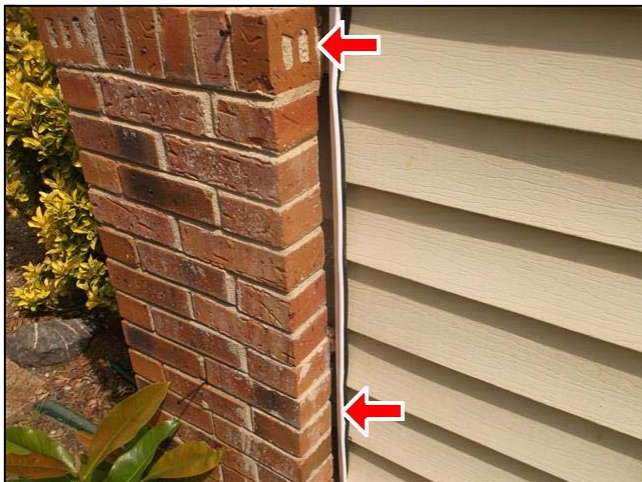
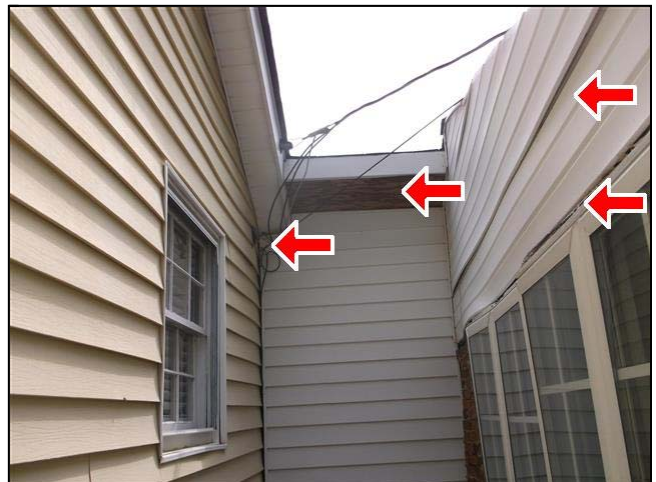
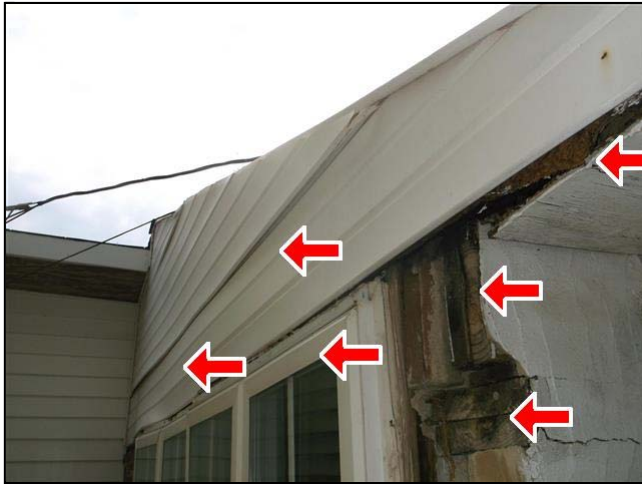
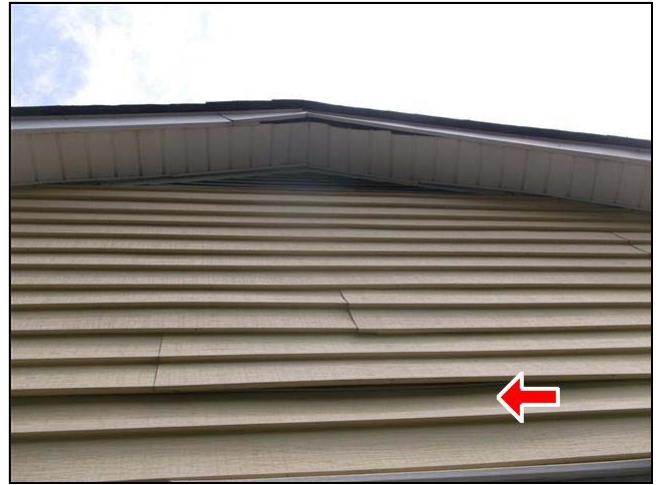
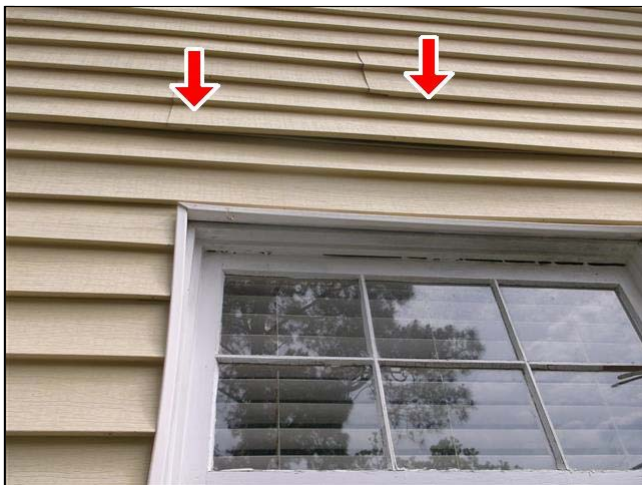
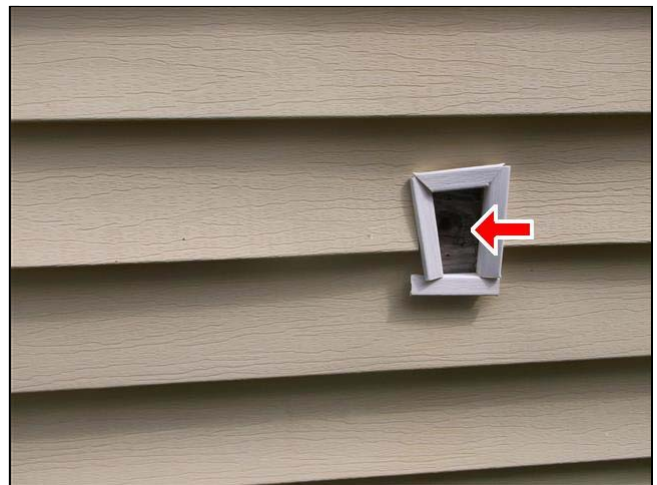
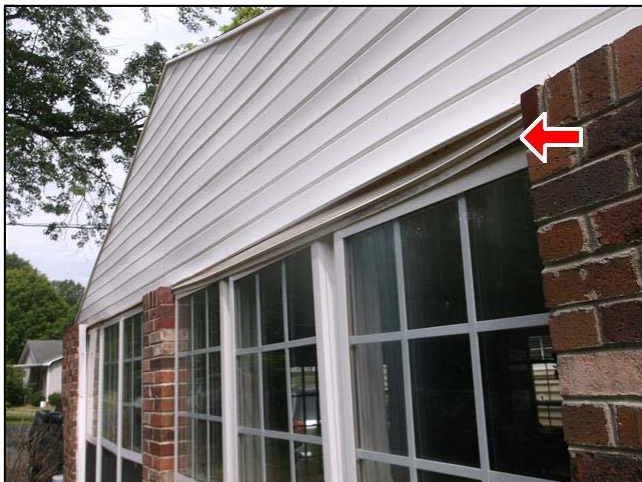
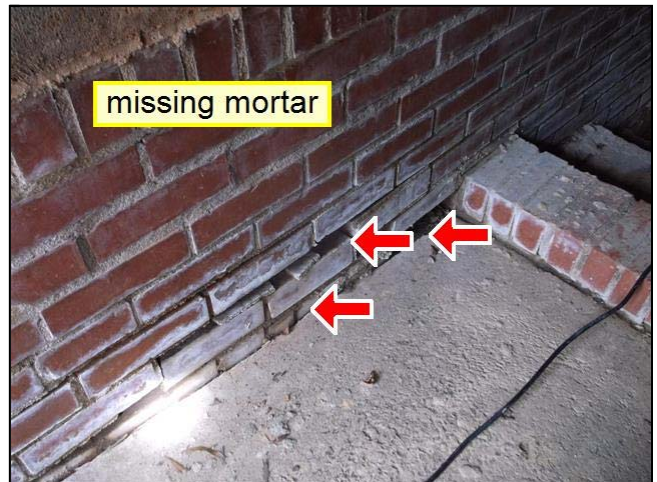
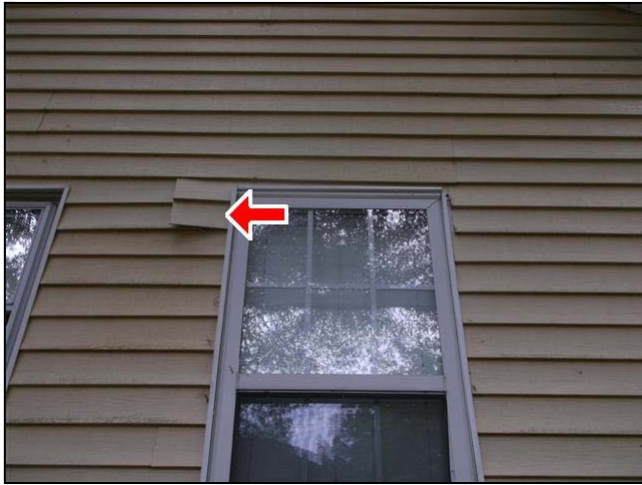
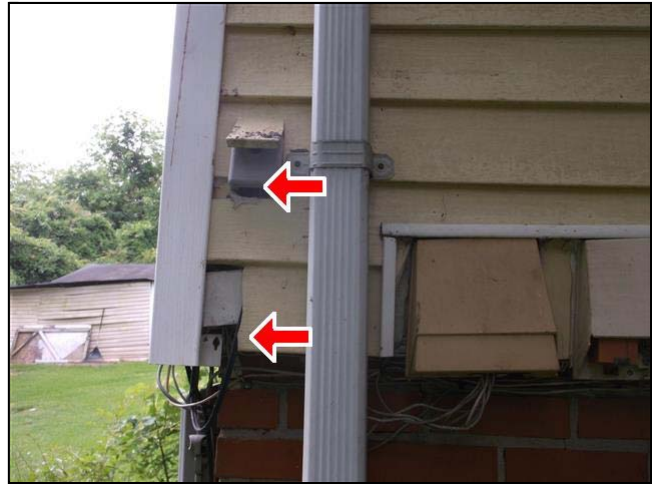
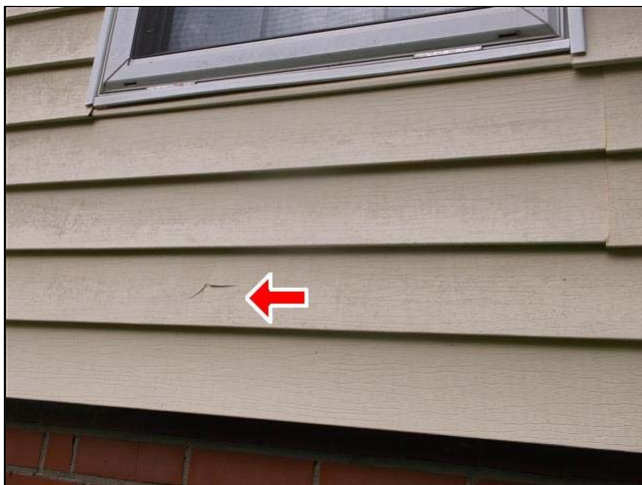
Localized pointing of deteriorated mortar between the bricks of the exterior walls is advisable. Replace or repair as needed. Holes in siding or damaged siding need repairing or closing off with sealant or liquid foam at various locations. Water may enter if not corrected. Vinyl siding not installed correctly at various locations. Damaged siding at various locations. Hole in siding needs closing off with sealant or liquid foam at various locations. Water may enter. A licensed technician should make repairs.

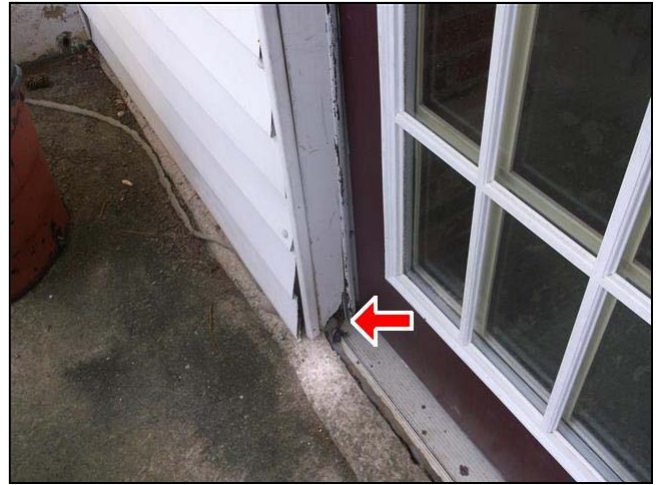
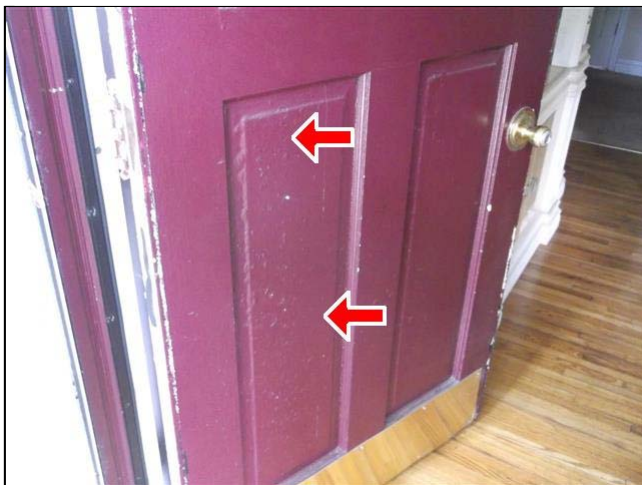
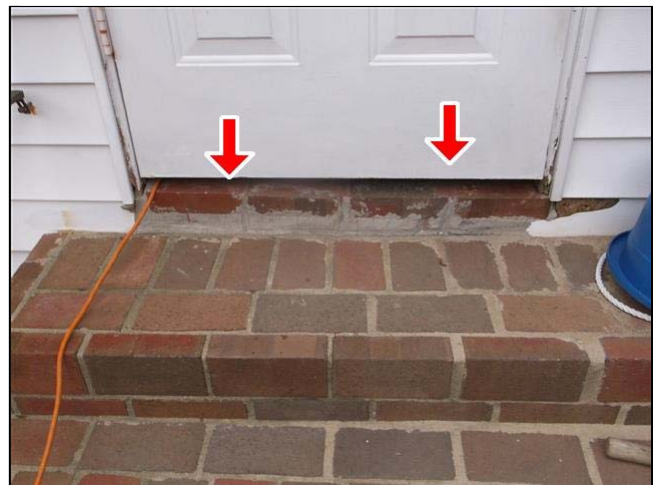
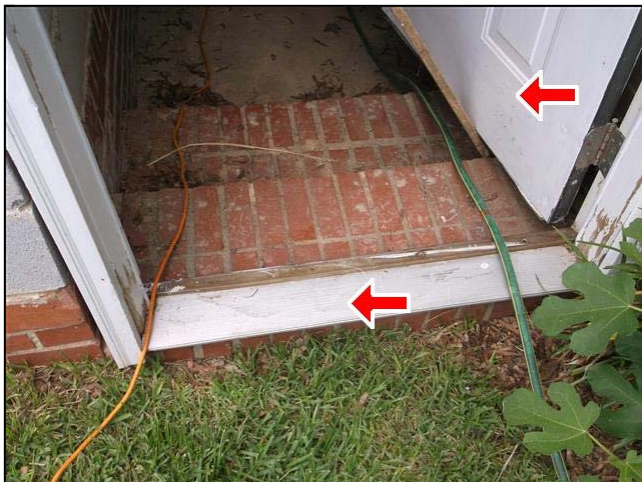
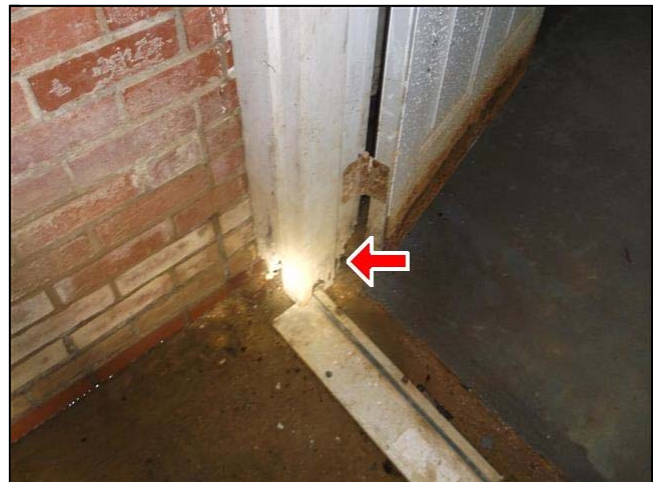
Exposed wood door frame and entry door at front are damaged and has wood rot. As with all repairs hidden damage may be discovered while repairs are being completed. Repair or replace. Damaged or non functional hardware needs replacing or repairing as needed. This condition should be improved. A licensed technician should be consulted to evaluate and make corrections.

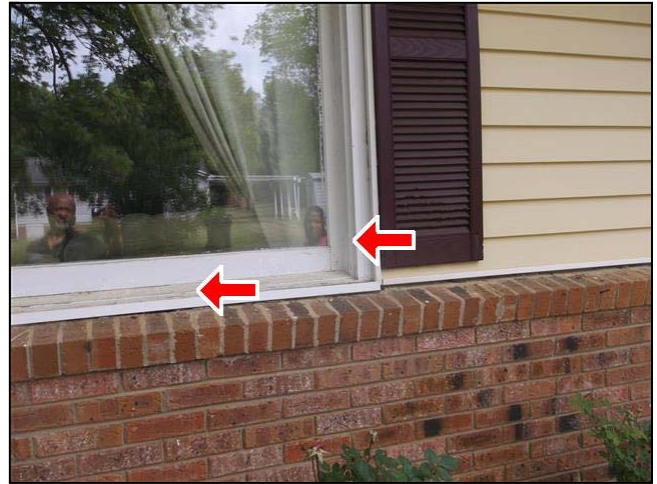
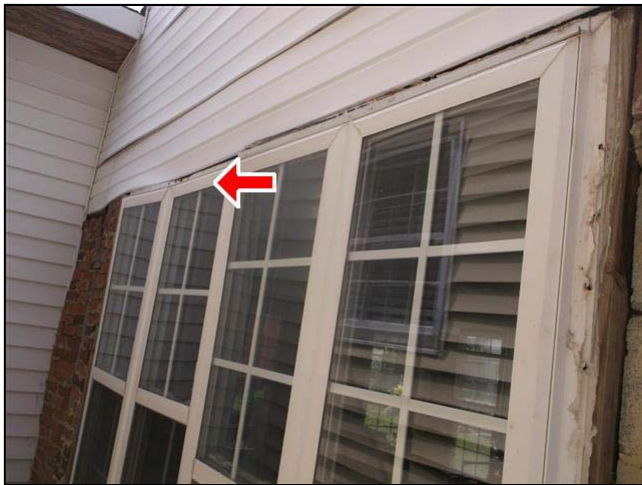
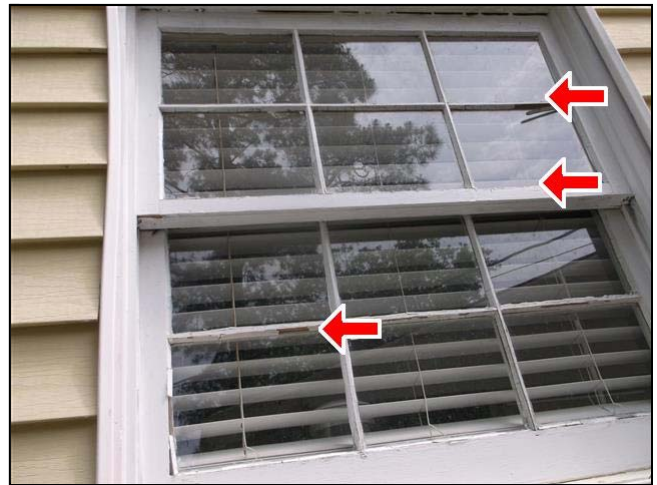
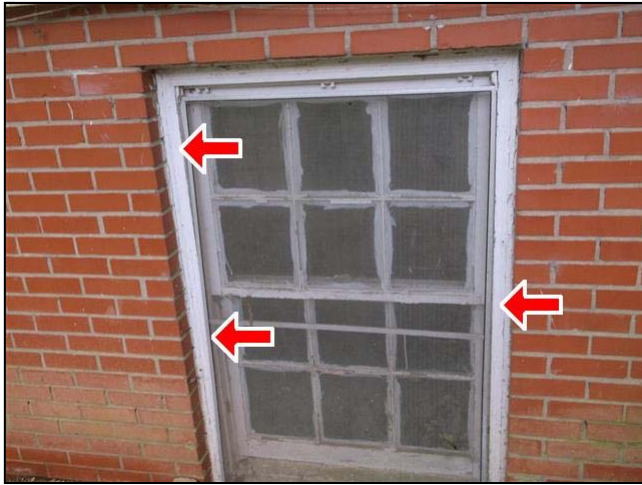
The windows are in need of repair. This is a common condition that does not necessitate major repair. Trimming and adjustment, hardware improvements and glazing repairs would be logical improvements. The most important

factor is that the window exteriors are well maintained to avoid rot or water infiltration. A licensed technician should make corrections.
