## Inspection Report

### ERD Home Inspections

**Property Address:**  
home inspection way  
Monroe NC

<b>Date:</b> 5/10/2016	<b>Time:</b>	<b>Report ID:</b> 5/10/2016
<b>Property:</b> home inspection way Monroe NC	<b>Customer:</b> ERD Home Inspections	<b>Real Estate Professional:</b>

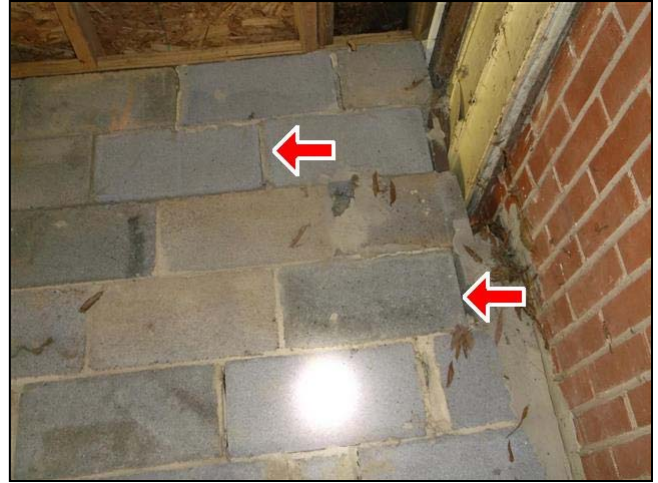
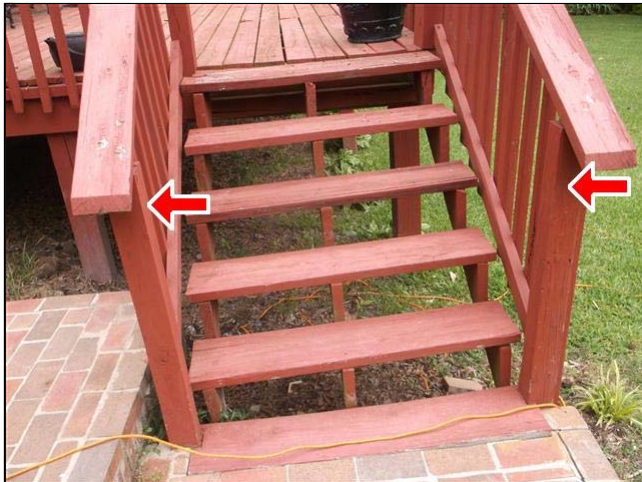
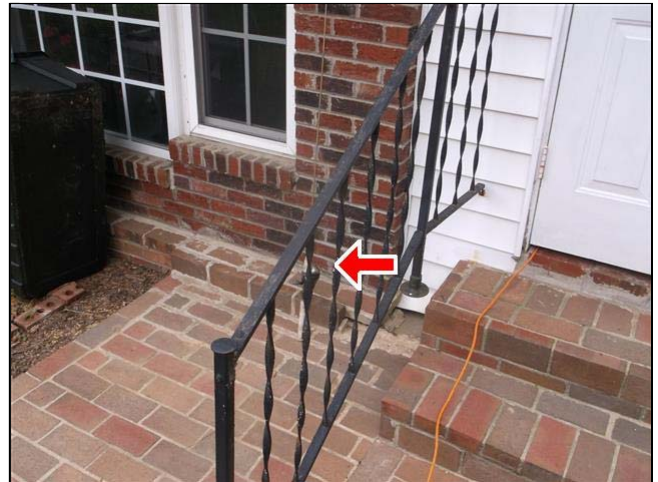
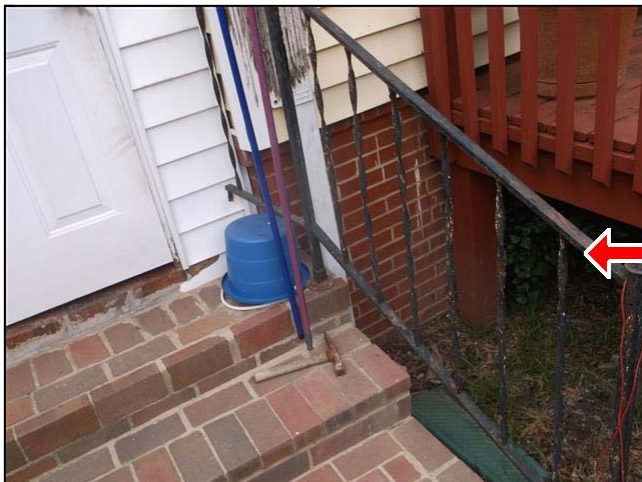
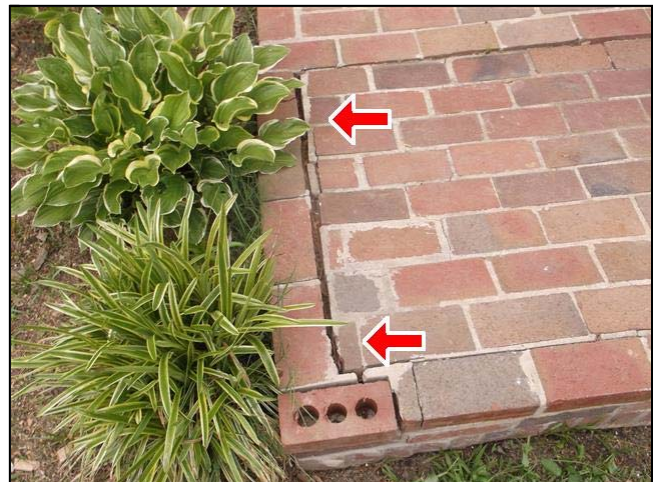
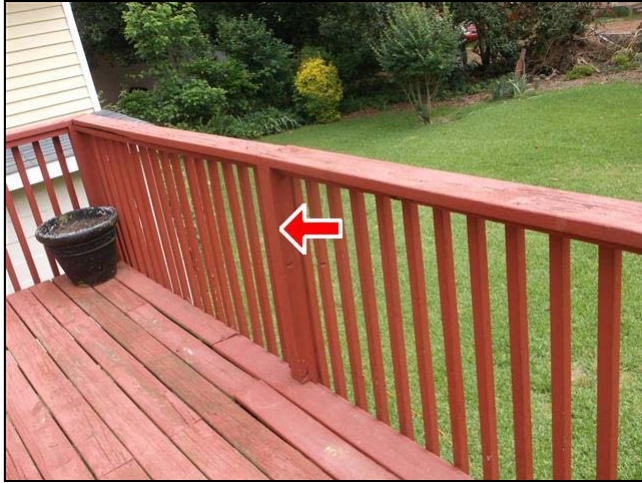
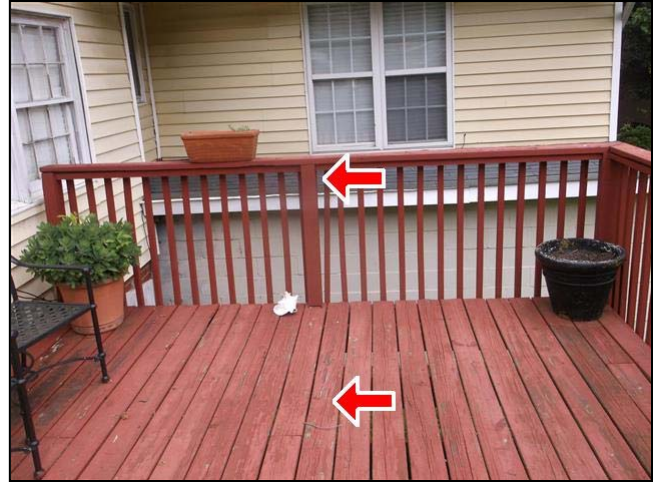
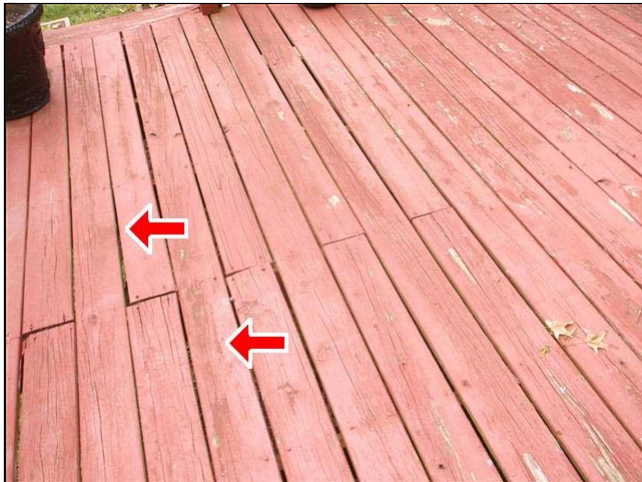
The masonry steps should be "pointed up" or tuck pointed and any loose material should be repaired or replaced. Water may enter if not corrected. The deck is in need of minor repairs. Loose hand rails need securing at rear deck and rear door. This is a safety hazard if not corrected. Staining the deck will prolong the life of the decking. A licensed technician should be consulted to make necessary repairs.

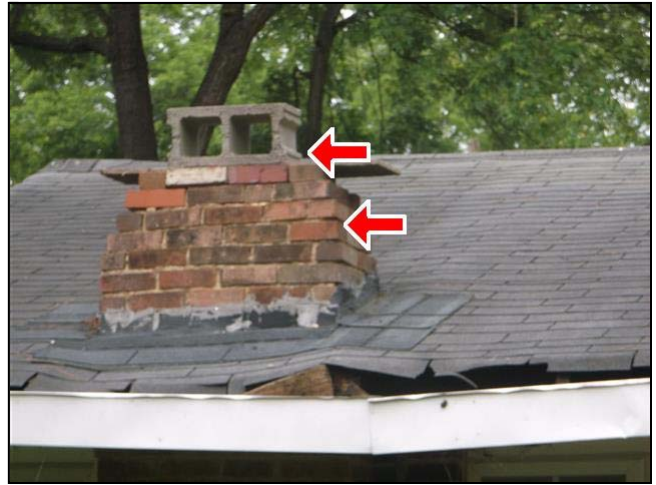
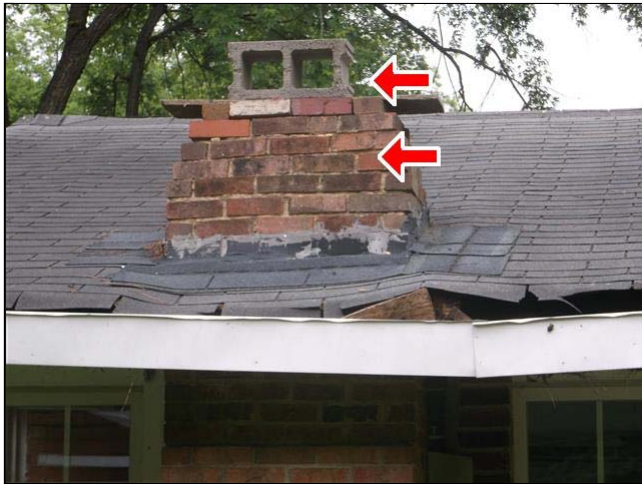
Brick chimney is missing metal caps. Recommend replacing to avoid critters from entering if not corrected. Masonry chimney has missing and loose bricks at top of chimney and needs repair. Recommend replacing or repairing missing or loose materials. A licensed technician should make corrections.

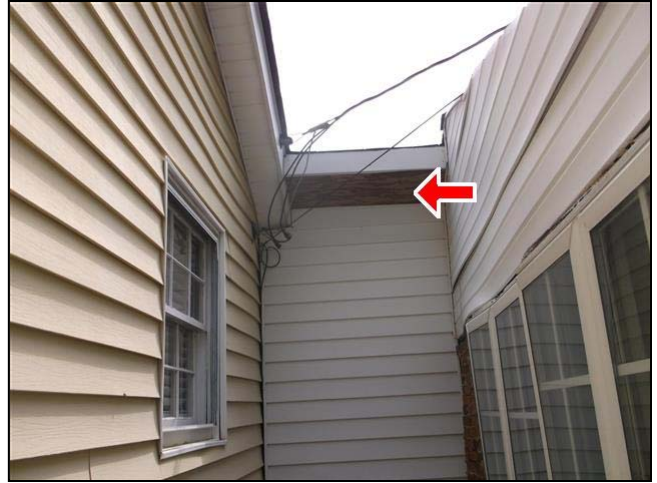
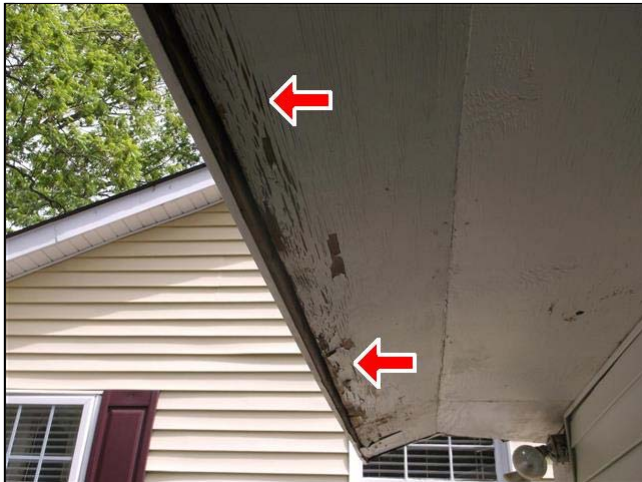
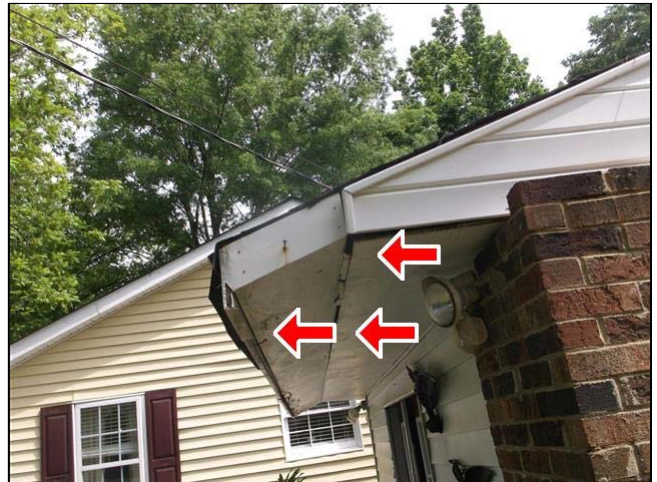
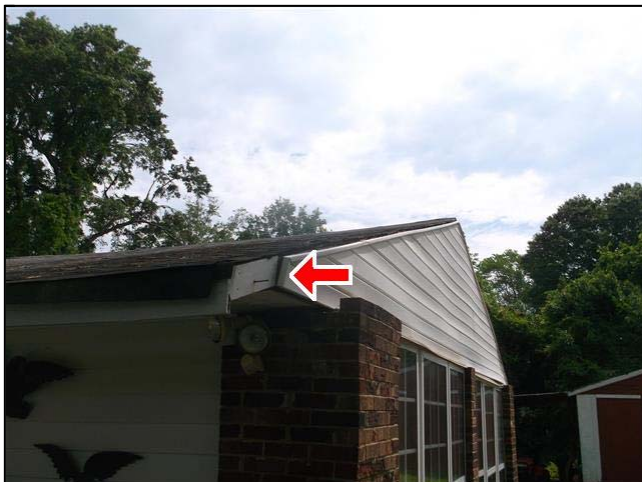
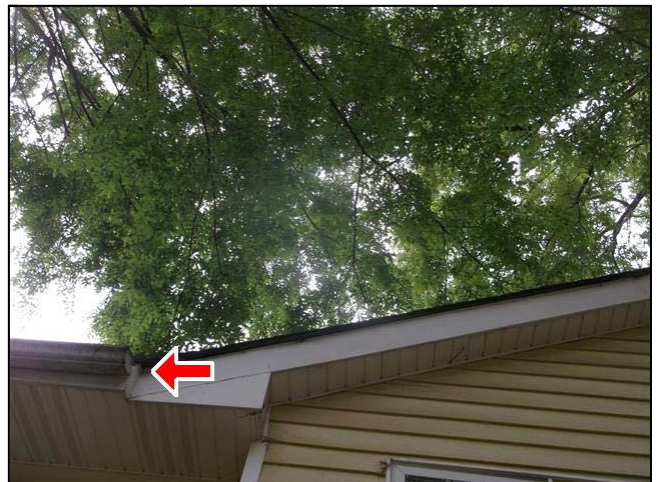
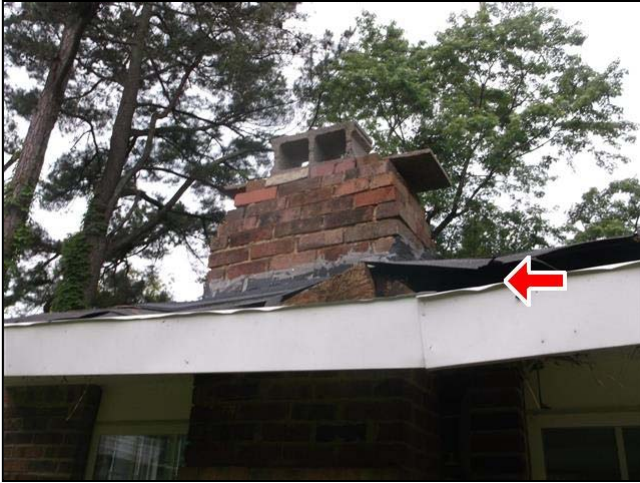
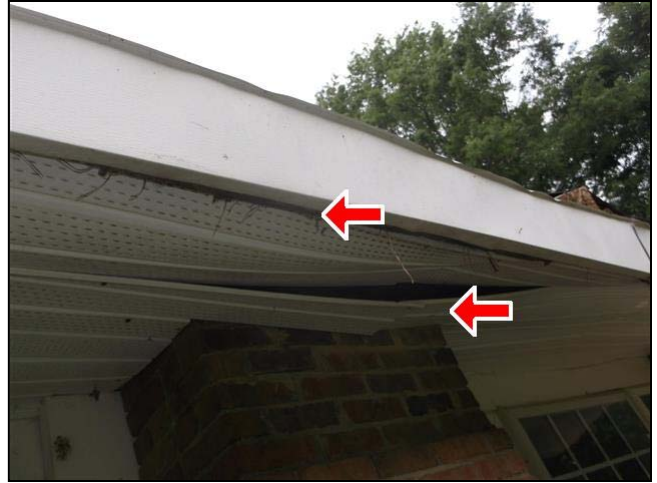
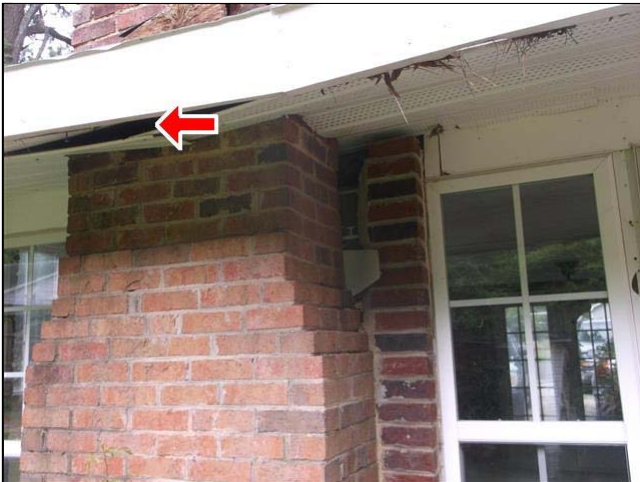
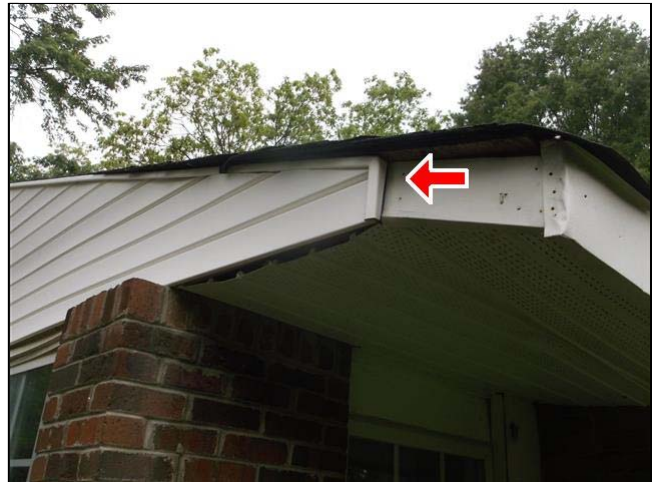
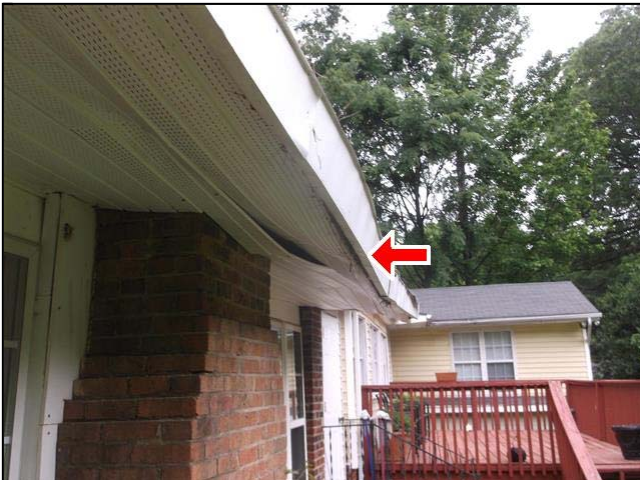
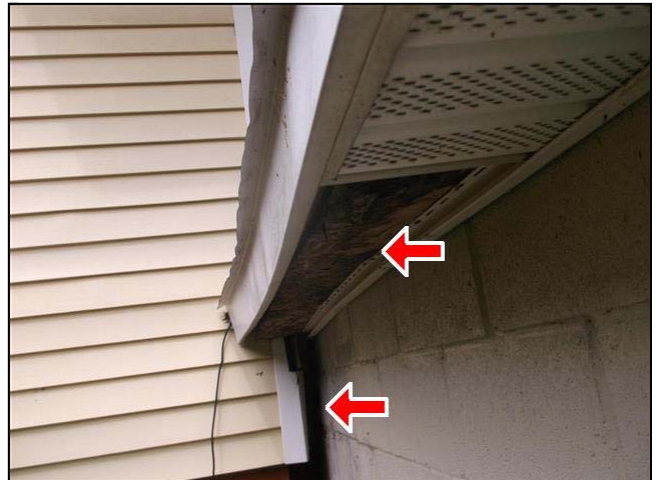
Fascia board and soffits at various locations of home are loose. Recommend repair or replace as necessary board at rear of home needs scraping, painting and caulking. Damaged or poorly painted and caulked wood may lead to water infiltration into the wall and / or floor cavities promoting serious structural damage. As with all repairs hidden damage may be discovered while repairs are being completed. A licensed technician should be consulted to make corrections.

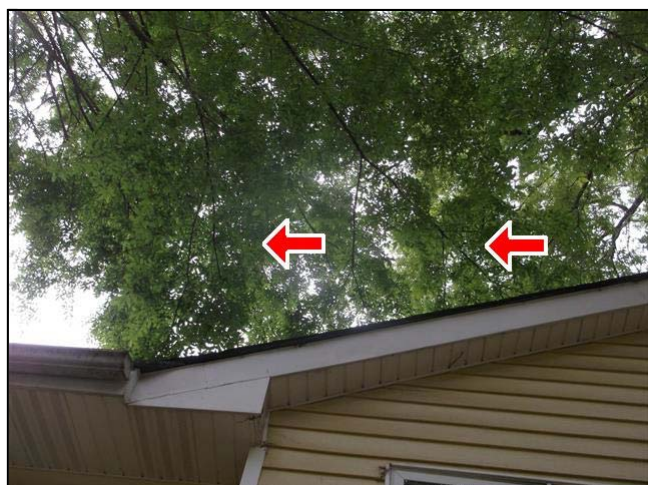
4.10 Item 1(Picture)

Photo depicts a sample of the observation. Not all areas were photographed. Tree branches and bushes should be trimmed away from the building.

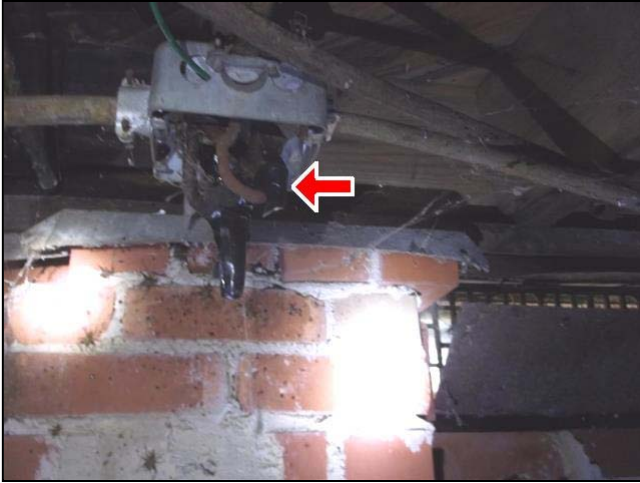
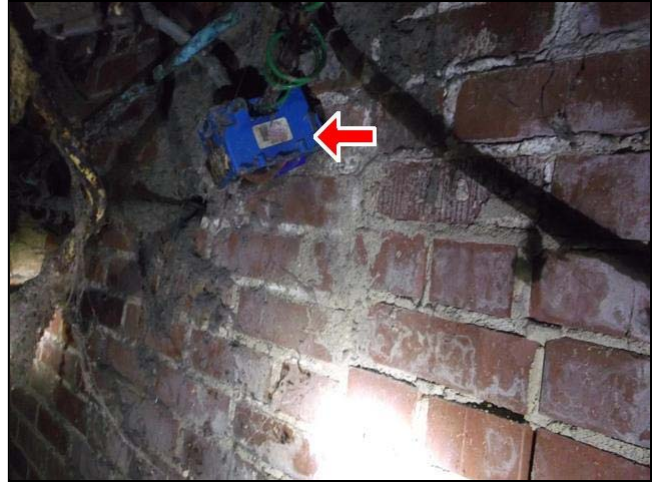
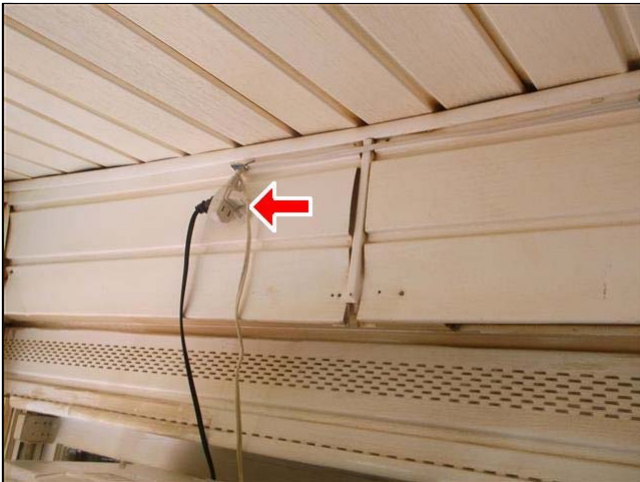
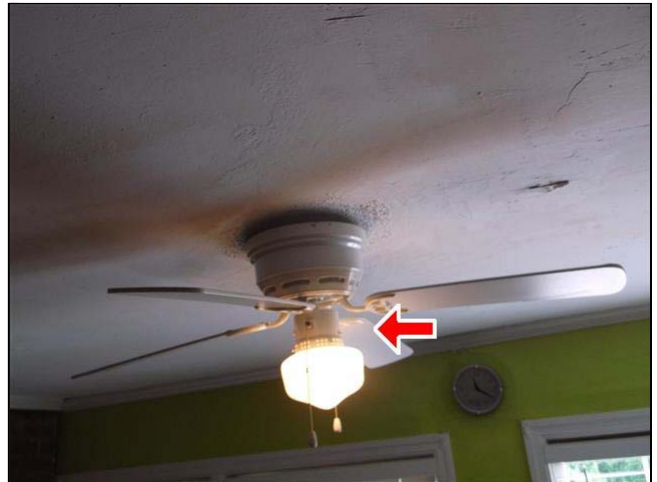
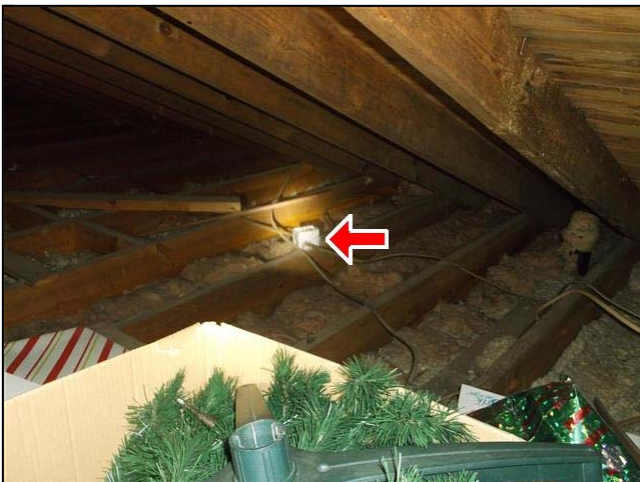
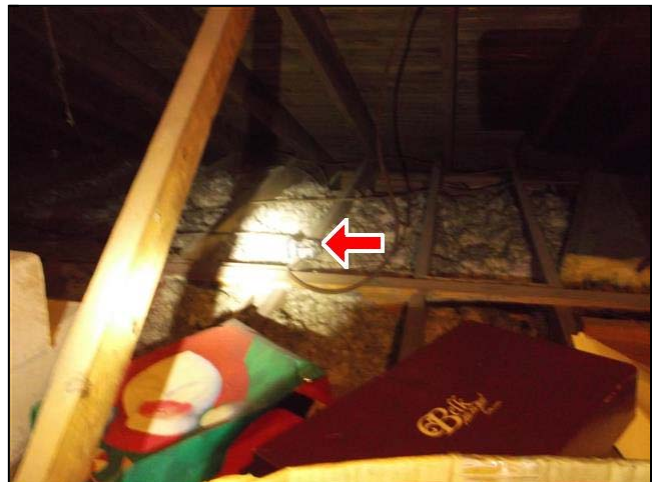
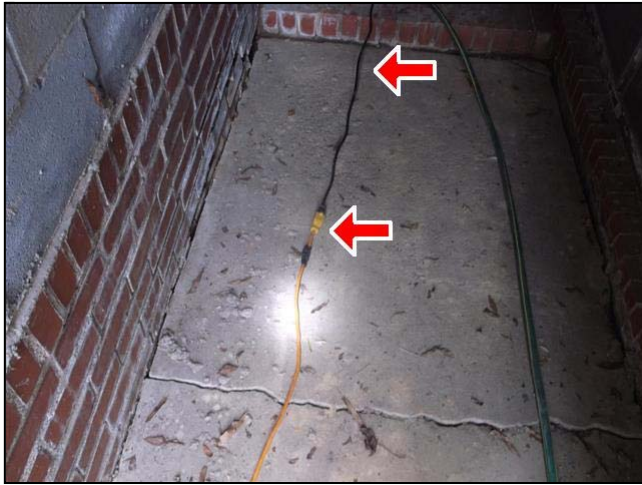
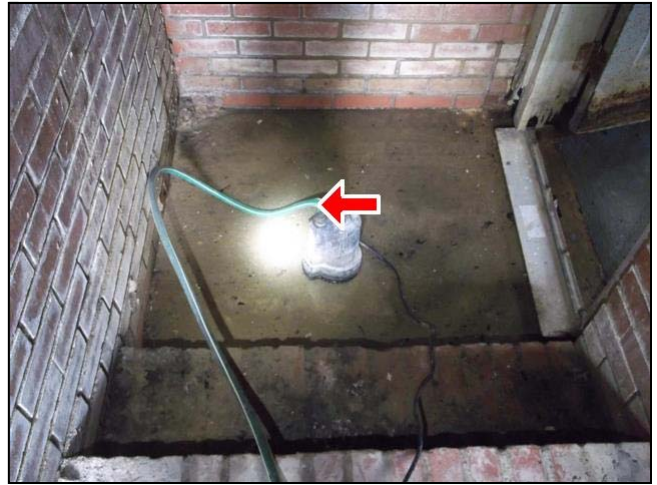
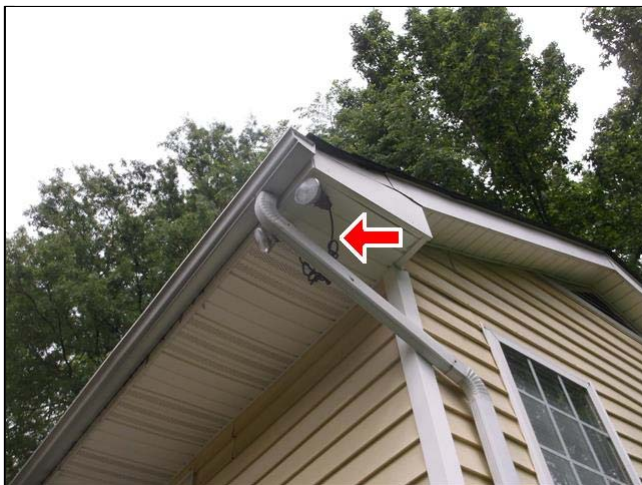
Several junction boxes need cover plates in attic space and in crawlspace. Extension cord used as permanent wiring at light fixture in unfinished room and at sump pump. Ceiling fan "wobbles" and needs repair in Living room. Exterior light fixture is not installed correctly. Replace or repair. A licensed technician should be consulted to evaluate and make corrections.

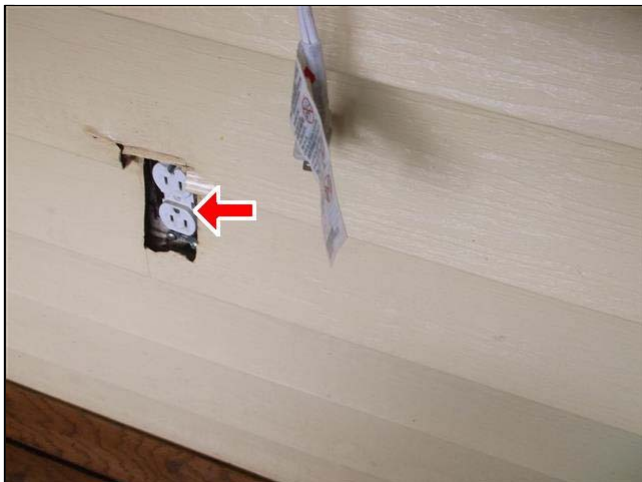
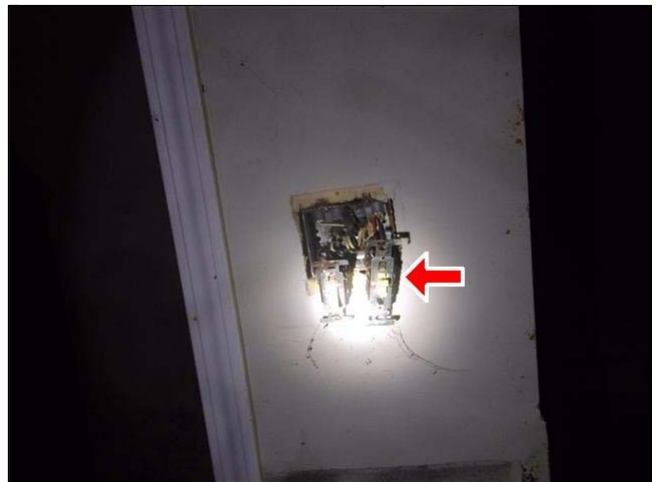
Outlet covers missing at various locations throughout home. This is a safety issue if not corrected. A licensed technician should make corrections.

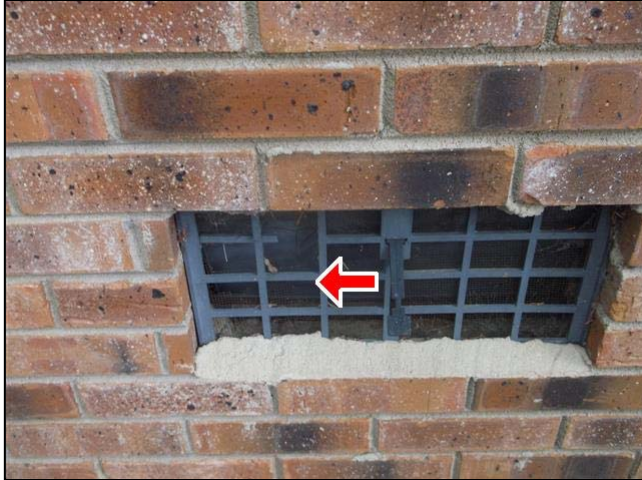
8.0 Item 1(Picture)

Foundation vent(s) need screens at various locations. May allow critters to enter if not corrected. A licensed technician should be consulted to evaluate and make corrections.

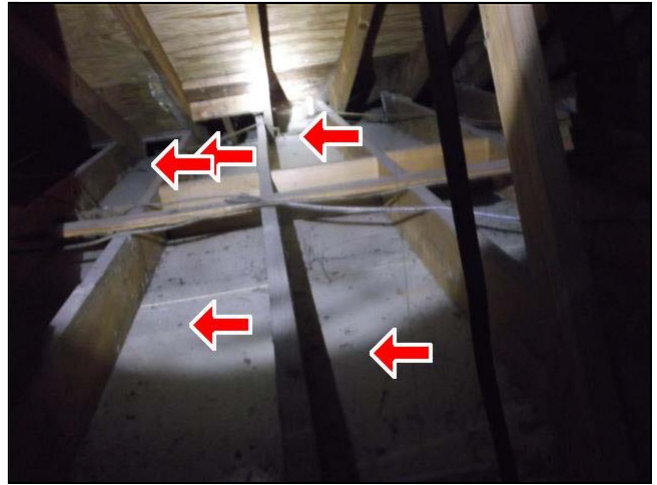
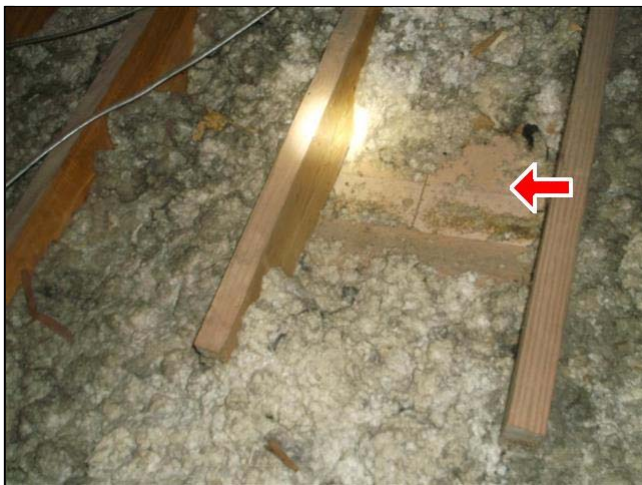
Un-insulated areas in the attic over conditioned space should be better insulated. This condition may cause energy loss if not replaced. A licensed technician should be consulted to evaluate and make corrections.

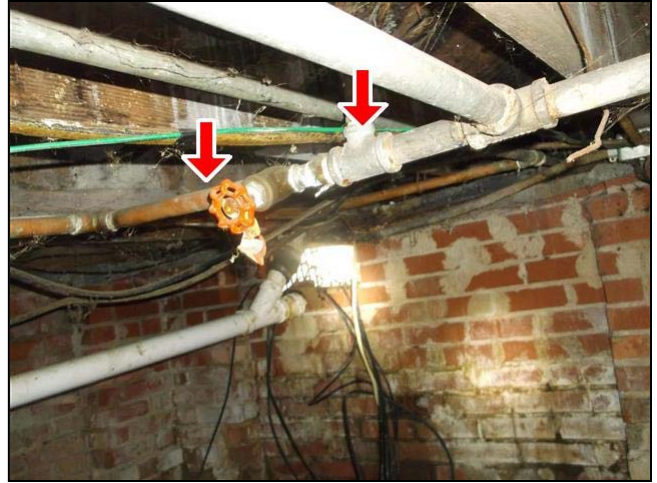
9.1 Item 2(Picture)

Copper and galvanized water lines connected in crawlspace. Replace or repair. A licensed technician should be consulted to evaluate and make corrections.

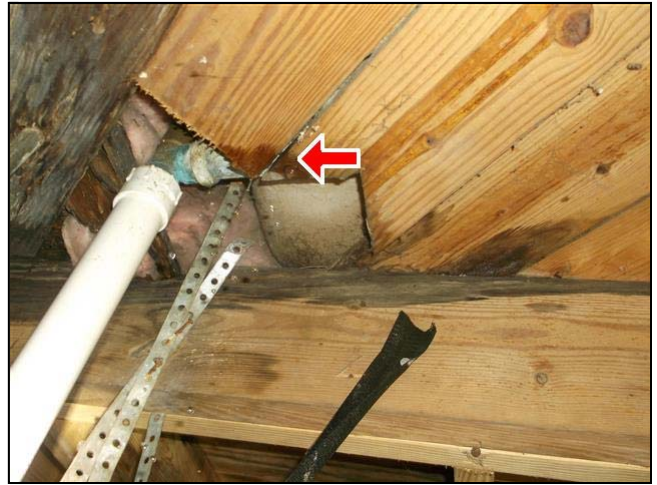
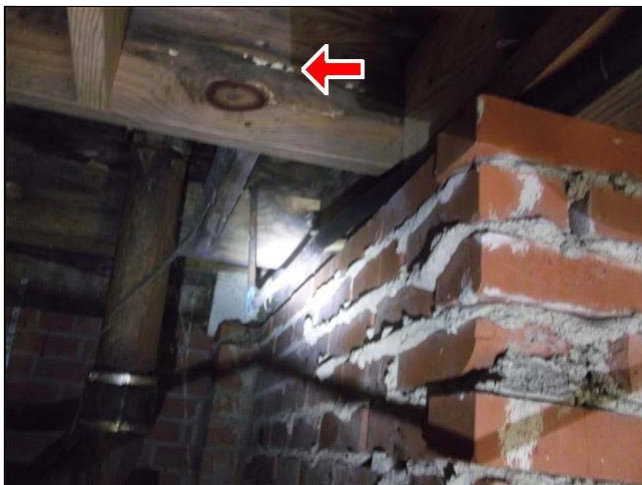
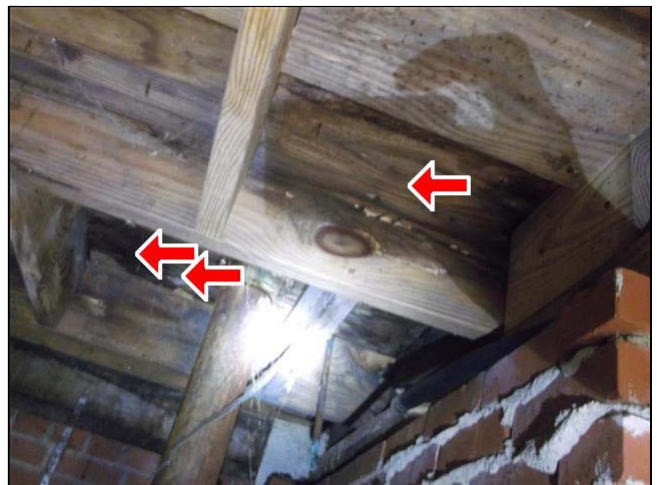
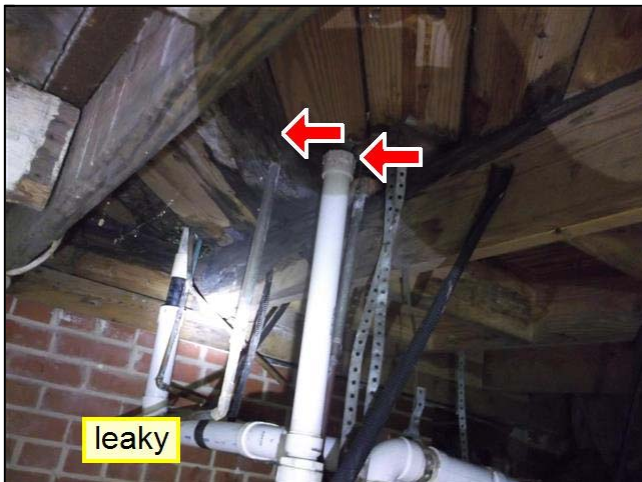
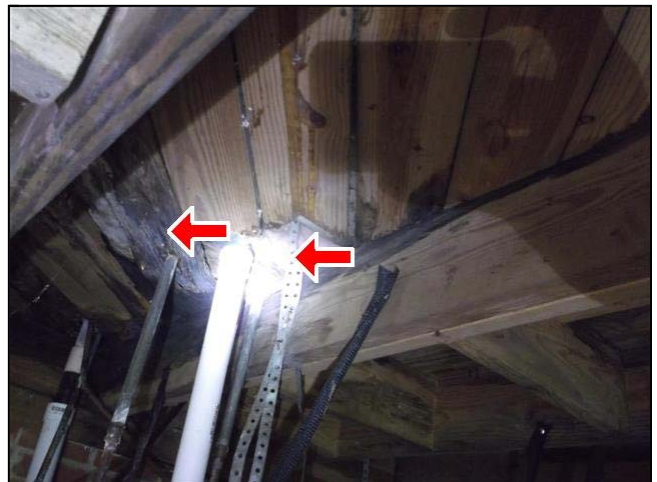
Plumbing waste line leaks is damaged and shows signs of previous leaking at Hall Bath. Recommend repairing. A licensed technician should be consulted to evaluate and make corrections.

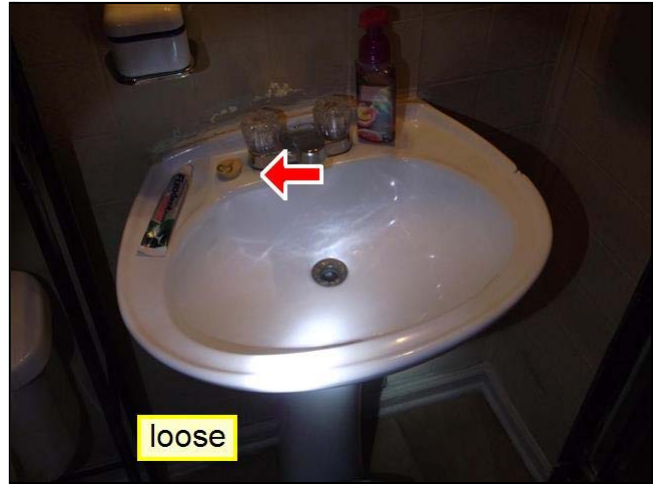
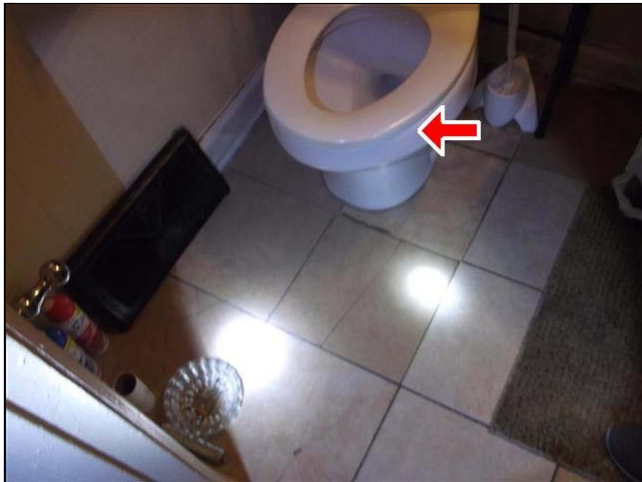
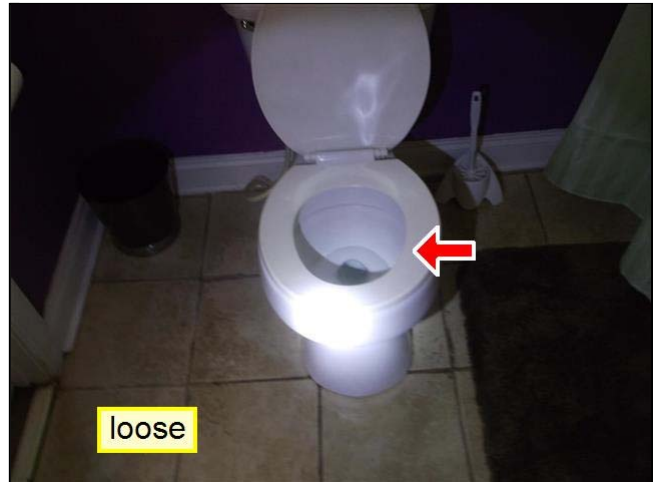
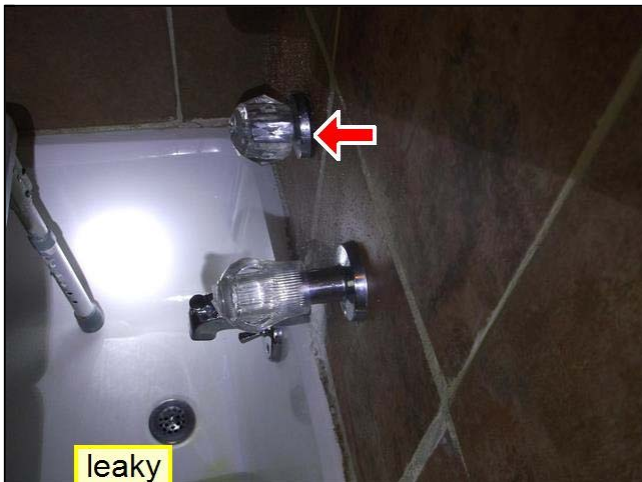
Spray nozzle is not working properly, and needs repair or replace at kitchen sink. Pedestal sink and toilet in hall bath are loose. Replace or repair. Tub faucet is leaky in hall bath. A licensed technician should make corrections.

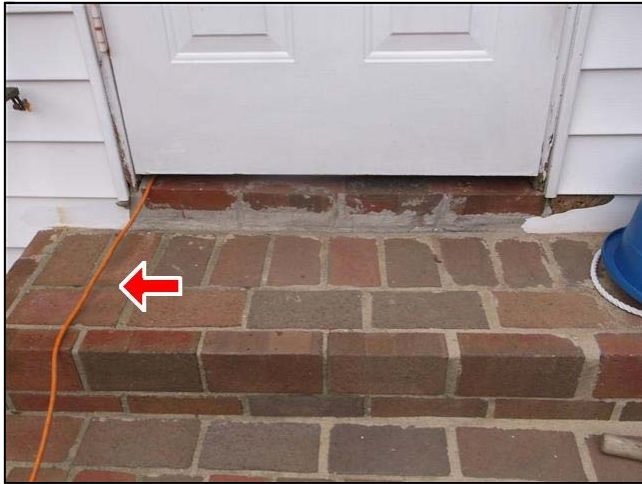
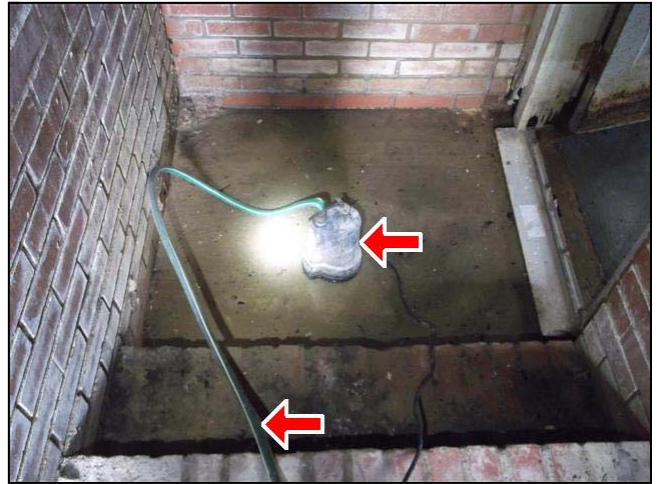
Visible signs of water intrusion in basement are present and a "Sump Pump" is installed. Existing sump pump fails to remove all areas of water intrusion. Replace or repair. The sump pump uses an extension cord as permanent power source. This is a safety issue if not corrected. A licensed technician should be consulted to evaluate and

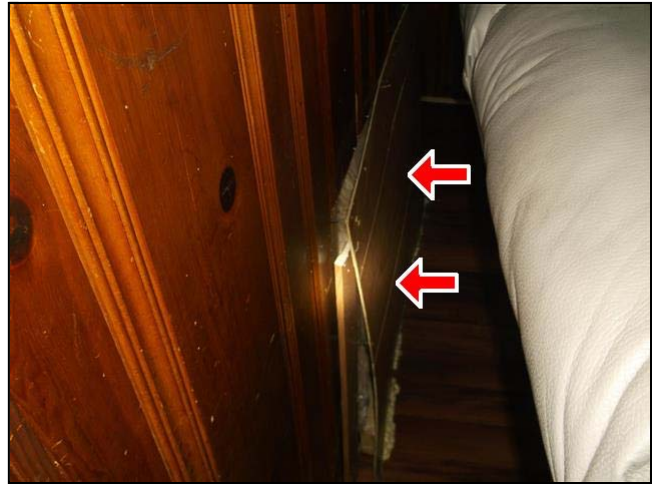
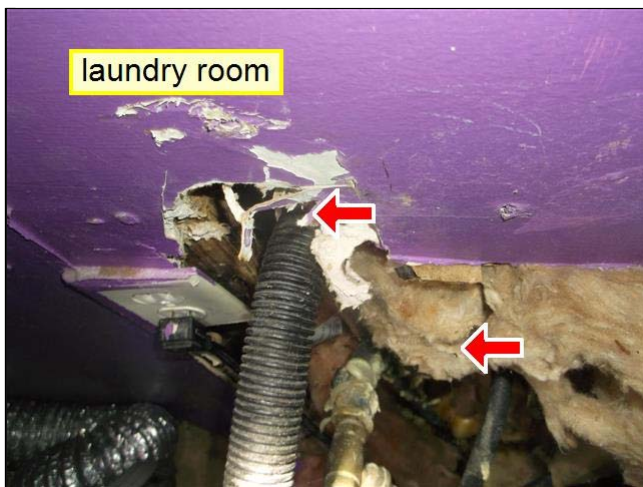
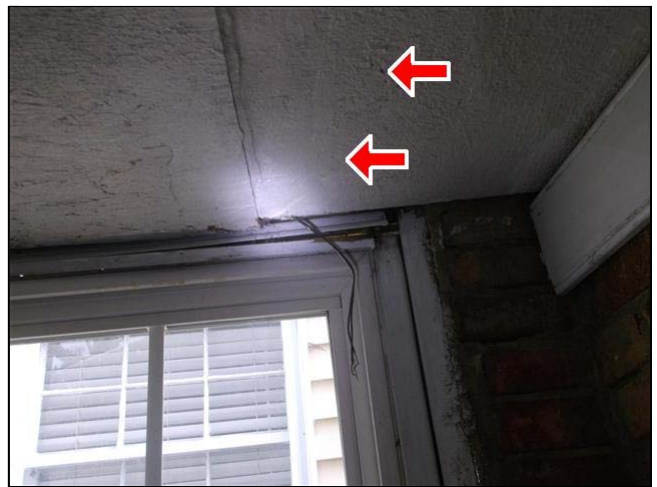
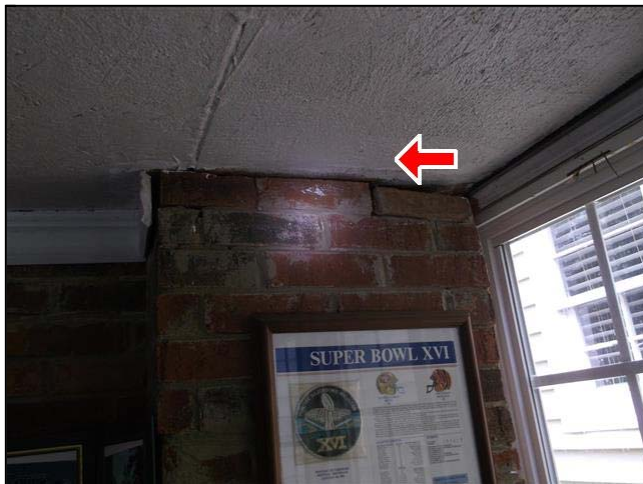
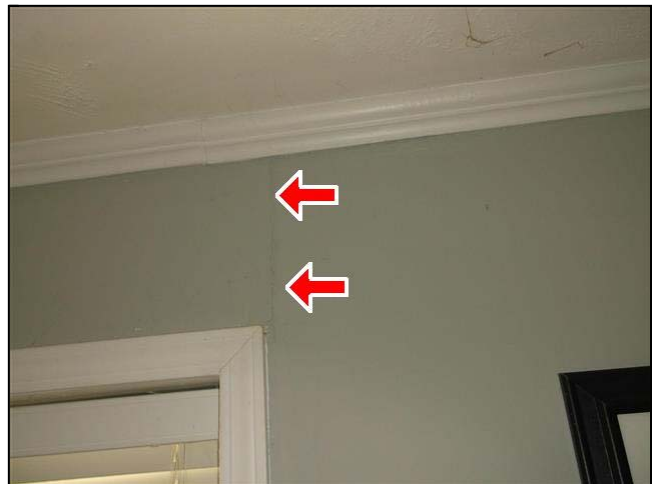
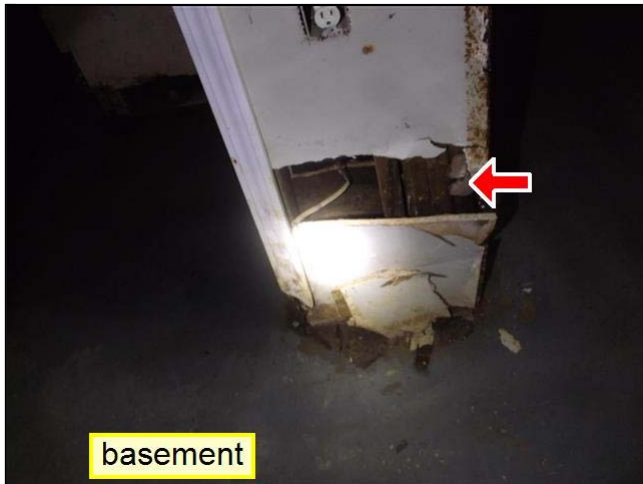
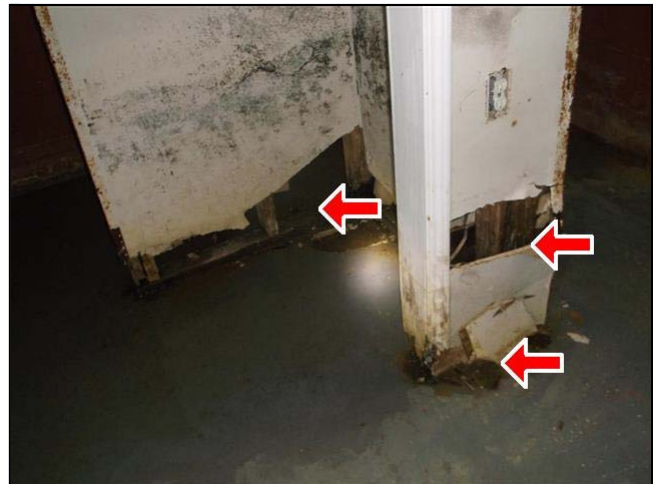
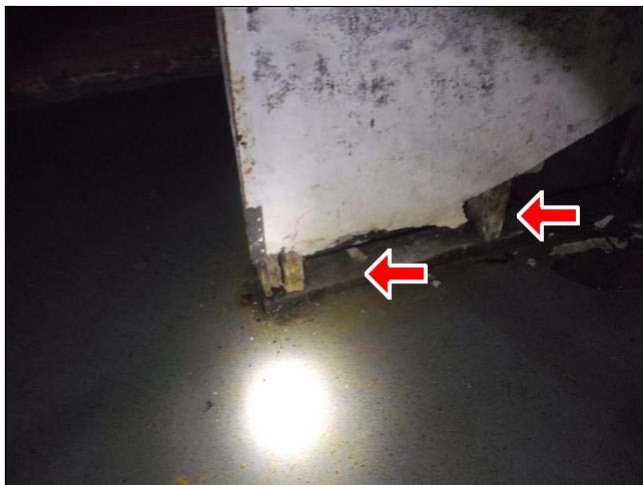
Damage to the interior finish was observed in various locations(mold in living room at fireplace). Recommend repairing. A licensed technician should make corrections.

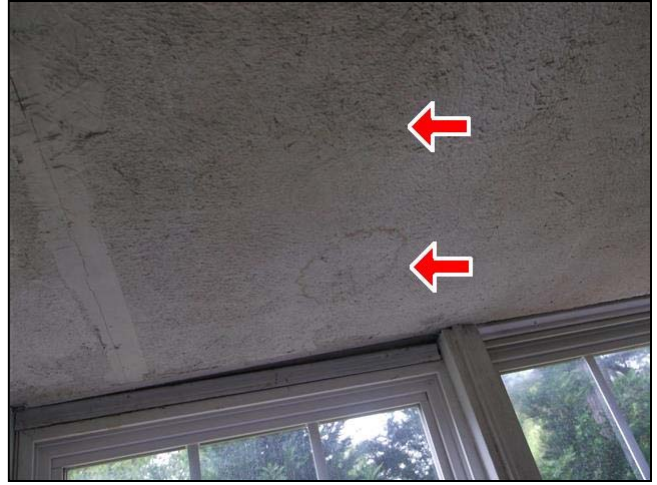
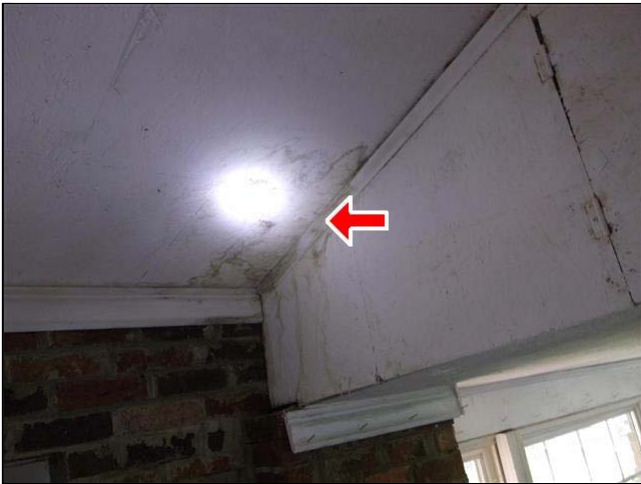
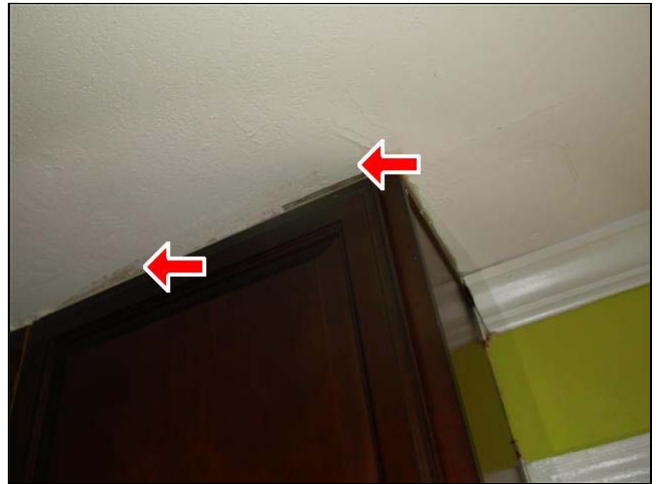
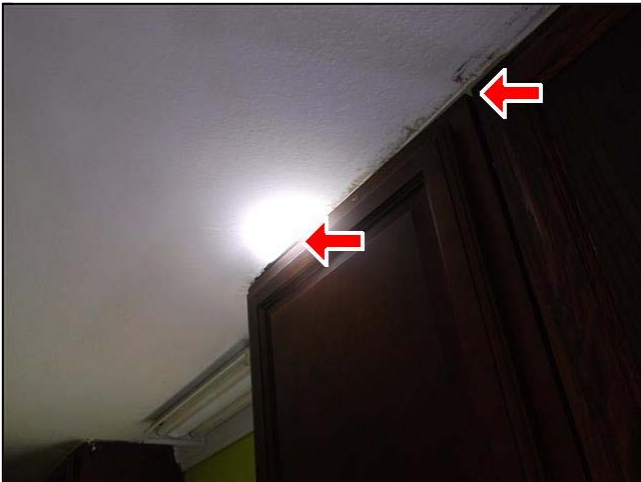
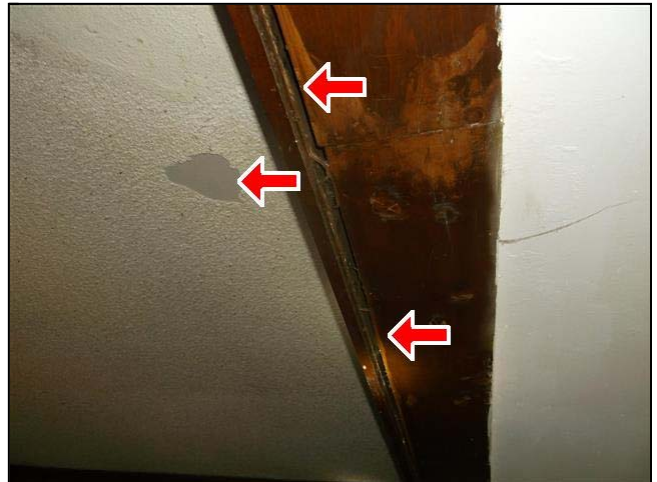
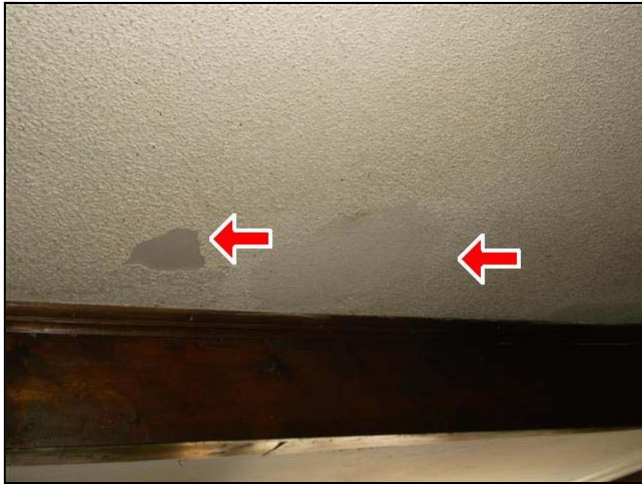
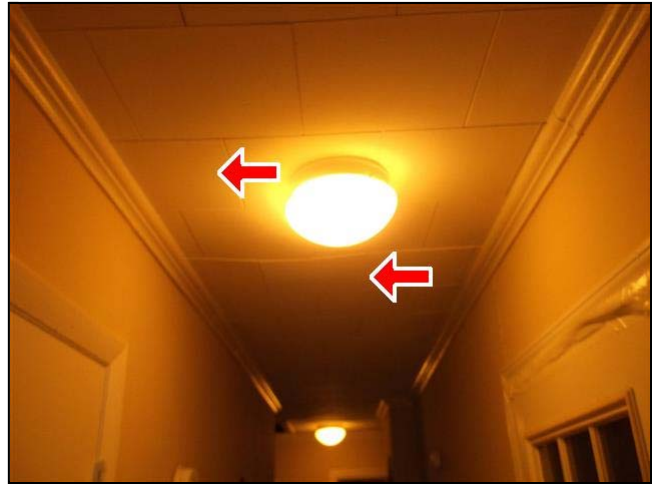
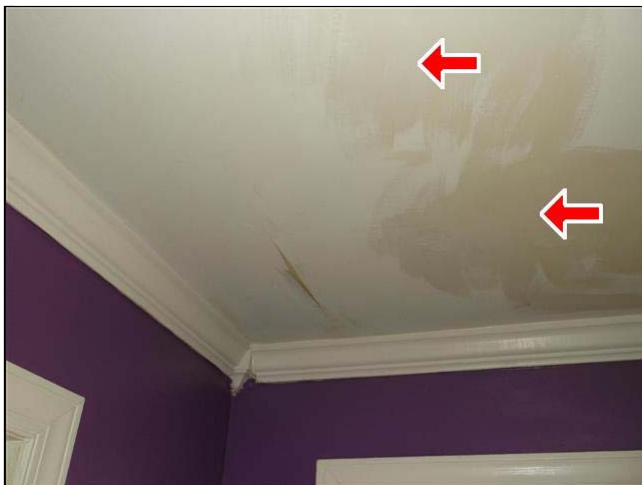
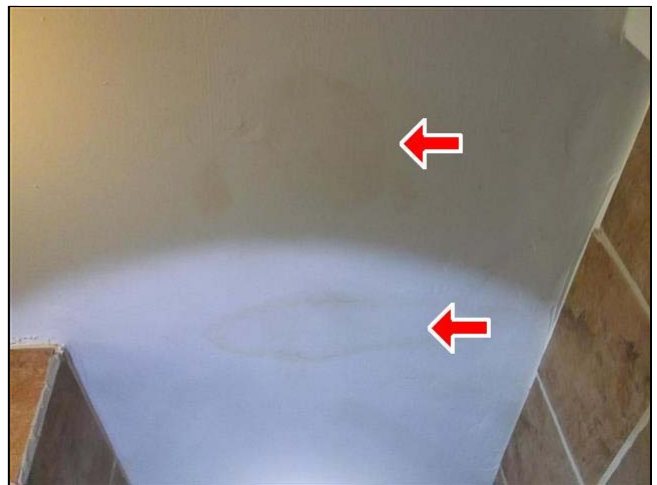
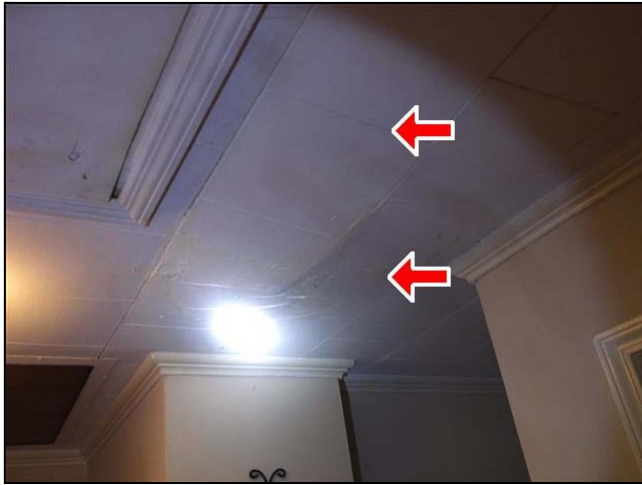
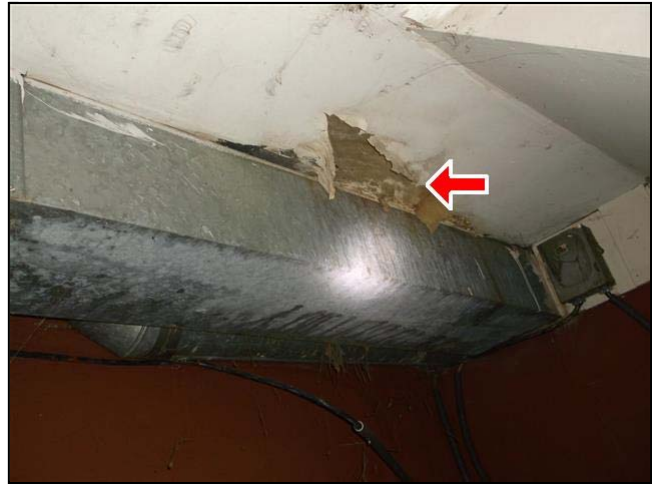
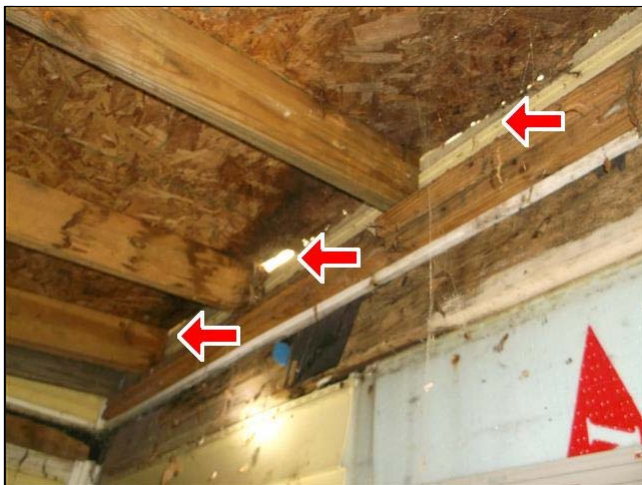
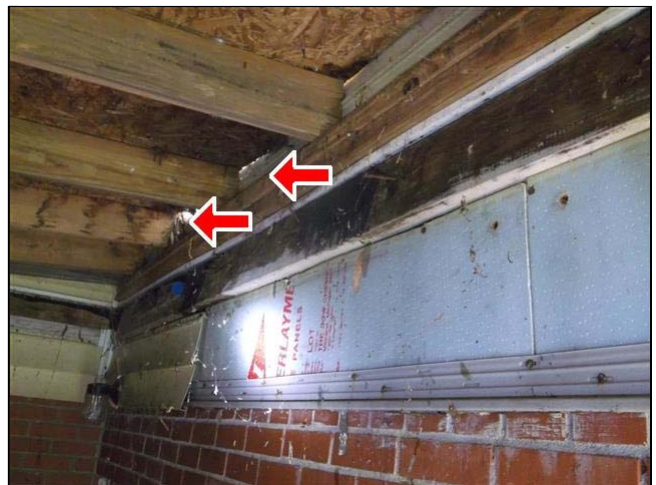
Damage to the interior finish was observed in several ceilings throughout home. Repair as needed. A licensed technician should make corrections.
