## Inspection Report

### ERD Home Inspections

**Property Address:**  
home inspection way  
Monroe NC

<b>Date:</b> 5/10/2016	<b>Time:</b>	<b>Report ID:</b> 5/10/2016
<b>Property:</b> home inspection way Monroe NC	<b>Customer:</b> ERD Home Inspections	<b>Real Estate Professional:</b>

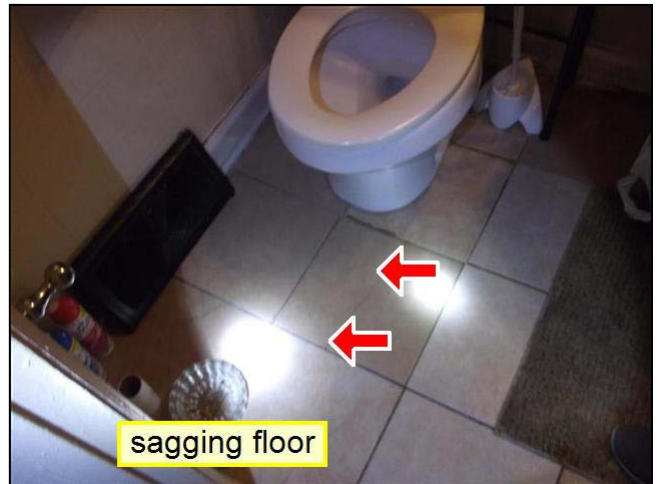
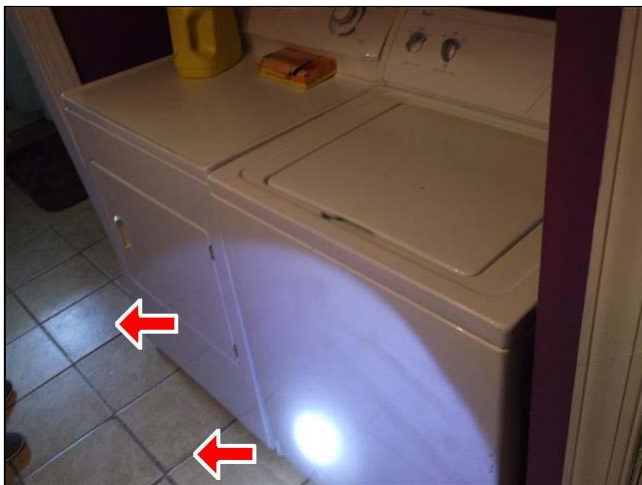
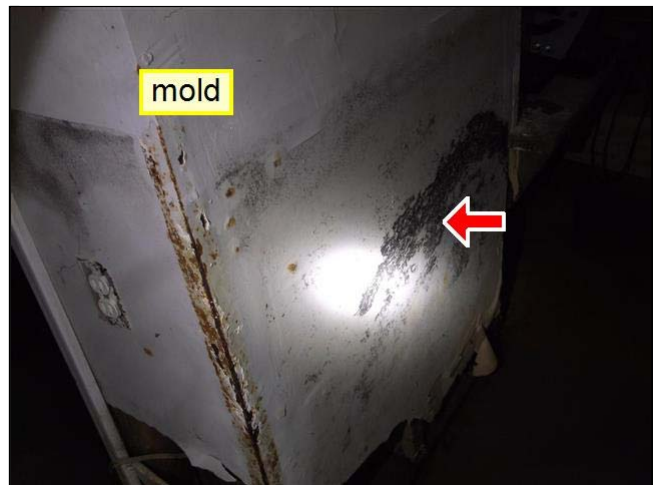
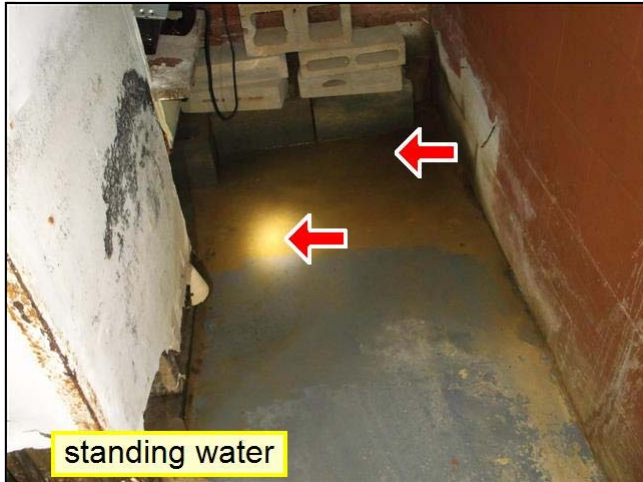
Sagging floors are apparent at kitchen and baths. Recommend repairing. Flooring in basement is flooded. Recommend repairing. A licensed technician should be consulted to evaluate and make corrections.

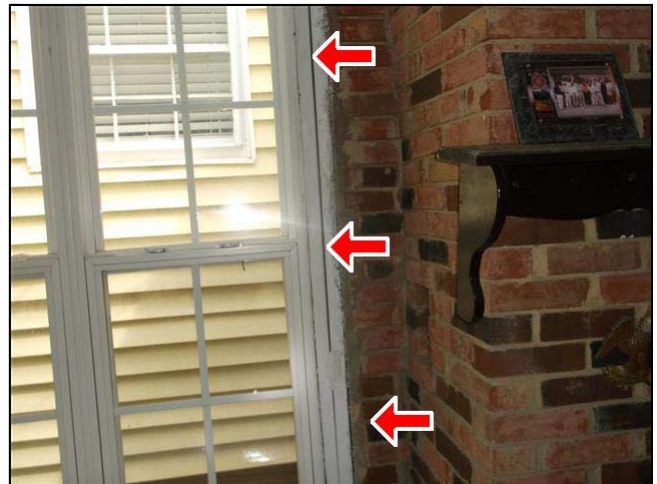
10.5 Item 2(Picture)

The windows are in need of repair. This is a common condition that does not necessitate major repair. Trimming and adjustment, hardware improvements would be logical improvements. The most important factor is that the window exteriors are well maintained to avoid rot or water infiltration. Windows are difficult to operate and are not considered a functional window at various locations. Recommend repairing. A licensed technician should be consulted to evaluate and make corrections.

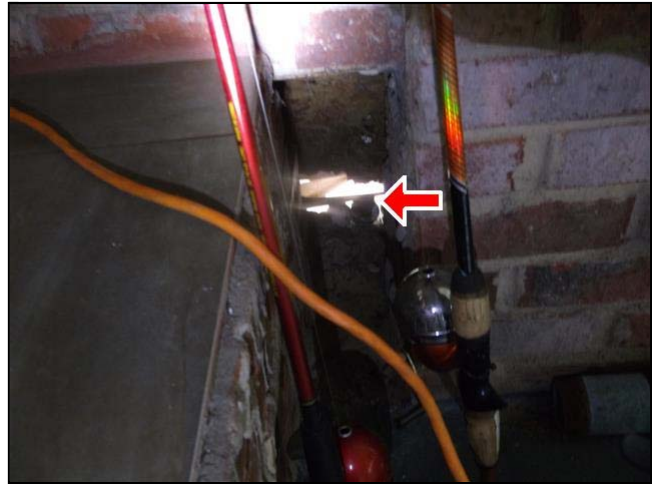
10.7 Item 2(Picture)

Entry door shows daylight when closed at patio. Weather stripping needs improving to keep out unconditional air. Several doors does not fit opening properly (out of square) . Replace or repair. A licensed technician should evaluate and make corrections.

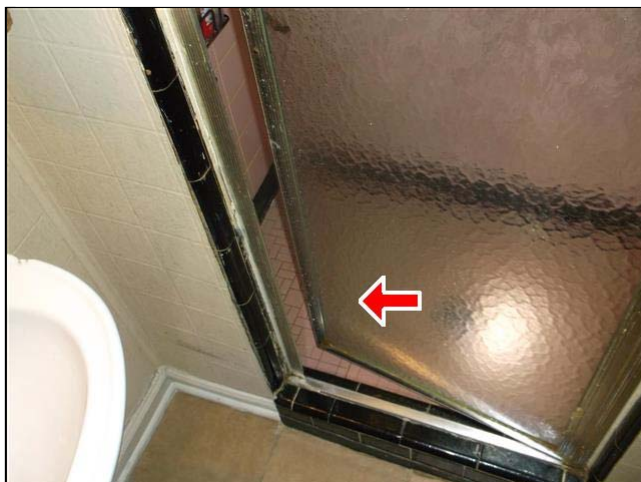
10.8 Item 1(Picture)

Shower door is damaged at hall bath. Replace or repair. Damaged metal door to basement . Replace or repair. A licensed technician should be consulted to evaluate and make corrections.

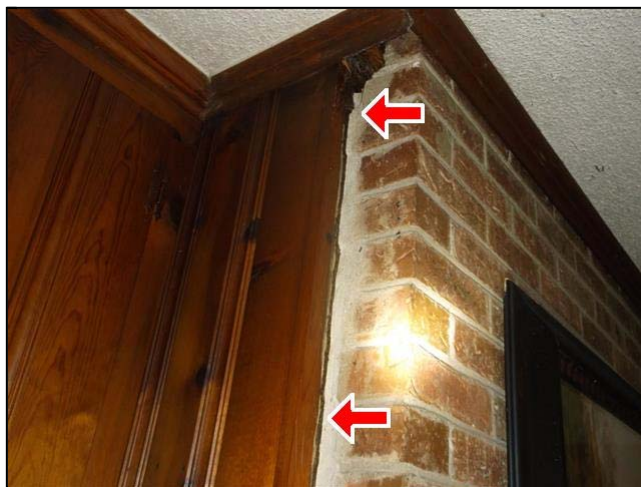
10.9 Item 2(Picture)

The hearth outside the fireplace is damaged. Replace. Localized pointing of deteriorated mortar between the bricks of the fireplace is recommended to avoid fire chips from entering. A licensed technician should be consulted to evaluate and make corrections.
